O.T.3.1.d Pilot Actions on 4 (6) Road Safety Thematic Areas

TA2 VRUS – CZECH REPUBLIC

**RADAR – Risk Assessment on Danube Area Roads**

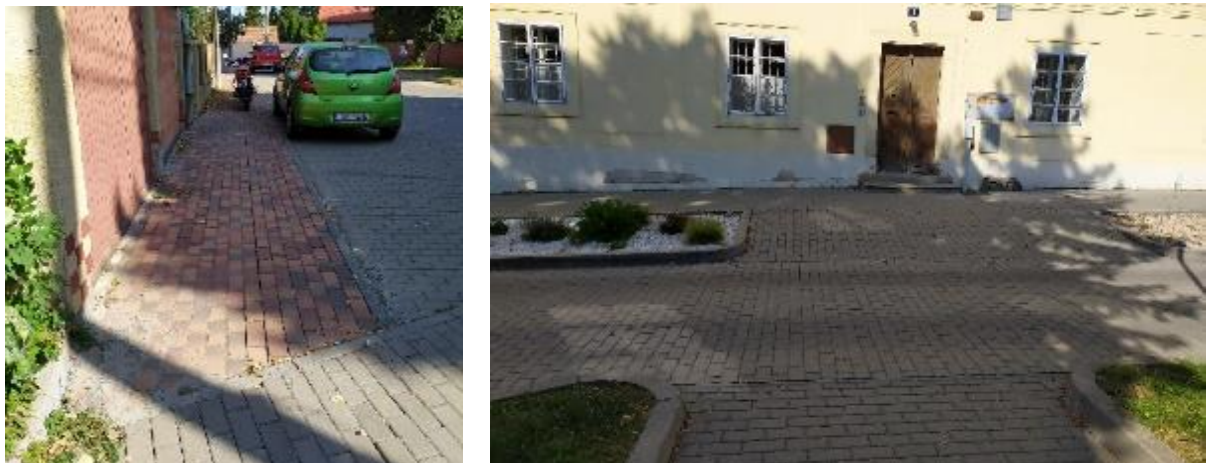
In certain locations, sidewalks are clearly expected to be used by cars, as well.

Figure 5 – Connections of sidewalk surface with road surface

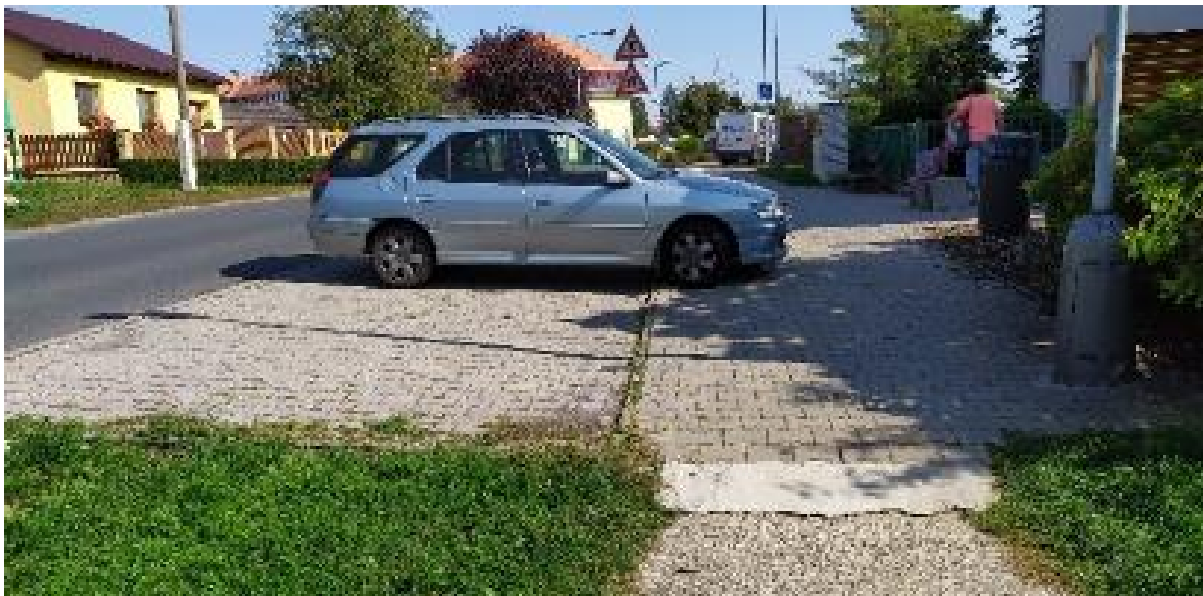
At some locations, parking is allowed on sidewalks perpendicularly to the road even in front of residential entrances, which creates a safety risk to pedestrians.

Figure 7 – Inappropriate parking obstructing pedestrian movement on sidewalk

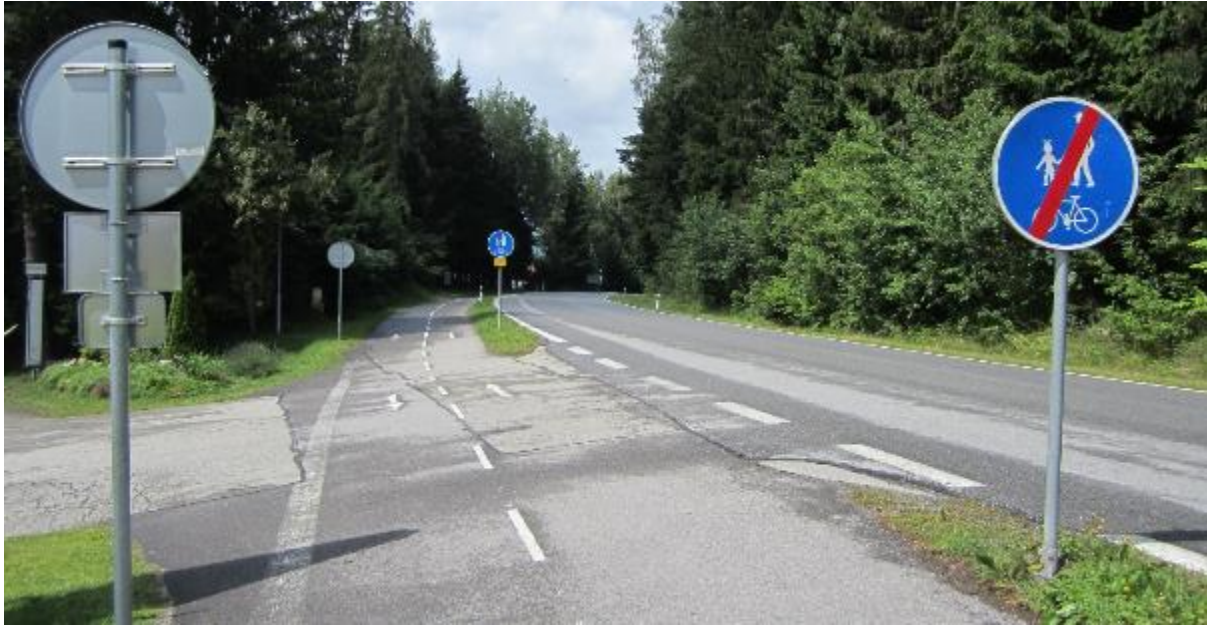
Figure 12 – Recreation area survey, road II/163, parallel mixed-use path along the Lipno water reservoir, interfered with the access to a camp site

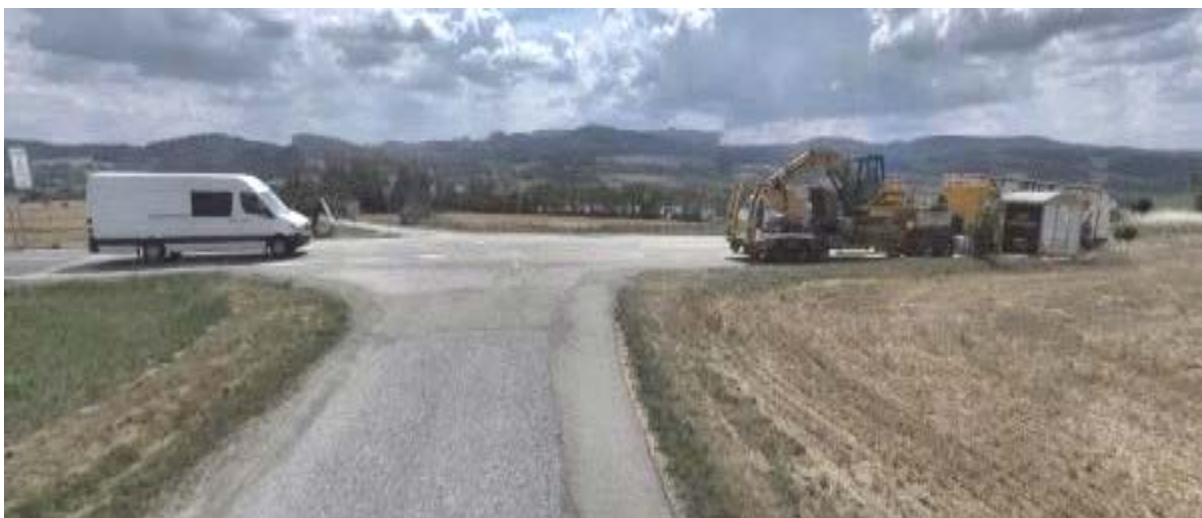
Figure 19 – Crossroad view from west, bus stop obstructed by parked heavy vehicle

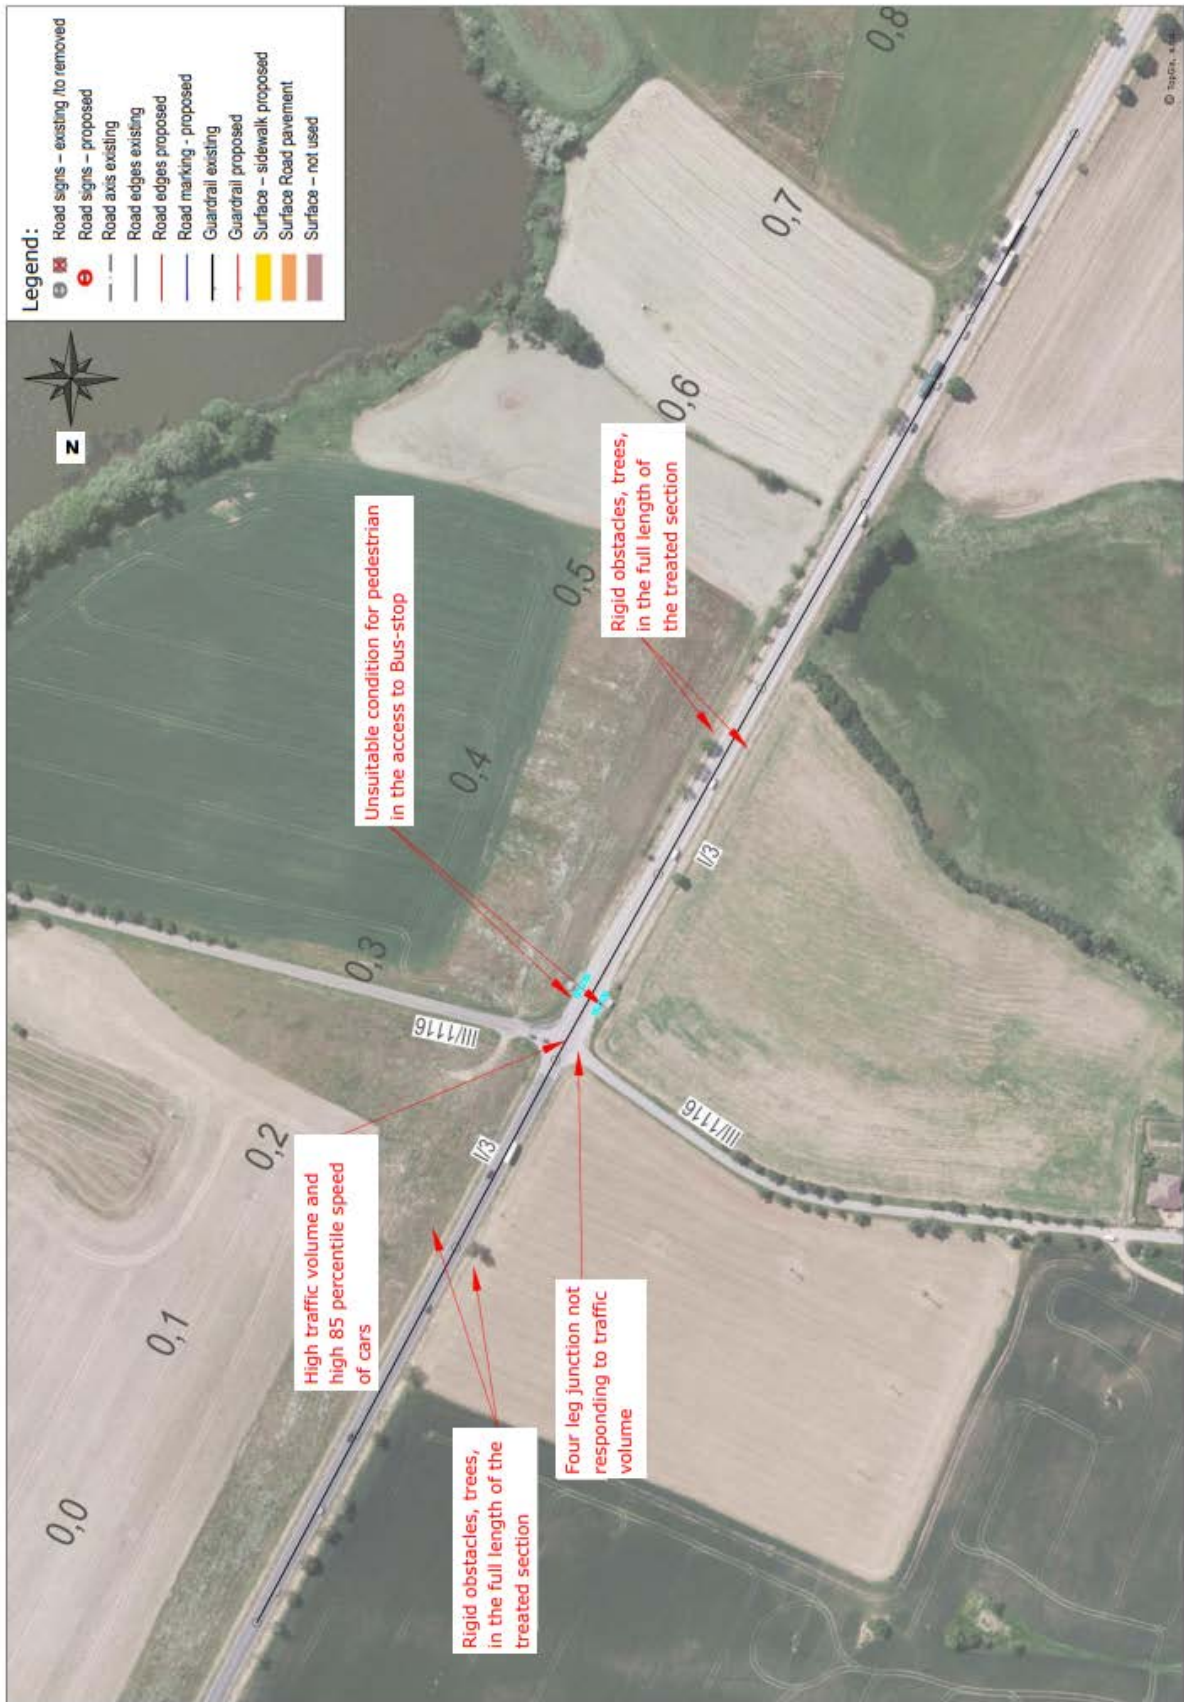
Figure 27– Case 1 existing layout scheme

- unsatisfactory 4-leg intersection with poor road marking (no marking on side roads);
- unsatisfactory conditions for pedestrian movements at the bus stop;
- high traffic volumes;
- high actual speeds;
- occurrence of solid obstacles – trees (almost along the whole length of the road section assessed).

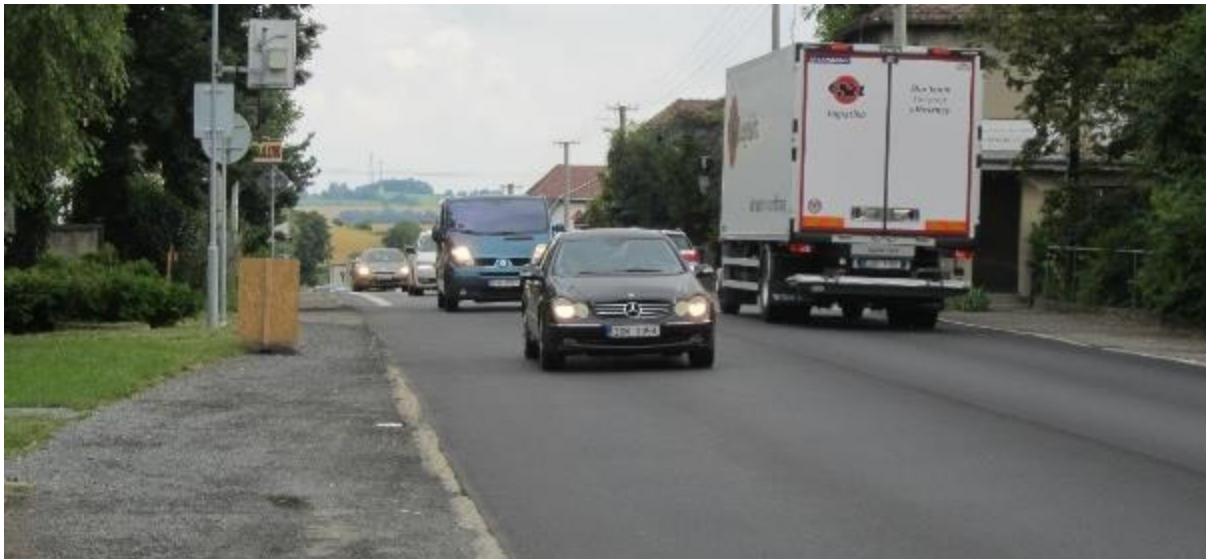
Figure 45 – 1/3 through road in Olbramovice – section with sidewalks on both sides, but levelled wit road surface due to numerous surface treatments

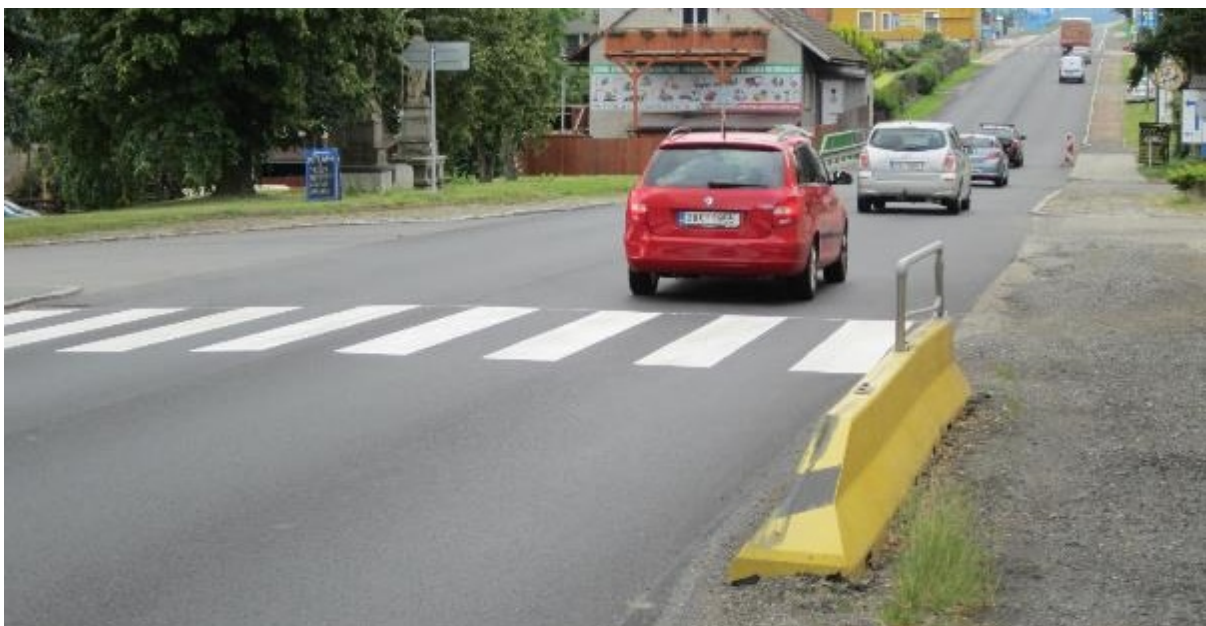
Figure 46 – 1/3 through road in Olbramovice – disputable highlighting of a crossing with a concrete barrier, sidewalks at the same level as road surface

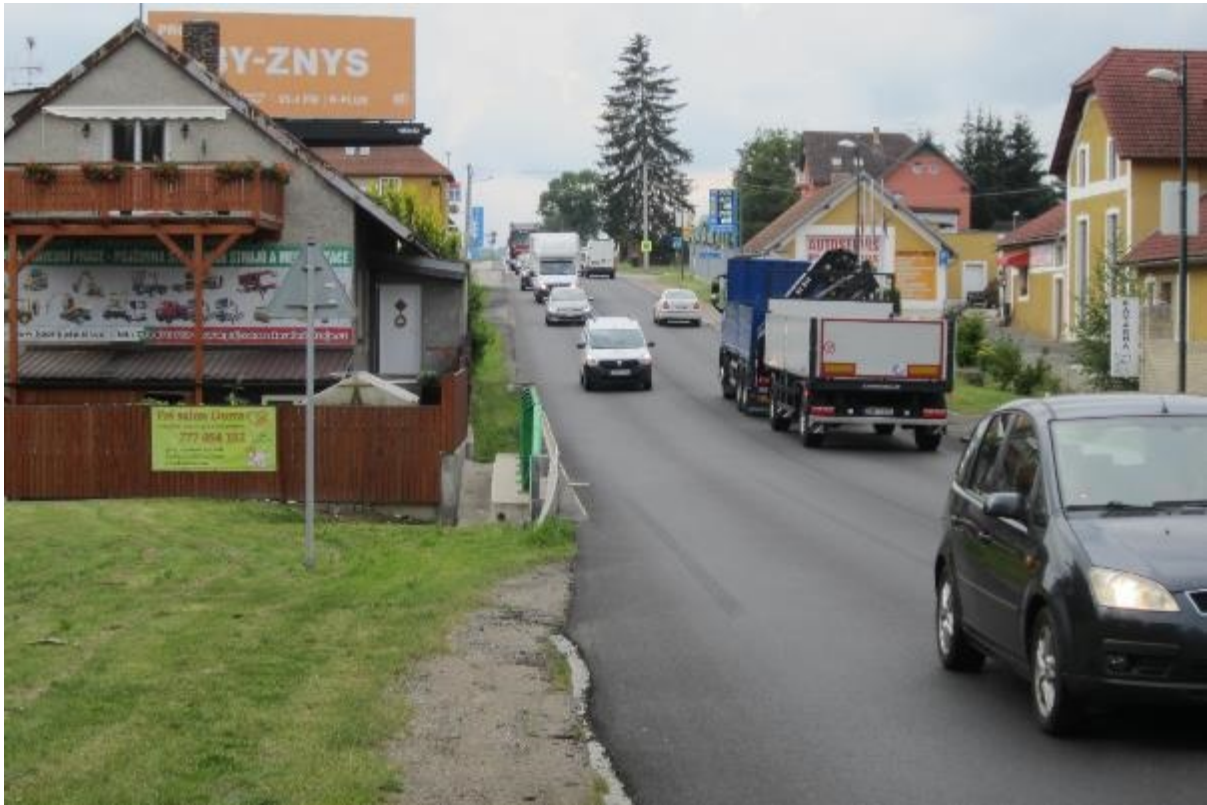
Figure 47 – 1/3 through road in Olbramovice – walking possible on one side only

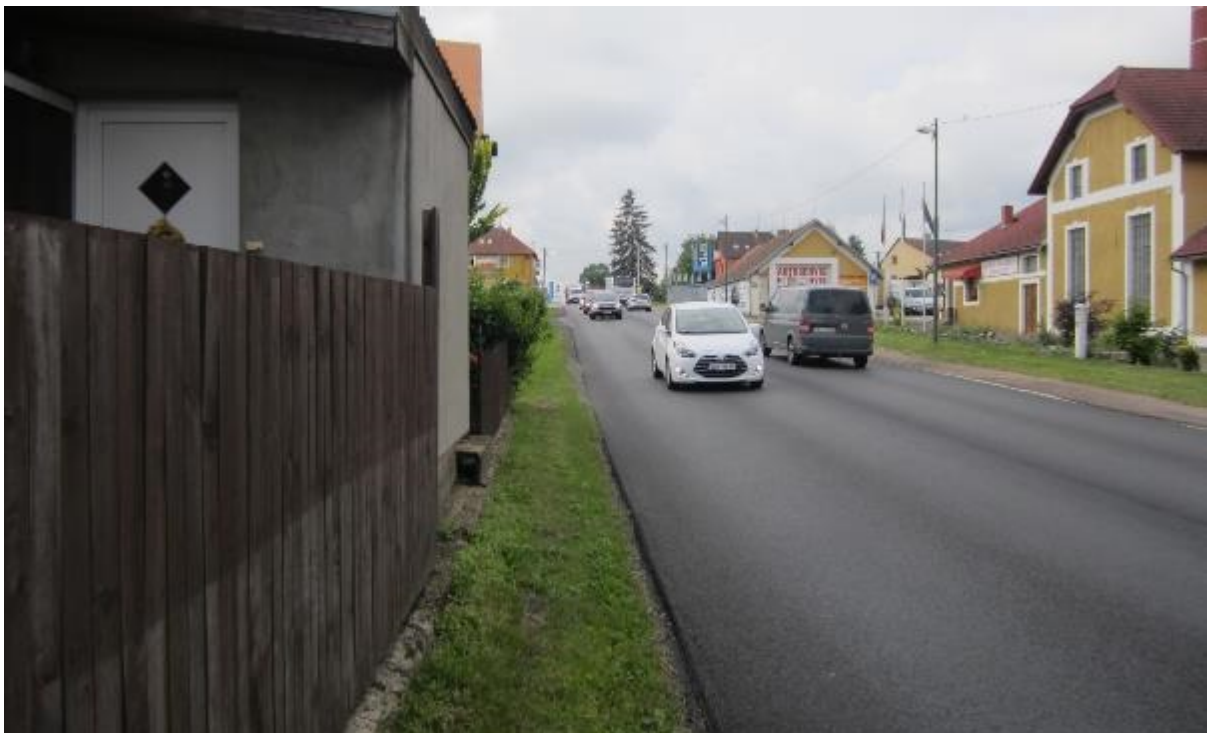
Figure 48 – 1/3 through road in Olbramovice – walking possible on one side only

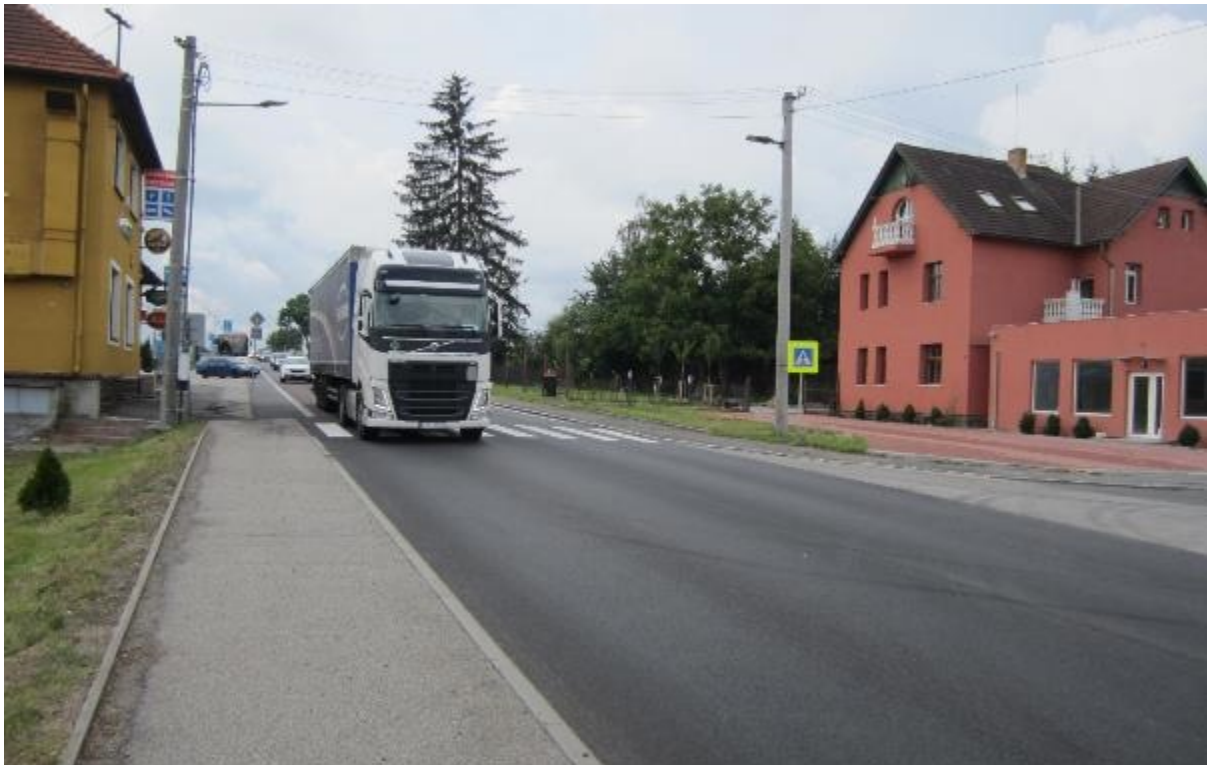
Figure 49 – 1/3 through road in Olbramovice – poorly equipped pedestrian crossing, pedestrian provisions not continuous

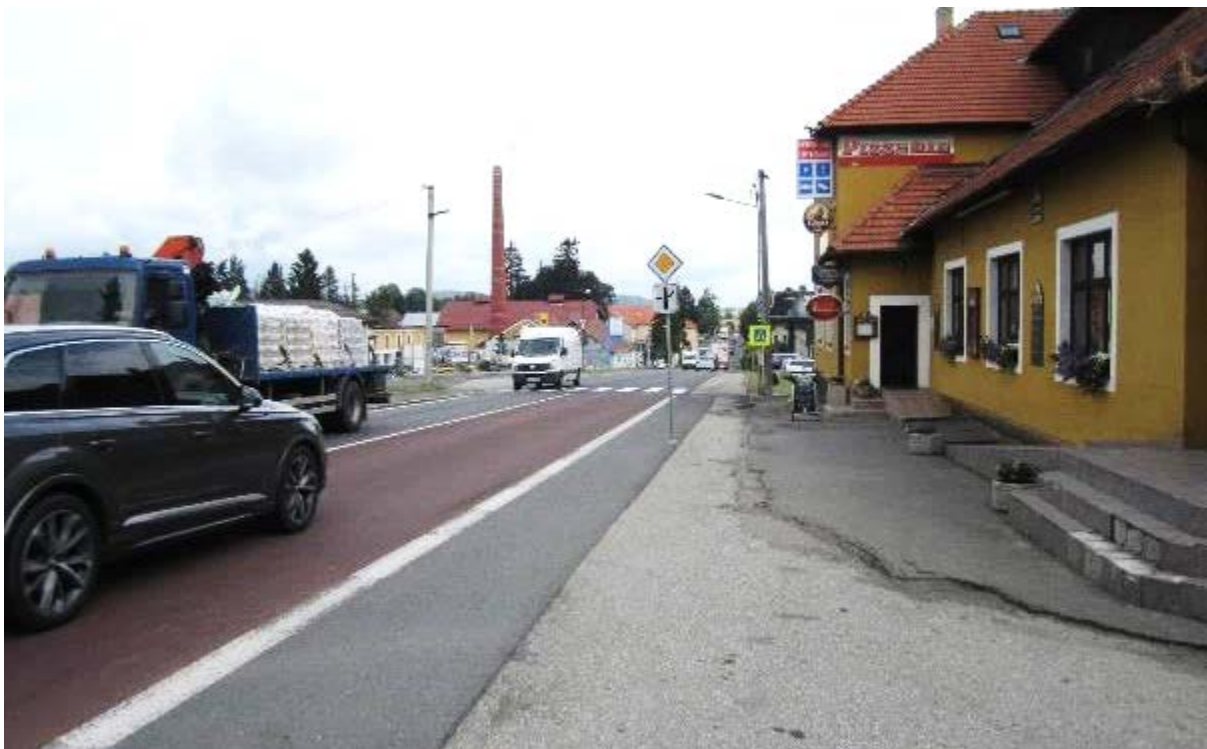
Figure 50 – 1/3 through road in Olbramovice – pedestrian crossing highlighted by coloured road surface but pedestrian facilities levelled with road surface

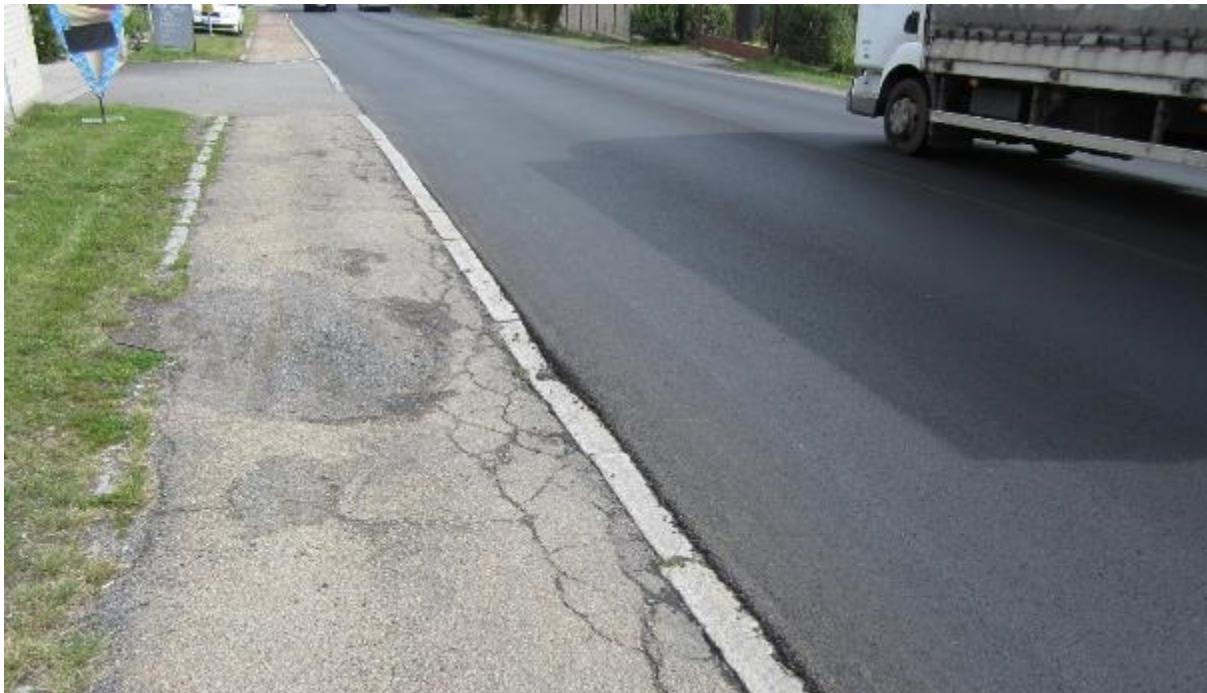
Figure 51 – I/3 through road in Olbramovice – detail of a sidewalk condition – bad surface, levelled with road surface

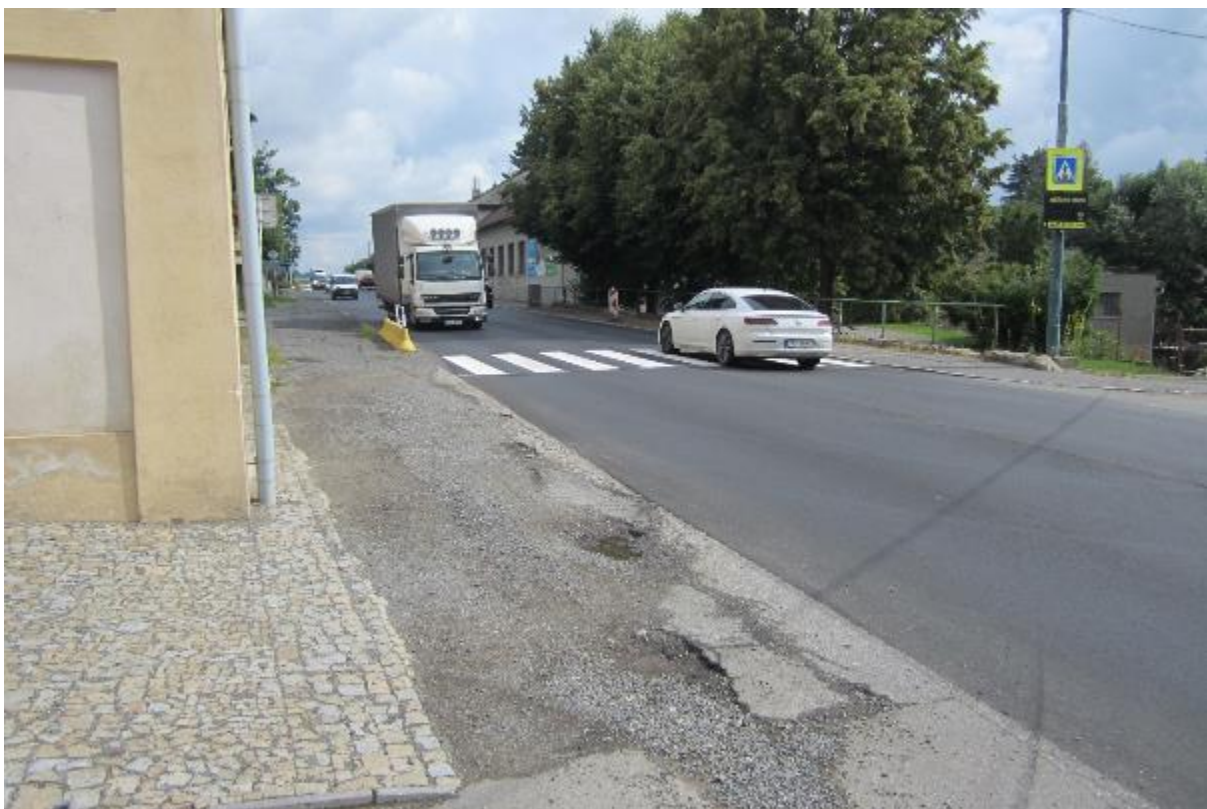
Figure 52 – I/3 through road in Olbramovice – another example of sidewalks condition on a road of international importance

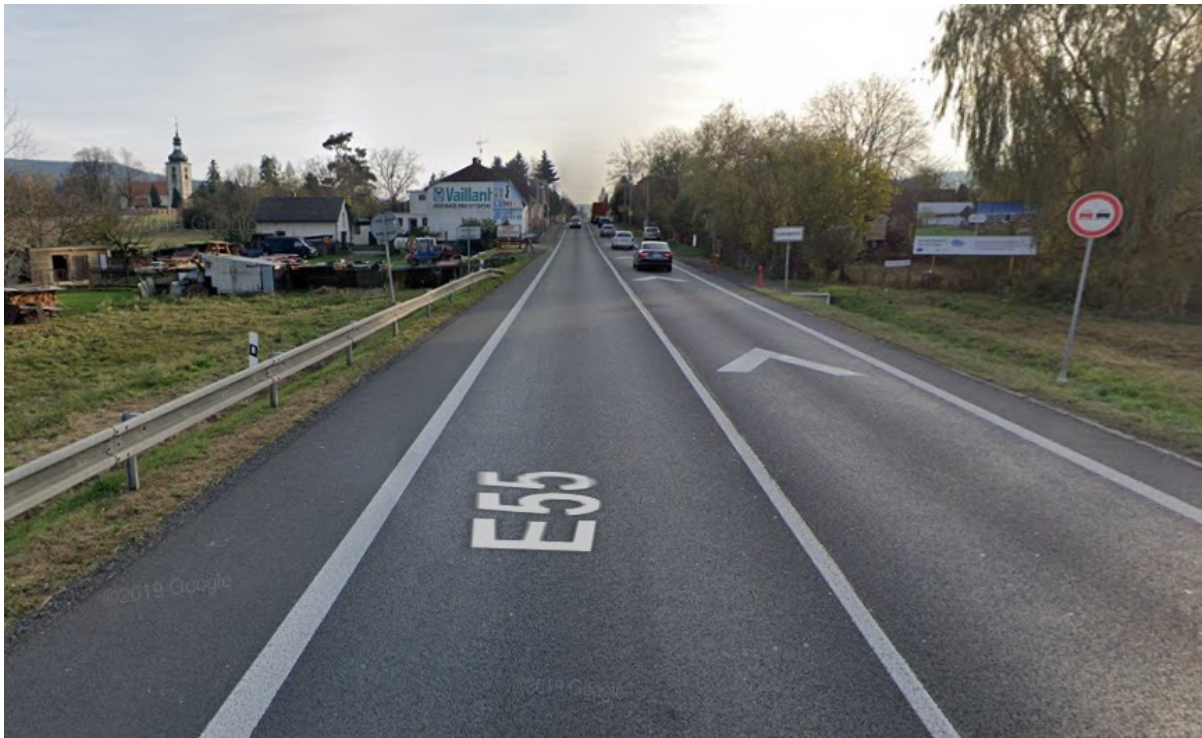
Figure 53 – North entrance to Olbramovice – no physical entry measures, 12 “safe distance” road marks

- entries to the municipality:
 - traffic calming measure – entry islands; (speed limit 50 is given by traffic law by sign “Village name”)

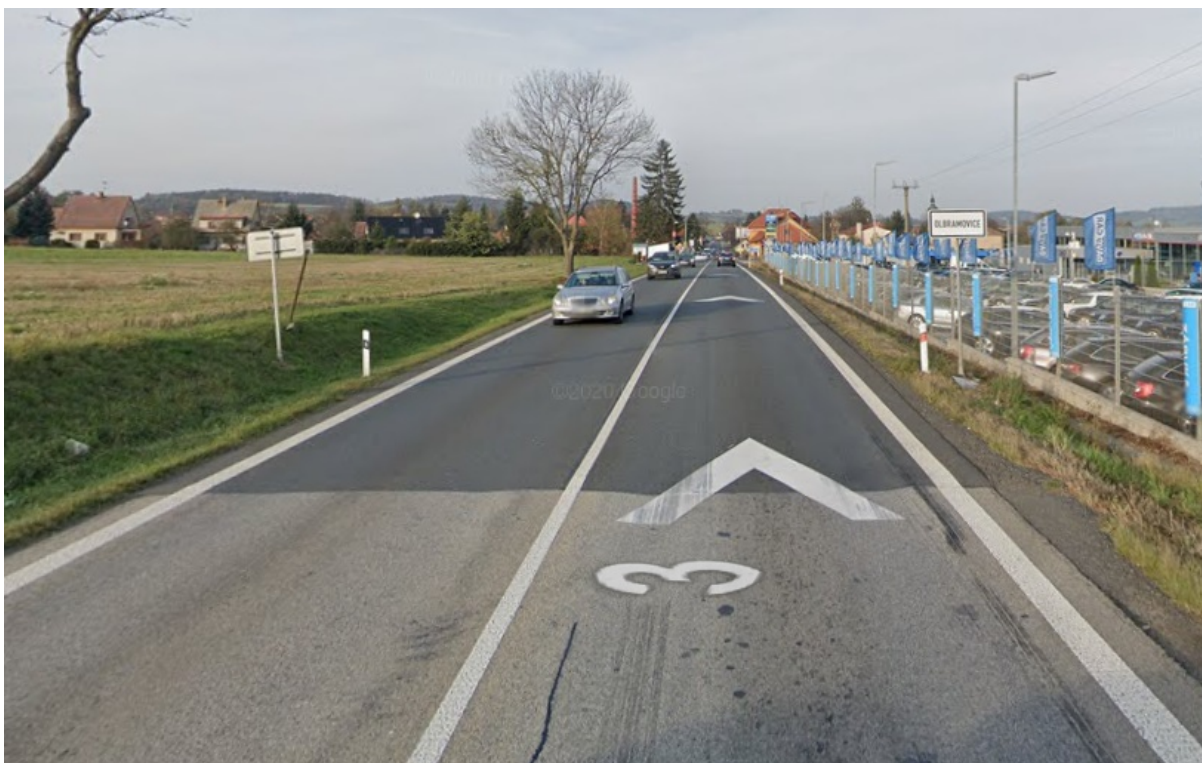
Figure 54 – South entrance to Olbramovice – no physical entry measures, speed limit signs 90-80-60-50 km/h, 13 “safe distance” road marks

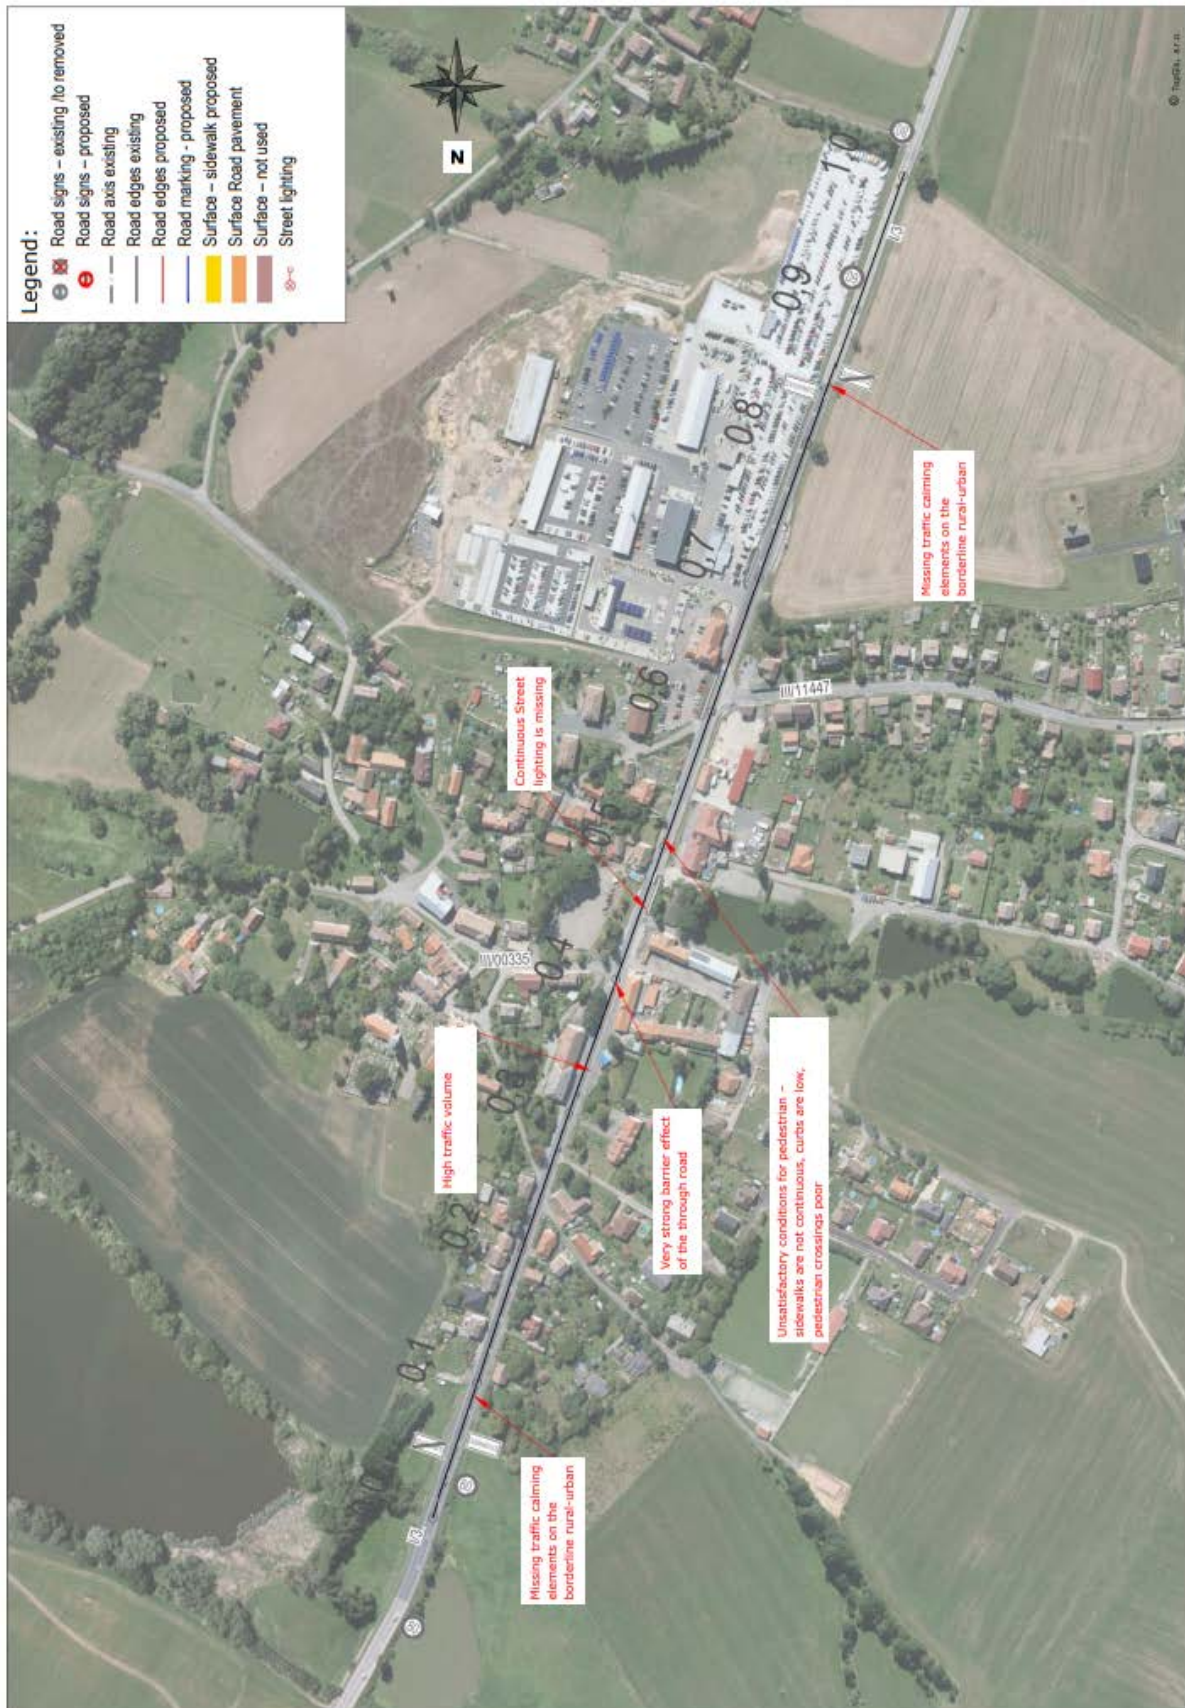
Figure 56 – Case 2 general layout of existing safety deficits

- missing traffic calming measures at the rural – urban interfaces on both entries;
- strong barrier effect in the municipality;
- unsatisfactory conditions for pedestrians:
 - discontinuous sidewalks
 - sidewalks with no raised edges
 - insufficient safety level of pedestrian crossings;
- high traffic volumes;
- missing continuous road marking.
