Long-term Morphological Development of the Danube in Relation to the Sediment Balance

Authors: Water Research Institute & project partners (BME, BOKU, OVF,
NARW, NIHWM, LfU, NIMH, EAEMDR, HRVODE, IzVRS, TUM, JCI, Plovput)

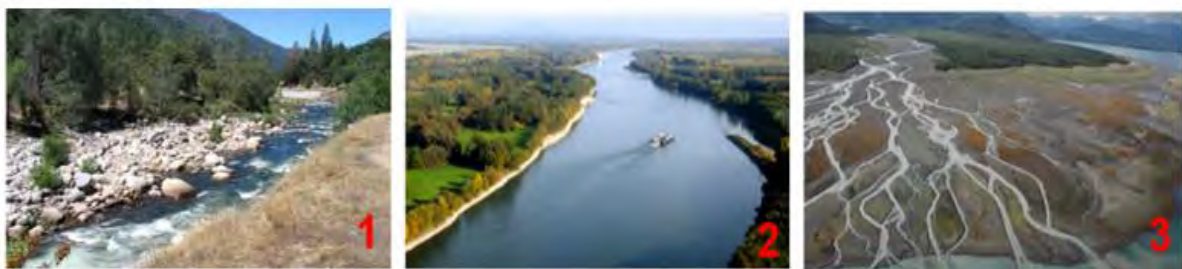
Figure 3.2.3 Examples of river channels in the upper and lower sections

In the upper valley, vertical erosion dominates, creating a narrow, relatively shallow V-shaped channel cut into the ground, with a steep gradient. Large amounts of coarse sediments produced by erosion in the upper valley and in the channel itself, are transported downstream. Vertical erosion decreases, while lateral erosion and deposition in the river channel prevail in the middle transitional section, hence the sediment load is lower there. The river channel is wider and deeper with a moderate gradient. There are more balanced sedimentary conditions in the transitional section, hence the erosion and deposition processes are in dynamic equilibrium. A wide and deep river channel with a gentle gradient is typical for the lower section, where lateral erosion (bank erosion, collapse) and channel sedimentation (the formation of islands and bars) dominate in response to the reduced sediment transport capacity.

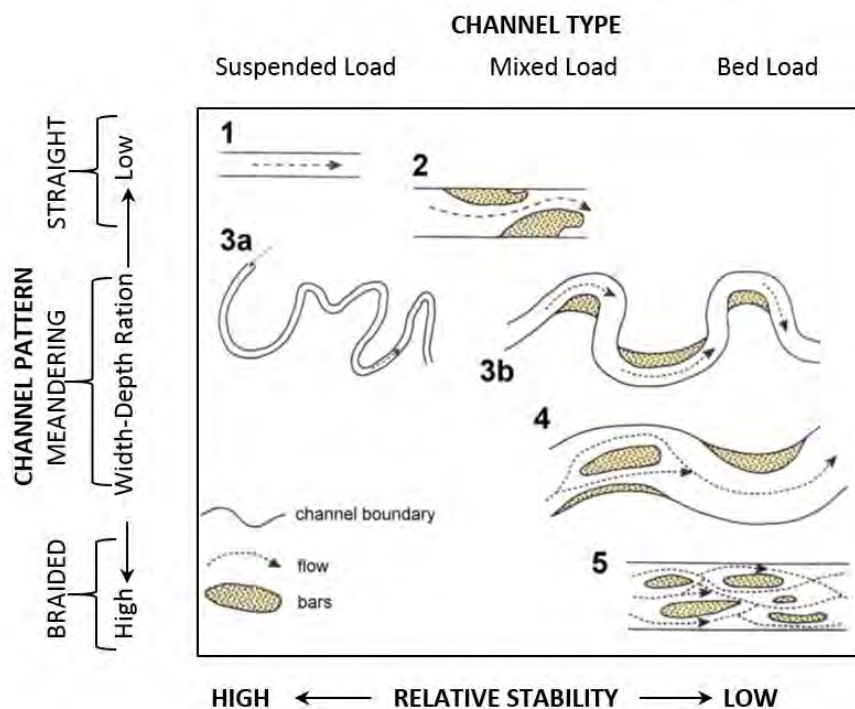
Figure 3.3.1 Classification of river types based on the relationship between sediment load and channel stability (Schumm, 1977)

Various systems can be found in literature (Leopold & Wolman, 1957; Schumm, 1977; Rust, 1978) for classifying channel patterns according to their morphological characteristics. Most of them assume a continuum of planform patterns using various combinations of geomorphological features for the river channel and/or river processes (sediment load, channel stability) to classify the river type. The general relationship between sediment load and channel stability/shape was first defined by Schumm (1977). The classification shown in Figure 3.3.1 grades from straight, through meandering, to braided channels.

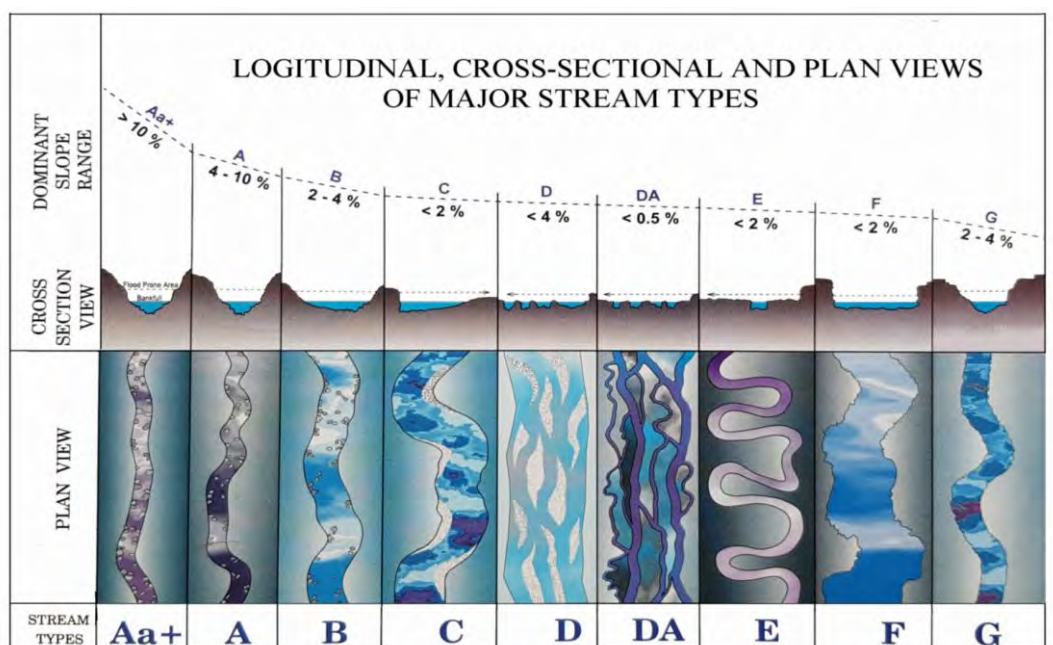
Figure 3.3.4 Rosen's morphological classification system – seven basic types of river channels and the corresponding morphological characteristics – gradient (modified by Rosgen, 1996)

The most comprehensive classification system developed by Rosgen (1996) divides rivers into seven basic types according to the degree of their entrenchment, gradient, width/depth ratio and sinuosity (Figure 3.3.4). In addition to these seven basic types, Rosgen divided each category into six subcategories according to the dominant type of bed and bank materials (94 subtypes in total). The result is a comprehensive classification system, but its proper application requires in-depth knowledge of the geomorphological conditions, as well as practical experience. Rosgen's system of semi-quantitative holistic morphological classification incorporates all three dimensions of the river channel, and takes into account the differences in the channel-forming materials, too. This approach, combining a qualitative description with the quantitative parameters in the definition of channel types, represents, without doubt, the way forward. However, Rosgen's method does not represent the final classification system.

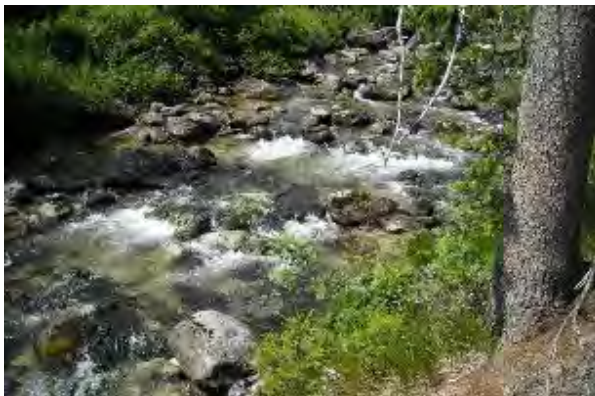
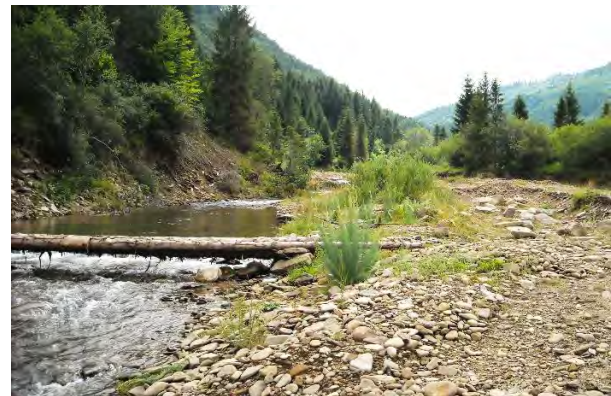
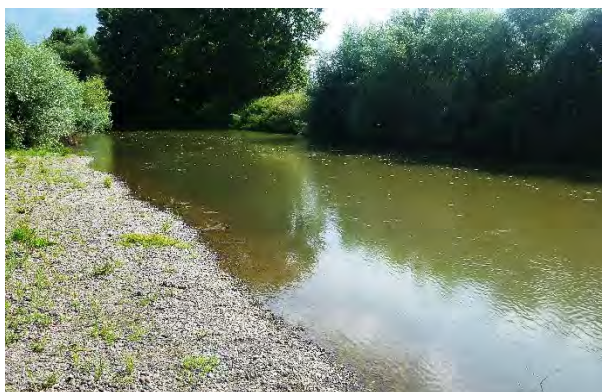
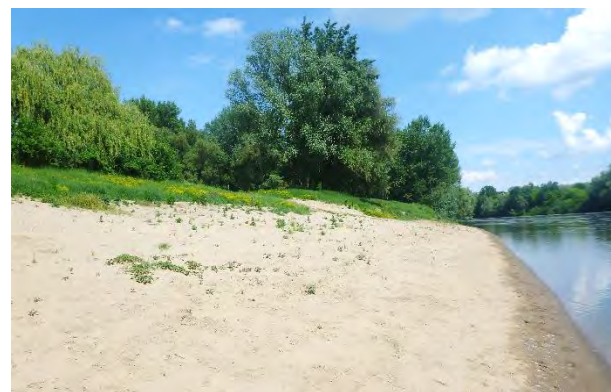
a) Boulder, cobble bed river

b) Coarse gravel bed river

c) Medium and fine gravel bed

d) Coarse and medium sand bed

Figure 3.4.1 Bed sediments in upland (boulders and cobbles), midland (gravel and sand) and lowland rivers (sand, clay)

- Bed sediment size (bedrock, boulder, cobble, pebble, gravel, sand, silt, clay, peat);
- Bed sediment features/units – spatial arrangement of bed sediments, which act in some forms as a complex on the river bed (e.g. waterfall, boulder step, cascade, rapid, bar (mid-channel, point, counterpoint, scroll, etc.), chute, riffle, pool, dune);
- Bed sediment structure representing the composition of the river bed, which may indicate transport, sorting and deposition processes (e.g. armouring, infiltration by silt-clogging).

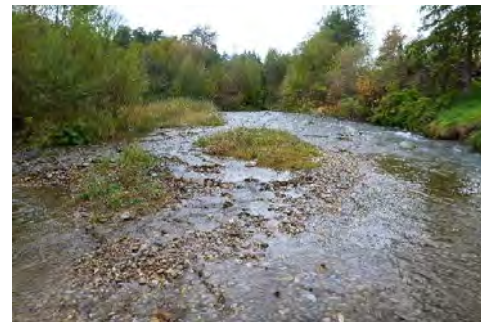
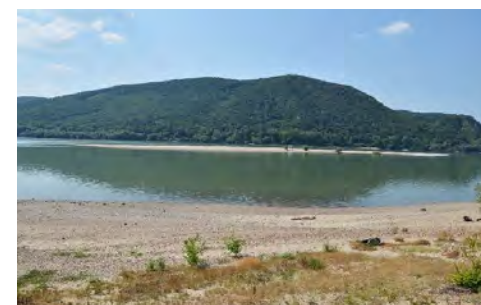
b) Diagonal gravel bar – Hron, Danube’s tributary

c) Longitudinal bar in the Danube at Štúrovo

Figure 3.4.3 Types of channel bars: a) according to Lewin (1978), b) diagonal gravel bar in the Hron River; c) longitudinal bar in the Danube at Štúrovo

Channel bars usually develop in river channels with excessive sediment load (gravel or sand), where the dominant process is aggradation. Various types of channel bars (Figure 3.4.3), including medial, transversal, longitudinal, crescentic and diagonal point bars, and the combinations thereof (Church & Jones, 1982), are typical for certain river types, particularly those with large sediment inputs, e.g. braided and anabranching rivers. Point bars formed on the inner sides of channel bends are also typical for meandering or sinuous rivers.

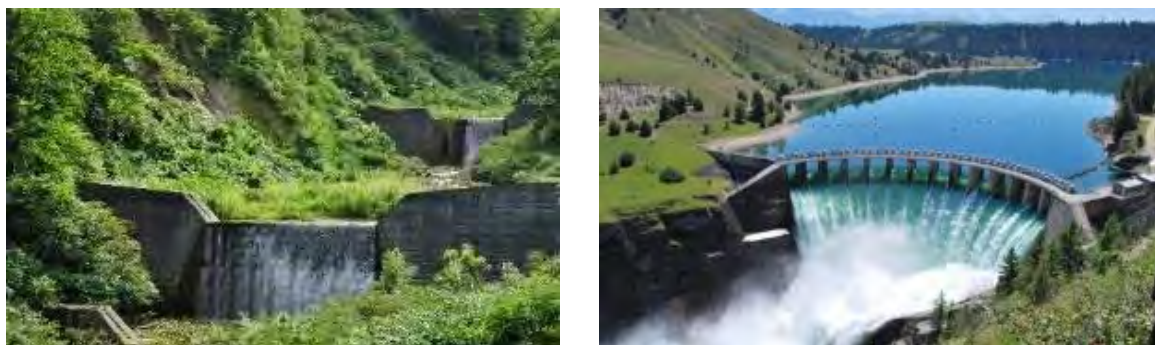
a) Weir for river bed stabilisation on a small river

b) Dam with a reservoir on a large river

River ecosystems form a continuum with gradual changes from the upper to lower reaches. Therefore, lateral and longitudinal connectivity disruption, accompanied by the ecosystem's fragmentation, represents one of the main human pressures on hydromorphology and ecology. River regulation (such as bank protection, the cutting-off of meanders and side arms), which separates the river and floodplain processes, leads to the reduction of lateral

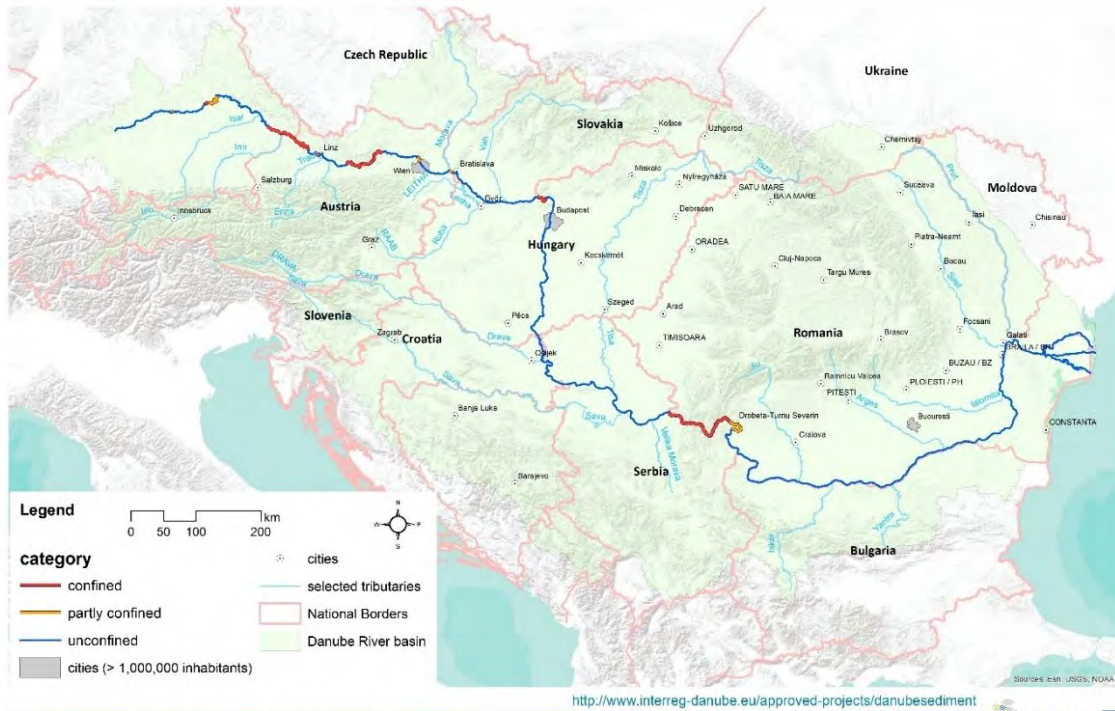
Figure 4.1.2 Confinement of the Danube River channel

Considering the confinement, longitudinal profile, riverbed slope, bed material calibre, channel pattern, floodplain and the morphological indexes, 9 river types were identified for the reference state and 4 types at the present state of the Danube River (Table 4.1.1 and 4.1.2). Longer sections of the Danube were categorised on the basis of short river reaches, which were identified in the first step – a certain level of generalisation was necessary in the context of the Danube river Basin's scale.

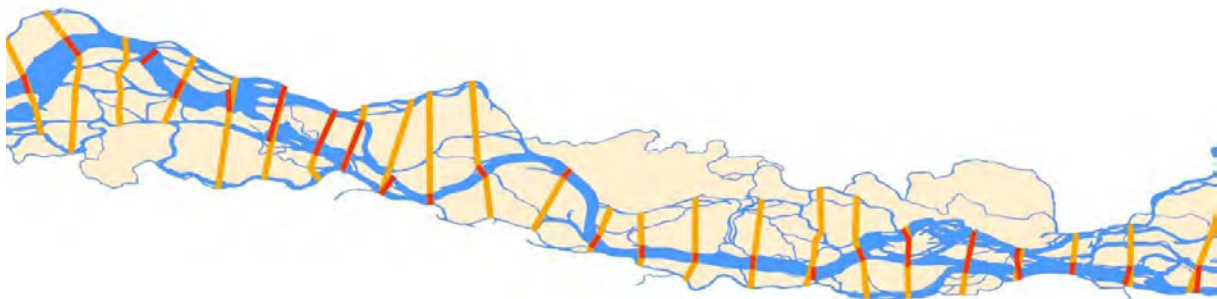
Figure 4.2.3 Estimation of the Danube river widths of the active channel (red colour) and of the river system (orange colour) for reference state

- **Active channel for bedload transport:** the width of the assumed active part of the river system for bedload transport - the main channel (usually navigational channel) and its branches comparable in size, without side-arms, only islands in the channel and among the main branches were included;
- **Full width of the river system:** covering the river channel/channels, branches and side arms, islands in the channel and within the whole river system; only side arms wider than 10% of the main channel were included.

An example how the Danube river widths were estimated for the whole river system and for the assumed active channel for bedload transport (reference state) is shown in Figure 4.2.3.

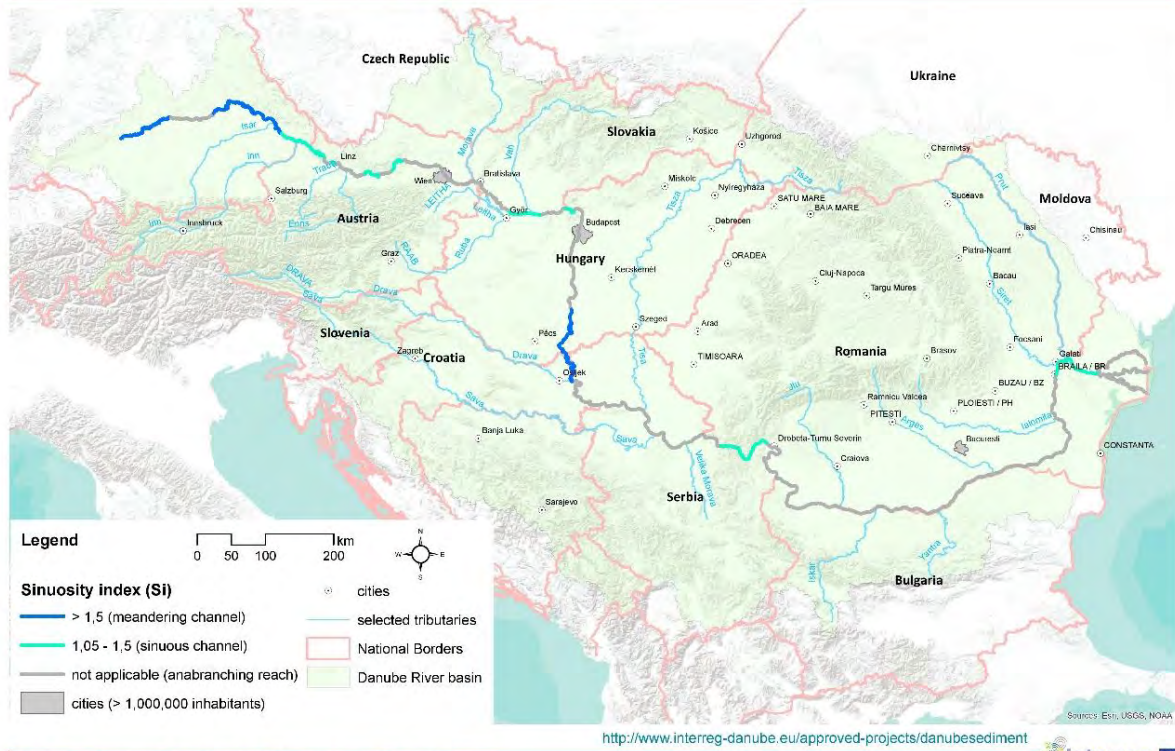
Figure 4.2.13 Sinuosity index of the Danube River at reference conditions

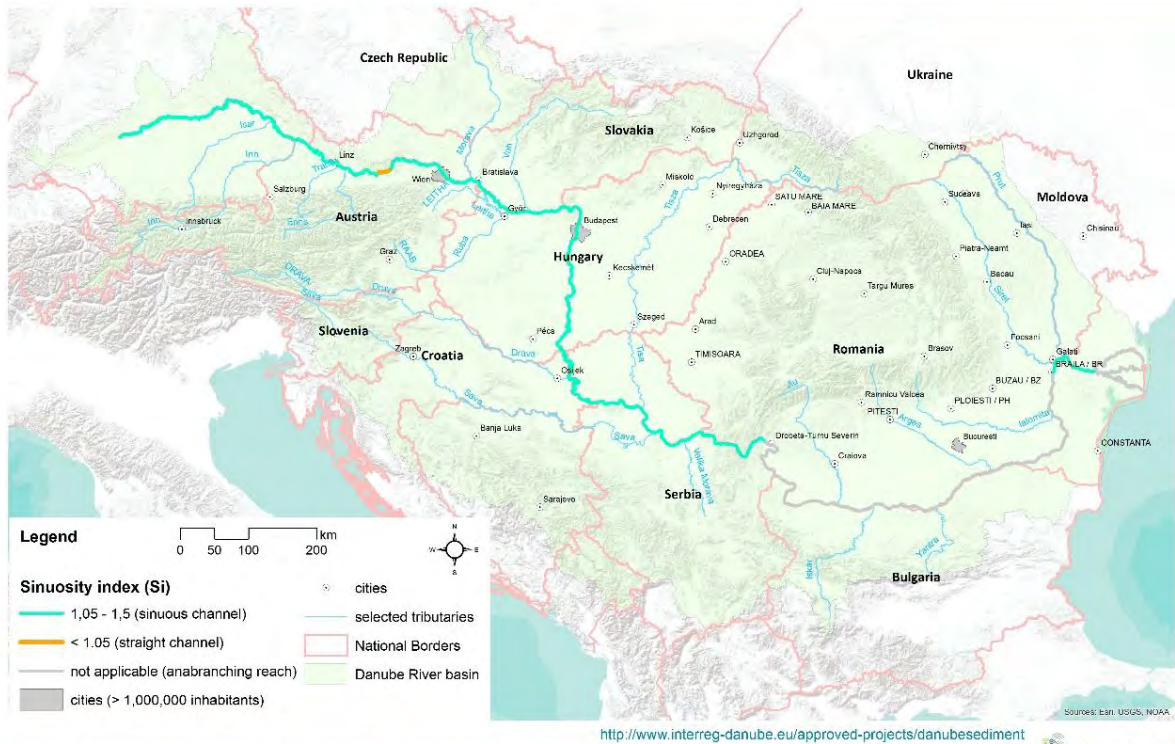
Figure 4.2.14 Sinuosity index of the Danube River at present state

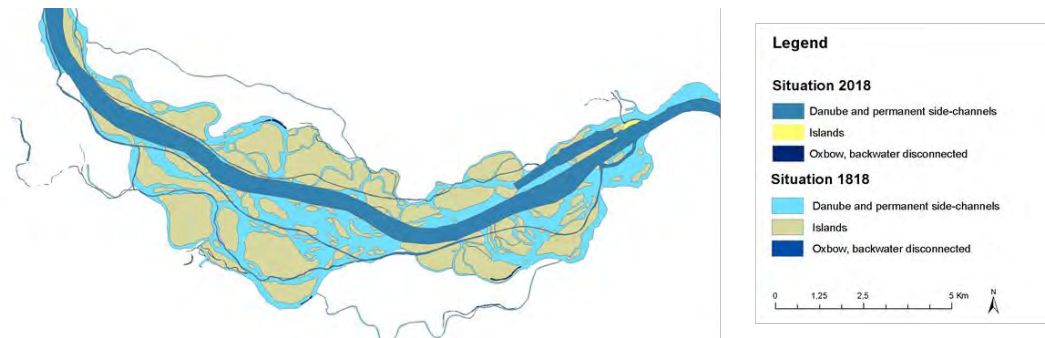
Figure 5.1.27 Eferdinger Becken (rkm 2,159 to rkm 2,144): the situation in 1818 and 2018

While the wider basins were filled with quaternary sediments and were subject to a variety of morphodynamic processes, the sections in the narrow valleys served more as a sediment transfer zone, owing to the natural restriction of the river width. According to Hohensinner et al. (2016), the alluvial sections of the Danube in Austria show elements of a braiding / anabranching or a sinuous-meandering river system before the systematic river regulation started in the first half of the 19th century. The Danube usually had one or two

dominant main stems, several smaller side arms and gravel bars, and point bars or mid-channel bars, with intense flow dynamics in some parts (Figure 5.1.27).

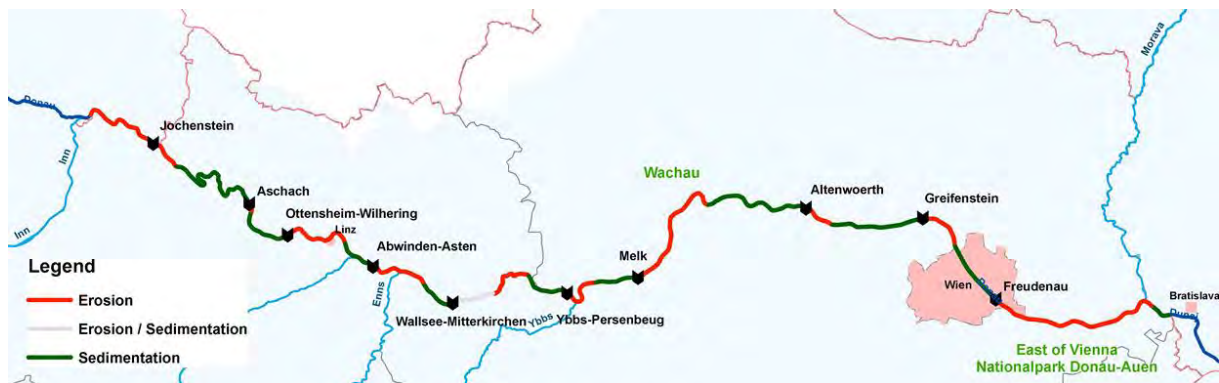
Figure 5.1.33 Classification of erosion and sedimentation in different parts of the Danube in Austria. Based on bathymetric measurements. For segments from the first measurement up to 2001. For the segment of the Freudenu HPP since 1998.

The two free-flowing sections, Wachau and East of Vienna, are subject to erosion. The same is true of the stretch between the Greifenstein HPP and the not yet operating Freudenu HPP. Sedimentation prevails only in the AT-SK border section East of Vienna, which is influenced by the backwater of the Gabčíkovo HPP. Except for the Jochenstein HPP with its oscillating erosion and sedimentation patterns and the Freudenu HPPs not yet operating at that time, all the reservoirs show sedimentation at least along the first few kilometres upstream of the dam and erosion in the head of the impoundment. The only exception is the Altenwörth HPP, which is situated downstream of the free-flowing section Wachau and is supplied with bedload from that section. The largest volume of accumulated sediments in the Austrian Danube can be found at the Aschach HPP and the second largest volume at the Altenwörth HPP. The intensity of sedimentation upstream of these HPPs varies considerably and depends mainly on the height of the dam and its location within the chain of hydropower plants. The Aschach HPP is the biggest hydropower plant in the Austrian section of the Danube, in terms of weir height, reservoir volume and reservoir length. It is situated at the upstream end of the

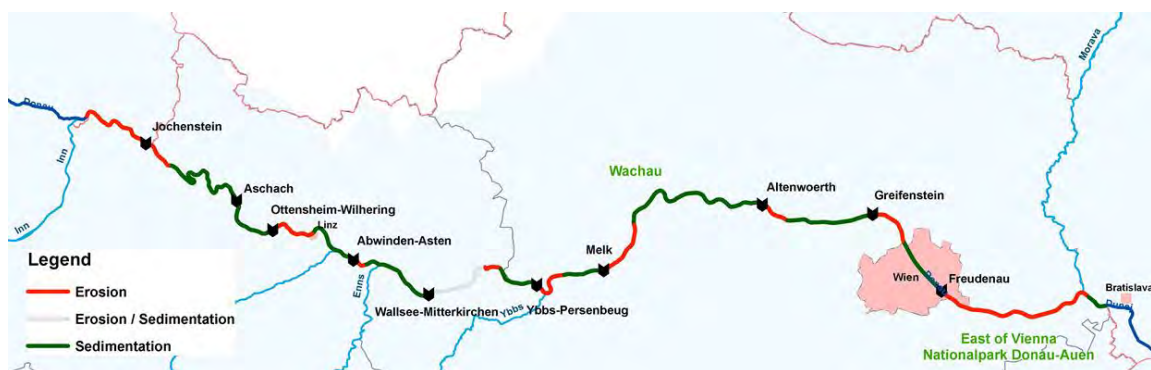
Figure 5.1.35 Classification of erosion and sedimentation in different parts of the Danube in Austria. Bathymetry, including dredging and feeding. Segments from the first measurement to 2001 for the Freudenau HPP since 1998.

The zone of sedimentation stretches over a longer part of the impoundments, but there is still some erosion visible at the tail of the upstream HPPs. As regards the Ybbs-Persenbeug HPP, the zone of erosion is currently located in the narrowest part of the Struden, where gravel is still mobilized and transported farther down into the backwater area (see Prazan, 1990). In the Wachau valley, sedimentation now extends further upstream. This is due to the fact that sediments for fairway maintenance were dredged mostly from the Danube (see Schmautz et al., 2000).

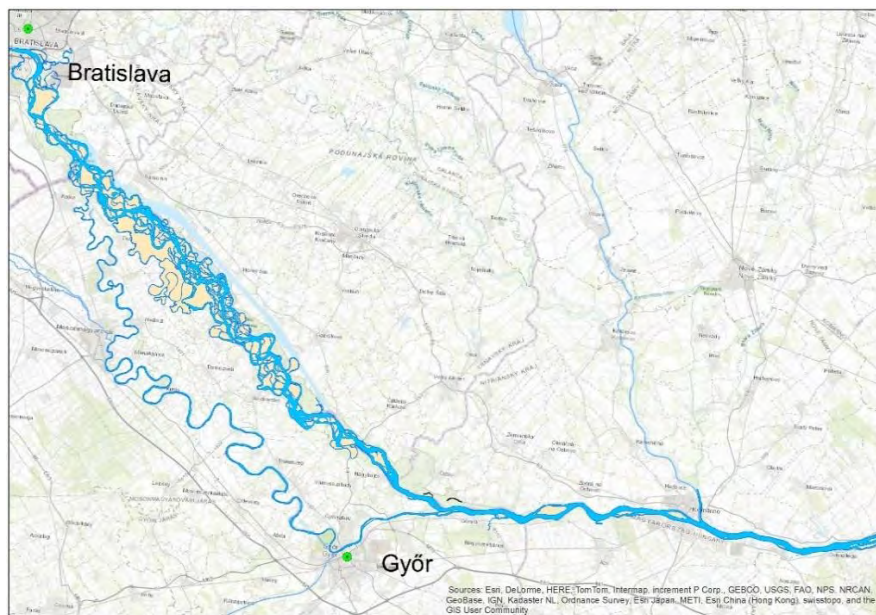
Figure 5.1.83 Layout of the Danube River's pattern corresponding to the reference conditions, illustrated in a topographic map (Esri, 2019)

In the past, the Danube River created a very dynamic fluvial system downstream of Bratislava (Figure 5.1.83). Large amounts of sediments (gravel, sand) transported from the upper parts of the Danube accumulated downstream of the 'Devín Gate' (at the mouth of the Morava River), forming extensive deposits in response to a major drop in the river bed gradient. The dynamic evolution of the river system resulted in a massive alluvial fan – today's Žitný ostrov (Žitny Island) and Szigetköz, which are bounded by the Small Danube on the Slovak side and Mosoni Duna on the Hungarian side.

With the Danube flowing at the top of this alluvial fan where, owing to the specific morphological conditions, a unique anastomosing river stretch developed gradually between Bratislava and Sap (rkm 1,810). This highly diversified anabranch system is referred to as *the Danube Inland Delta* (Figure 5.1.83).

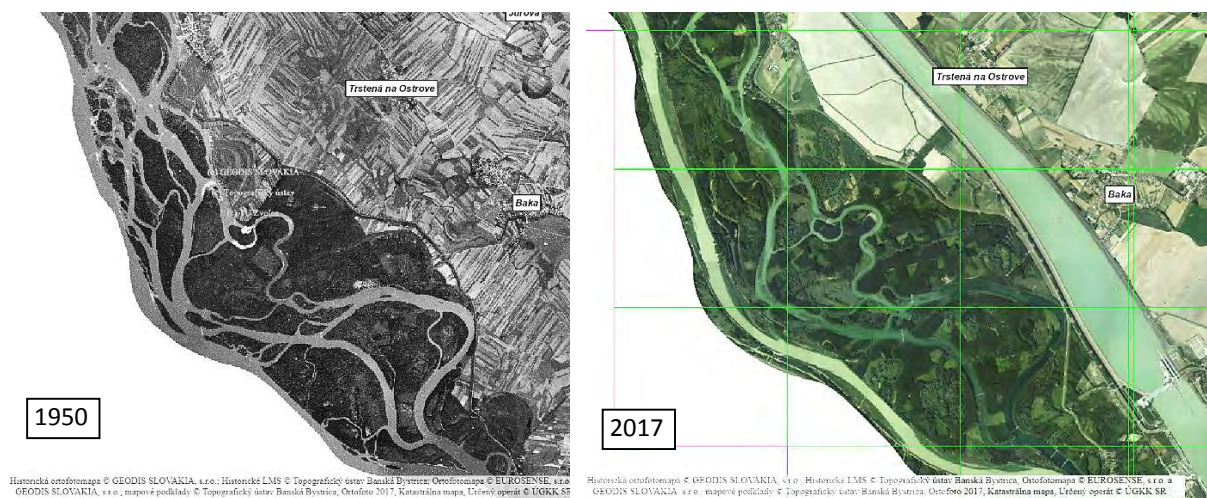
Figure 5.1.85 Satellite images of anabranching section of the Danube between Bodíky -Baka from 1950 and 2017 illustrate a successive degradation of the anabranch system (SK-HU area) (Source: GEODIS SLOVAKIA, s.r.o., © Topografický ústav Banská Bystrica, © EUROSENSE, s.r.o., © TU Zvolen)

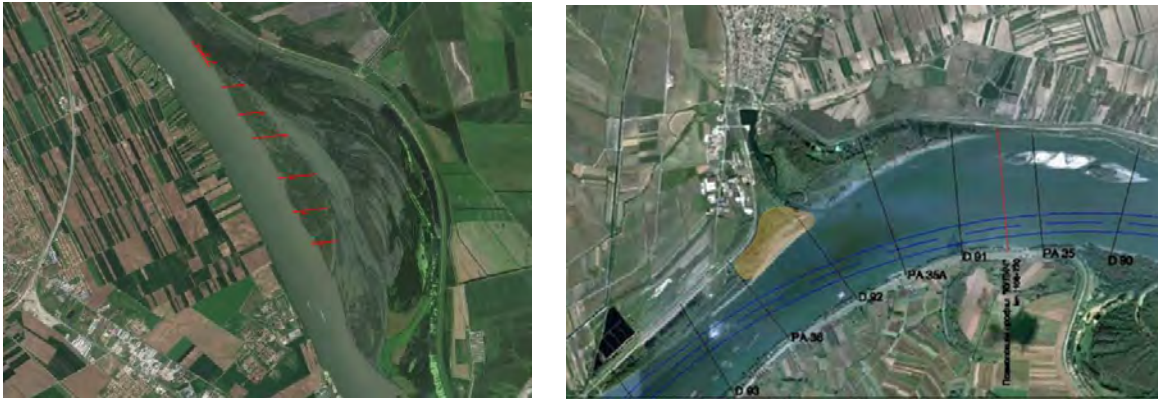
Figure 5.1.124 a) Groyne field built 10 km upstream of the Sava River's mouth; b) T-shaped groyne built at rkm 1,108+500 of the Danube (upstream of the Kovin winter shelter)

The rate of sedimentation in a groyne field was estimated for a T-shaped groyne built at rkm 1,108+500 (upstream of the Kovin winter shelter, marked orange in the picture) in the mid-60ties (Figure 5.1.124b). The siltation process was intense and the area behind the structure is now completely filled with sand, up to the average water level. Based on a 3D model of the area (Figure 5.1.125 a,b,c) from the period before the T-groin was built (1963), it is estimated that 1,9 million m^3 of sand accumulated behind the structure over the course of roughly 50

years. It should be noted that this area is currently under the influence of the Iron Gate 1 dam, and this may enhance the sedimentation process.

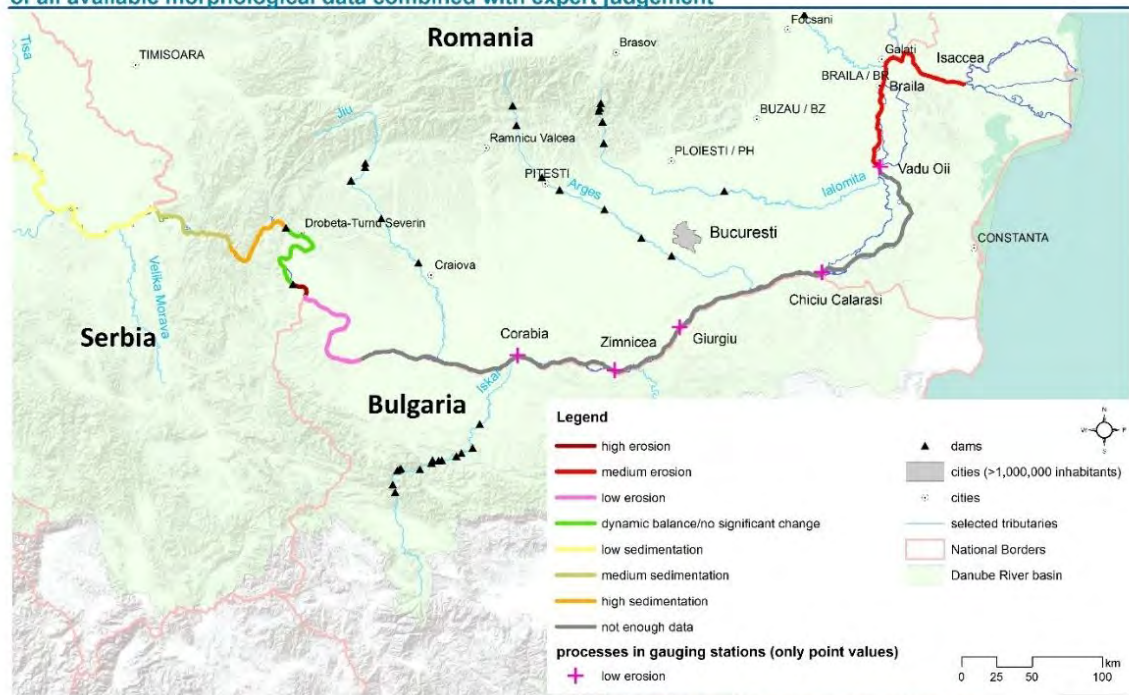
Short-term erosion and sedimentation reaches based on synthesis of all available morphological data combined with expert judgement

Figure 5.1.134 Map of the main trends of the river processes (erosion/sedimentation) prevailing along the Lower Danube

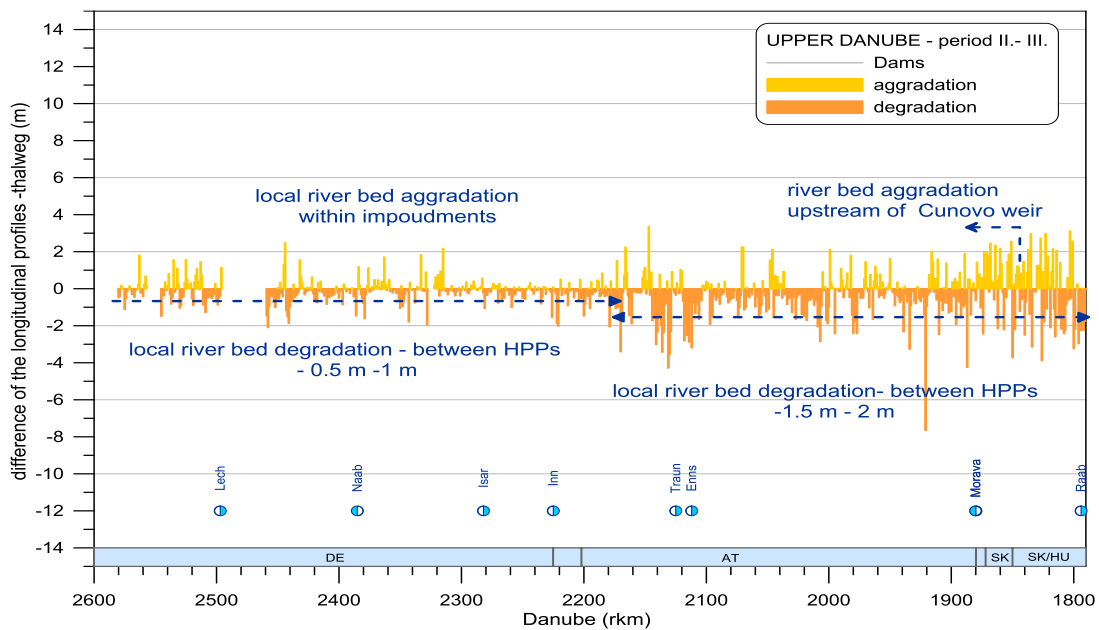
Figure 5.2.11 Differences in river bed elevation (thalweg) in the longitudinal profiles of the Upper Danube (periods II-III)

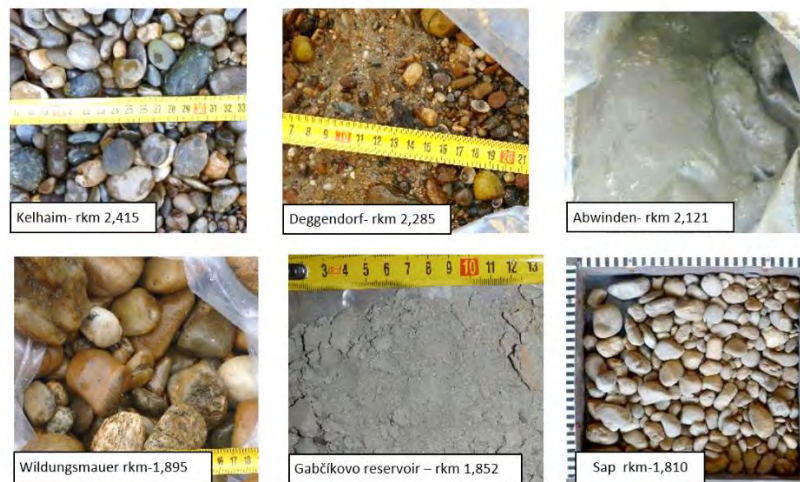
Figure 5.3.10 Bed material (sediment) samples from the Upper Danube, Period III.

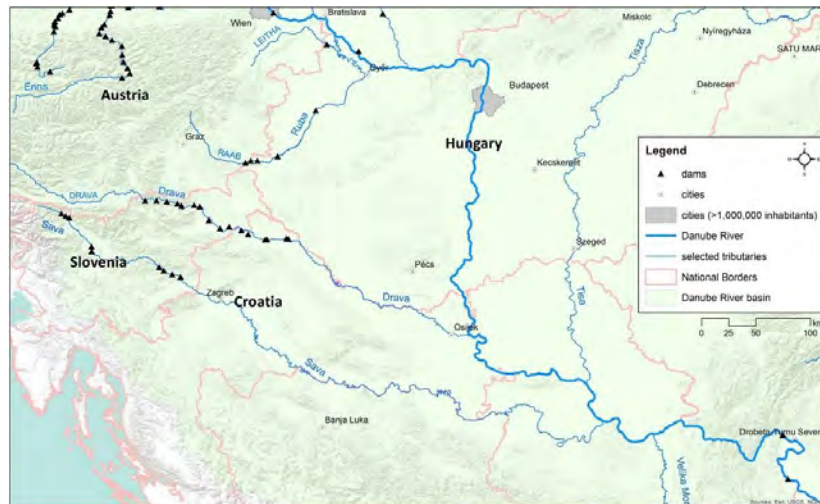
Figure 5.3.38 Localities of hydropower dams on the Middle Danube and its tributaries

Sediment balance, as well as the composition of the river bed, was greatly affected in the past by sediment transport from the river’s tributaries. The construction and operation of numerous hydropower dams on the tributaries considerably reduced the sediment input during the second and third periods. Although these barriers have modified the conditions for bedload transport, there are still longer free-flowing sections downstream of hydropower dams, allowing partially reduced bedload transport in some of the tributaries (Figure 5.3.38).

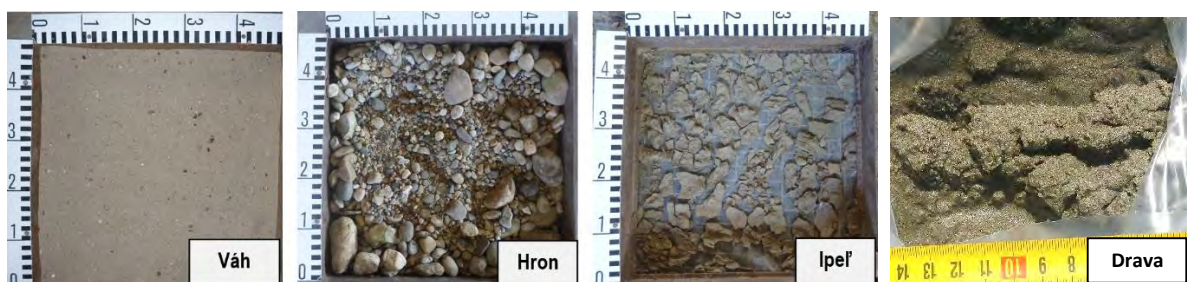
Figure 5.3.40 Bed sediment samples taken from the tributaries of the Middle Danube : Váh (SK), Hron (SK), Ipeľ (SK) and Drava (HR), Period III

Tributaries in the upper part of the Middle Danube, i.e. Váh, Hron and Ipel (see Figure 5.3.39 and Figure 5.3.40) affected the composition of the river bed in the past. The Hron River transported larger amounts of coarse gravel into the Danube causing river bed coarsening (along a few rkm- long section downstream), while sediments transported from the Váh and Ipel rivers (sand/silt) have enriched the Danube with fine sediments (Figure 5.3.31). The damming of these tributaries (Table 5.3.3) has greatly reduced the transport of sediments into the Danube over the last few decades and thus their current effect on the river bed is minimal.

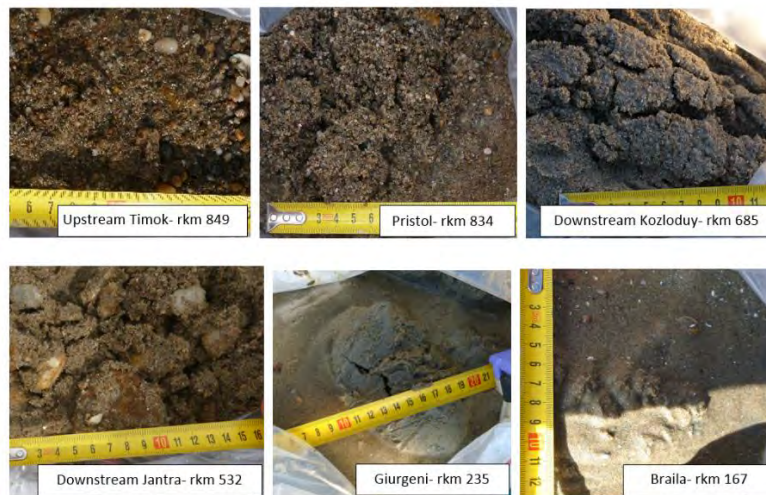
Figure 5.3.42 Samples of bed sediments taken from the Lower Danube (Period III.)

Although this effect is only local, it is clearly manifested owing to big differences in the size of gravel from the tributaries (figures 5.3.46 and 5.3.42) and sand, which is the original bed material in the Lower Danube. An overview of the tributaries, which may contribute to the content of gravel in the bed sediments, is provided in Table 5.3.4. This table also includes an assessment of the possible sediment input into the Danube in view of the dams built on the tributaries (based on expert opinions and the partner’s practical experiences).

Natural river bed coarsening is caused by fractions of coarse grains (gravel) are transported into the Lower Danube the bed of which is composed of sand (see Figure 5.3.42, downstream of Jantra). The consequences of river bed coarsening from the past (before the

Natural river bed coarsening is caused by fractions of coarse grains (gravel) are transported into the Lower Danube the bed of which is composed of sand (see Figure 5.3.42, downstream of Jantra). The consequences of river bed coarsening from the past (before the tributaries were dammed) have remained in the Lower Danube. By now, the sediment input – bedload transport from the tributaries has stopped almost completely owing to the barriers (hydropower plants, dams, weirs) built on the Danube’s tributaries during the second and third periods (Figure 5.3.45).

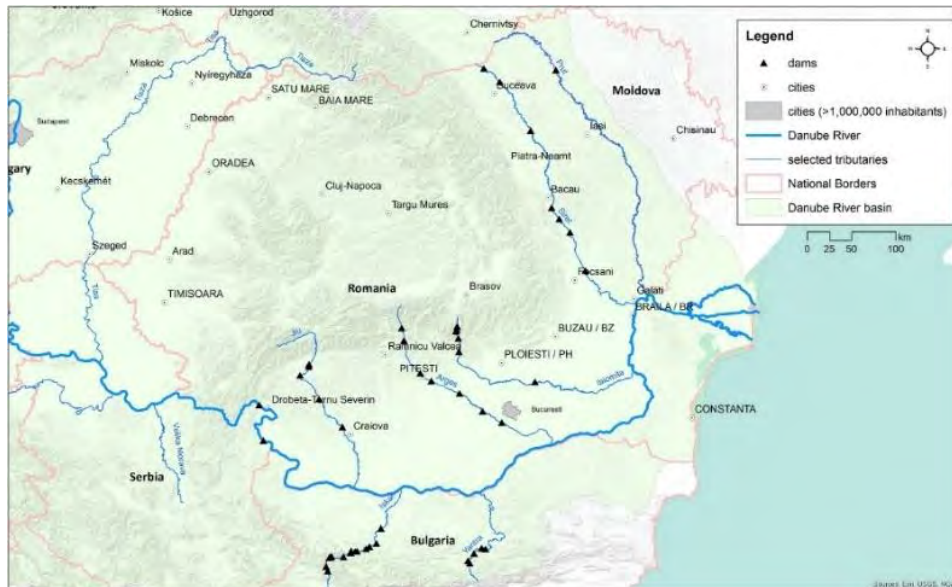
Figure 5.3.45 Hydropower dams on the Middle Danube and on its tributaries

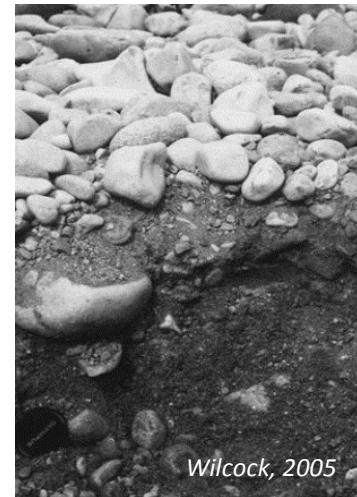
Gravel-river beds typically have an ‘armoured’ layer of coarse grains on the surface, which protects the finer particles underneath from erosion (Behrooz Ferdowsi et al, 2017)

Armouring process (Curran & Tan, 2010): the water flow exerts shear stresses weaker than required to move large particles but strong enough to move the fine particles. The flow entrains the fine particles, winnowing them from the bed surface forming a coarse surface layer without fine grains. The coarse layer increases its resistance to entrainment, while gravel bed armouring influences in-stream hydraulics and habitats. Dams that are very distinct, both spatially and temporally, exacerbate armouring in gravel bed streams.

Armour layer- gravel bed river

The armour layer clast size distribution is generally coarser than its substratum such that the armour ratio (armour median/sub-armour median) lies generally within the range of 1.5 to 2, but its ranges not untypically up to the value of 6 (Andrews and Parker, 1987; Sutherland, 1987).
