Restoring Art Nouveau

Architectural Decoration in the Danube Region

Proceedings of the international conference Restoring Art Nouveau,
Budapest, 6 November 2017

GÁBOR GYÖRGY PAPP: Foreword	7
LÁSZLÓ CZIFRÁK: Experience from the Conservation of the Zsolnay Architectural Ceramics in the Entrance Hall of the Budapest Museum of Applied Arts	11
ALEKSA CIGANOVIC: Decades of Restoring the Subotica Synagogue	23
GÁBOR DÖMÖTÖR: Restoration of the Raichle Palace in Subotica	33
RAMONA NOVICOV: Lost Beauty Rediscovered. The Black Eagle Palace and Adolf Moskovits Palace, Examples of Good Practice in Restoration	45
ASTRID HUBER: Architectural Surfaces and Plaster Façades around and after 1900 in Austria	57
DAVID MIŠIĆ and NINA NAHTIGAL: The Baroness House in Maribor. Sustainable Protection and Promotion of Art Nouveau Heritage in the Danube Region	69
EVA RADOLOVIĆ: Renovation of Two Zagreb Residential Buildings. Comparative Analysis of Two Façade Restoration Projects	83
IOSEFINA POSTĂVARU: Restoring Art Nouveau Buildings throughout Romania. The Lutheran School in Cincșor and the Sofian House in Botoșani	93

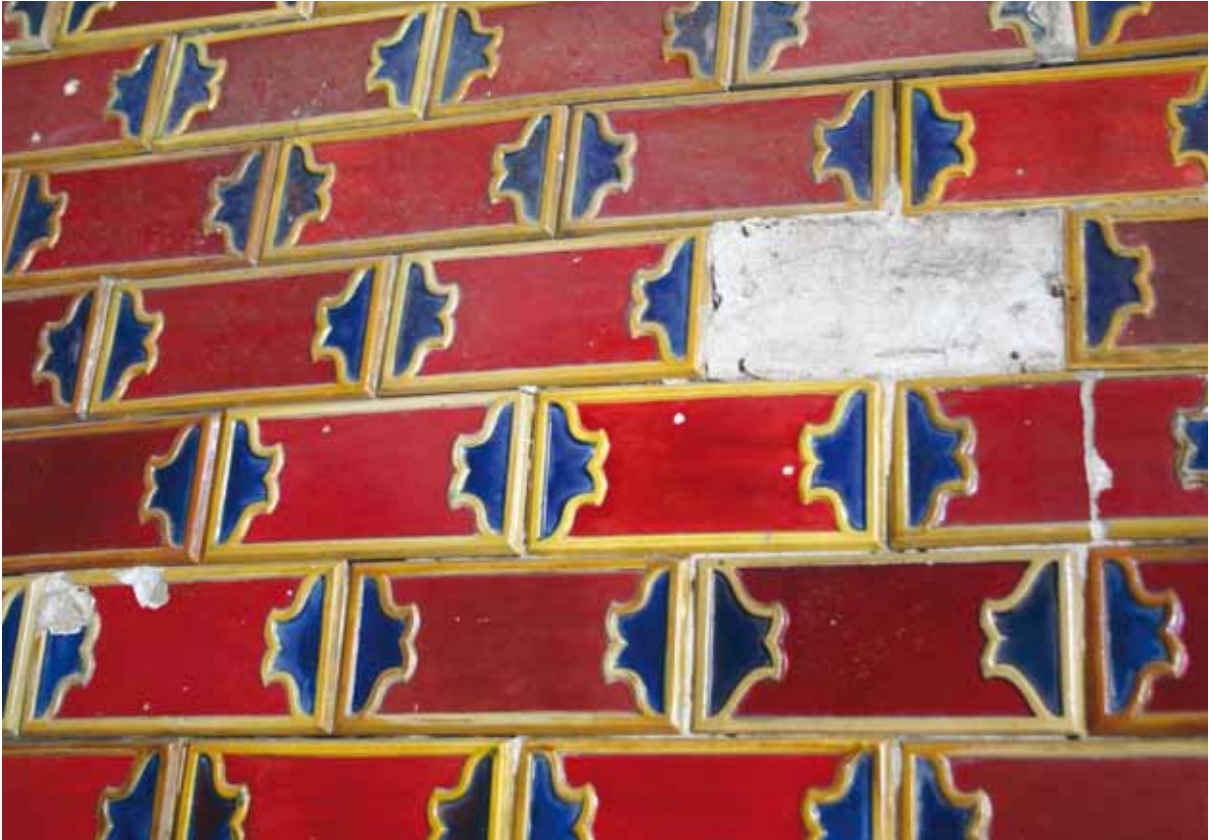
5. Decorative elements with ruby-colored luster glaze. The types of damage: gunshots, mechanical damage, damage due to leaks and fractures due to tension

These unique tiles were produced specifically for this lobby, so the expert restoration and maintenance of the original forms were essential. Unfortunately, they had begun to come loose, and as a result of this the ceramic tiles were pushed together. Because of this stress, certain tiles fractured or broke in half in the middle. This stress was so powerful that at certain points there was a good 5–6 cm between the tile and the wall itself. In order to avoid these tiles falling off, the first step was to temporarily stabilize the ceramics and to precisely pinpoint the number of the elements in need of restoration. Every ele-

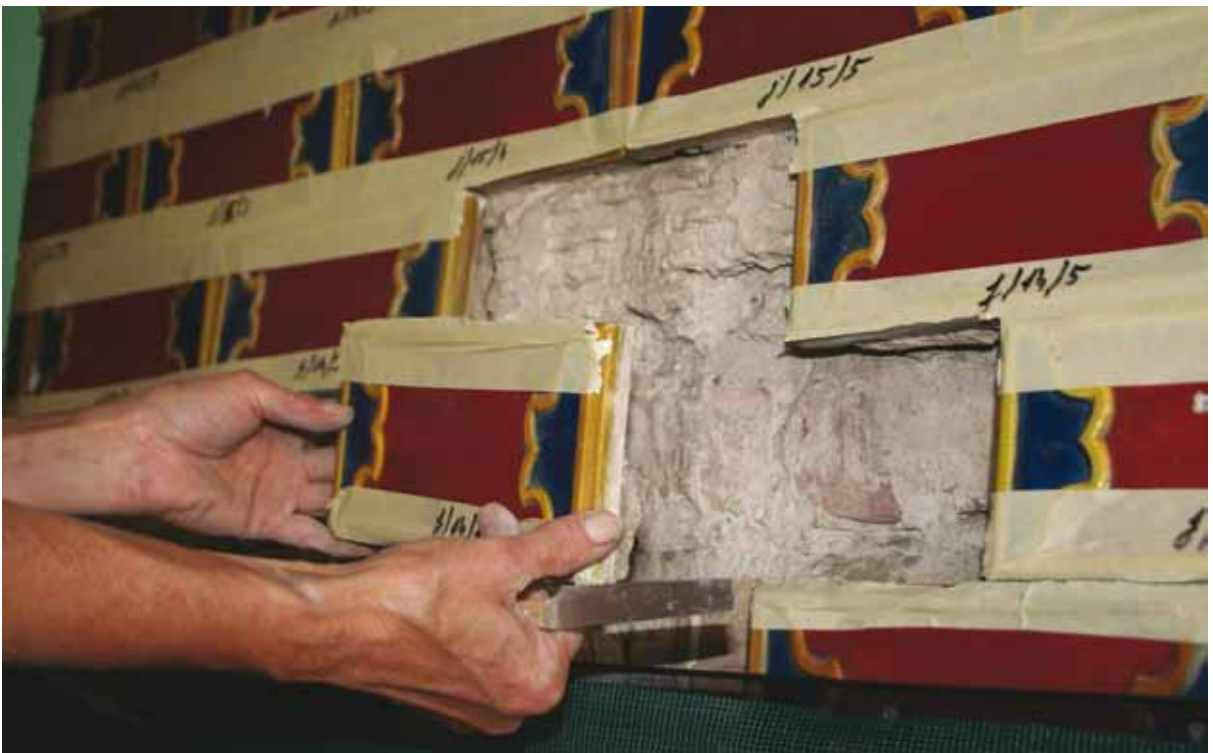
6. The numbered tiles during their removal

The wall behind the removed ceramics was cleaned properly, and the level of moisture damage was examined. Because previously these walls had been dried from the inside, the water damage was not severe. This was important, because after the restoration, the tiles could only be replaced on a physically stable and clean brick wall surface. The pieces that had been removed, nearly 500 tiles, were taken to a workshop. (*Figs 4–5*)

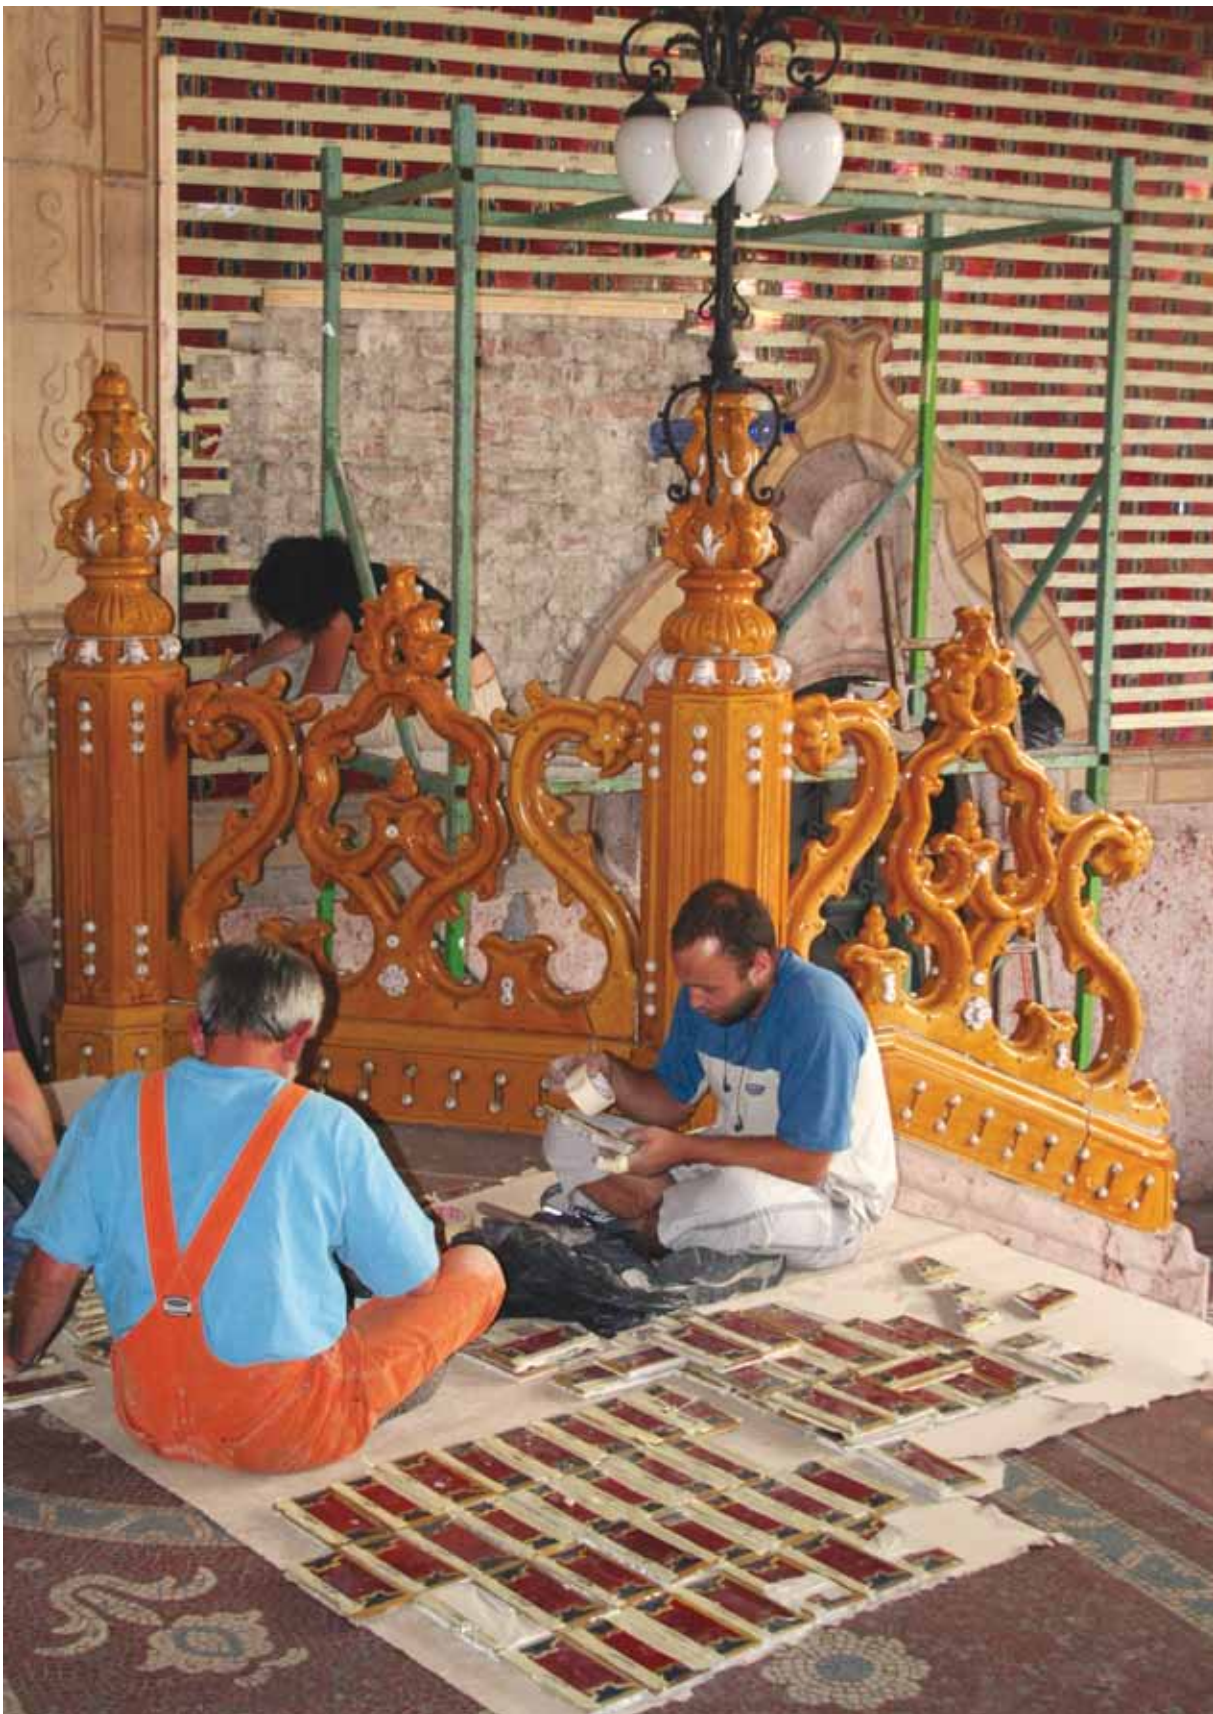
7. All the removed tiles were properly cleaned, and damaged tiles were taken to our workshop for further restoration processes

back side was cleaned, and a detergent-based cleaning procedure was used on the front side. After the cleaning, every broken piece was precisely adhered together, paying attention to perfectly match the glazed surfaces. We used a two-component epoxy adhesive, which ensured the original durability of the pieces. After the re-adhesion process, the replacement of the missing parts was the next step. These tiles were treated with a special glaze, called *ruby-colored luster glaze* that is extremely

protective layer was a double component acrylic and polyurethane varnish. This layer is strong enough to stand up to mechanical and UV damage. After finishing the restoration of the damaged tiles in the workshop, we transported them to the building and replaced them in their original positions according to their numbers.⁷ (Fig. 7)

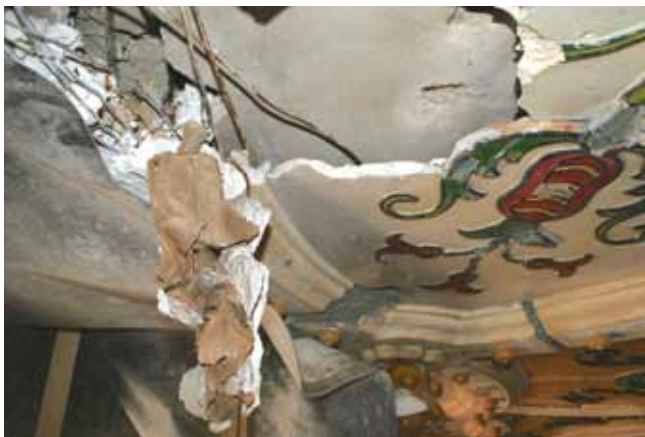
10. After the cleaning and the removal of the ceiling ceramics in bad condition, the problems turned out to be critical

the ceiling, which in most cases was not limited to surface cracks but included actual cross section fractures, had also caused distortions in the levels of the flat surfaces in numerous cases. The structural status of the ceiling elements had been weakened because of this damage, and upon exploration we discovered structural damage that had been concealed before the restoration work. After the removal of the damaged ceramic elements from the ceiling, we discovered damage that lied behind the décor. (Fig. 11a–b) The spalling of the plasterwork was typical, so its treatment was also an important task before the reinstallation of the restored ceramic elements. However, this mortar spalling was not typical of all the surfaces, and even the brick structure behind them was in top quality. However, in order to allow the restoration process to continue without further disturbance, a thorough material and wiring study was necessary.⁸ According to a professional suggestion coming from restoration experts, the Museum of Applied Arts hired additional professionals in order to determine whether the prospective restoration processes were feasible according to the plans without the full removal of the ceiling elements. Thanks to the precision and thoroughness of the examination results, the work processes were able to proceed undisturbed. The results of this progression are included in the appendix.

the elements with varying levels of contamination and pollution could be cleaned easily, safely and at an even quality. The other very important aspect of the application of the dolomite-blasting technique in the determination of the cleaning process is that we were not able to use chemicals that were either too acidic or too alkaline. The absorption of these chemicals can also cause chemical damage to the structure of the ceramic in the long run. The dolomite-blasting mechanical surface cleaning was only performed in the case of unglazed pyrogranite elements, and in accordance with the test-cleanings we used a low-pressure wet dolomite-blasting procedure. Under constant supervision, this gently removed the strongly cured build up from the capillaries of the unglazed elements, but it did not cause any kind of damage to the outer structure of the pyrogranite, and so the original surface remained unscathed. Upon completing the cleaning process, we started removing the damaged surfaces. (Fig. 10) The structural damage to

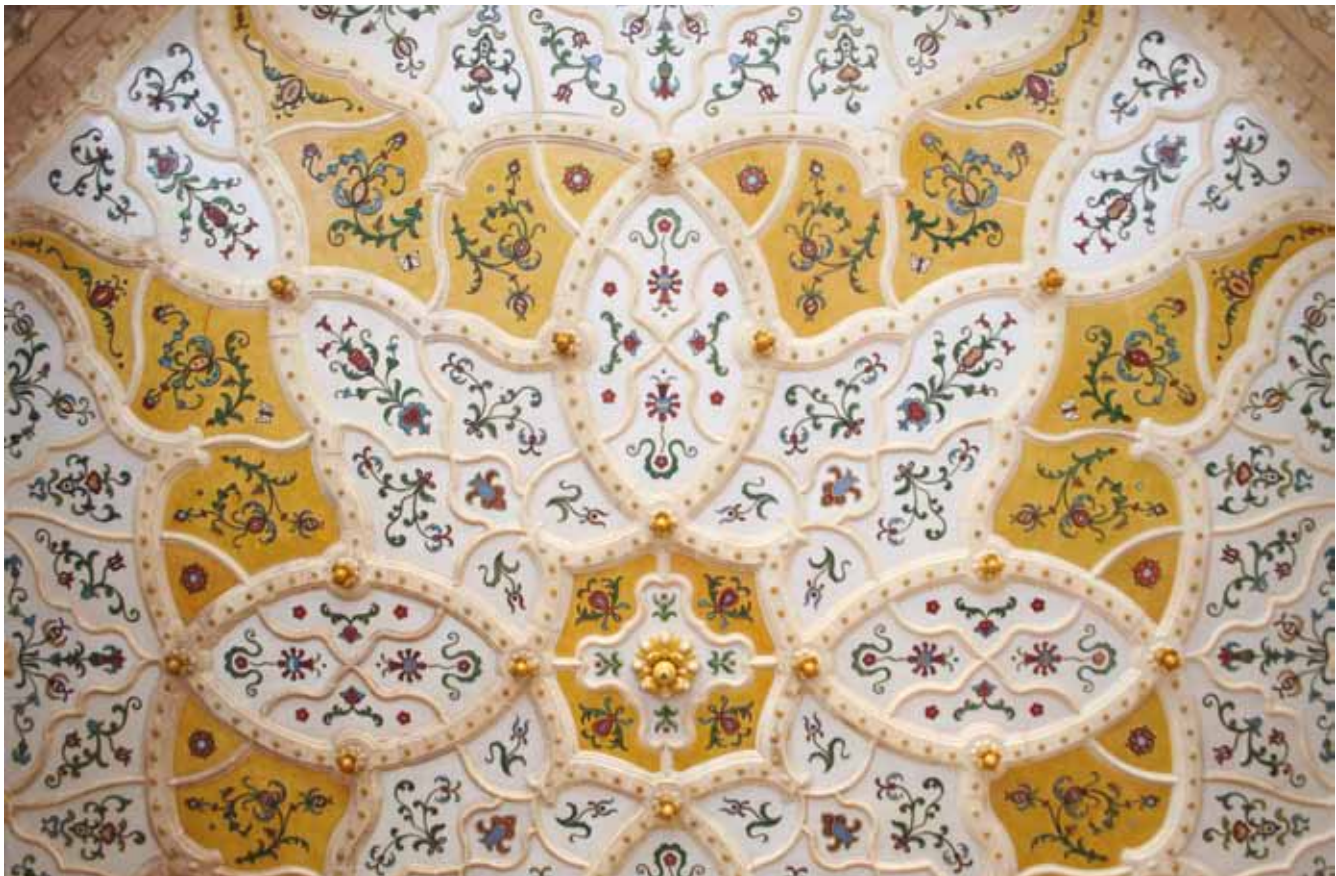
13. The ceiling in the main entrance after restoration

In the second phase, in 2010, the ceiling of the lobby had to be restored. (Figs 8–9) In addition to structural damage, a great deal of mechanical decay had been caused on the surface of the ceramics during the Hungarian Revolution of 1956. This damage had been restored and they did not seem to be in a bad condition, but after up-close examination it turned out that the previous work and the ceiling were in a critical state. In addition to the natural signs of aging missing pieces and cracks were noted on numerous parts of the cladding of the columns in the lobby as well as on the ceiling.

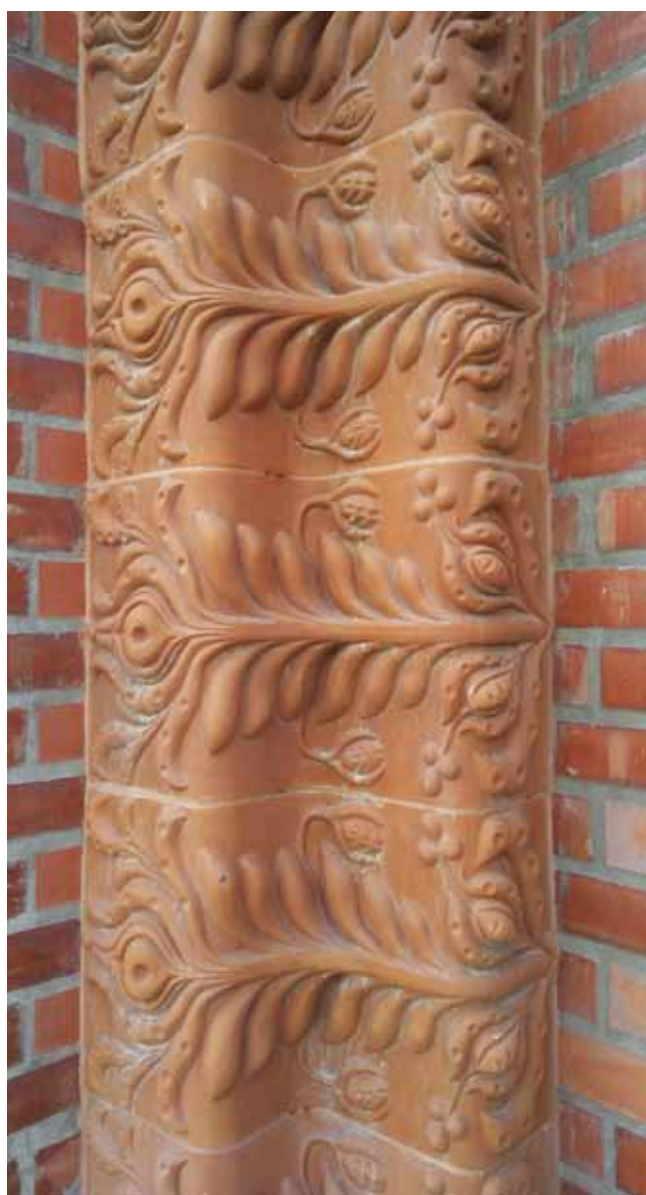
1. Detail of the terracotta on the synagogue's entrance portal

The earliest work on the rehabilitation of the synagogue facility began in 1991, under the leadership of the Intermunicipal Institute for the Protection of Cultural Monuments in Subotica. This work included the first replacement of the elements of terracotta decoration on two opposite sides – the southeast and northwest façades of the synagogue in 1991, in consultation with the master plaster sculptor József Halas from the Zsolnay manufactory in Pécs (Hungary). During the dismantling of the decorations, it came to light that the cast elements of terracotta had been affixed with iron nails, directly through the relief without pre-defined holes, causing damage. This rather inexpert solution had been holding up the relief for 90 years since its construction. Due to its porous nature, some elements fell apart on touch. (Fig. 1)

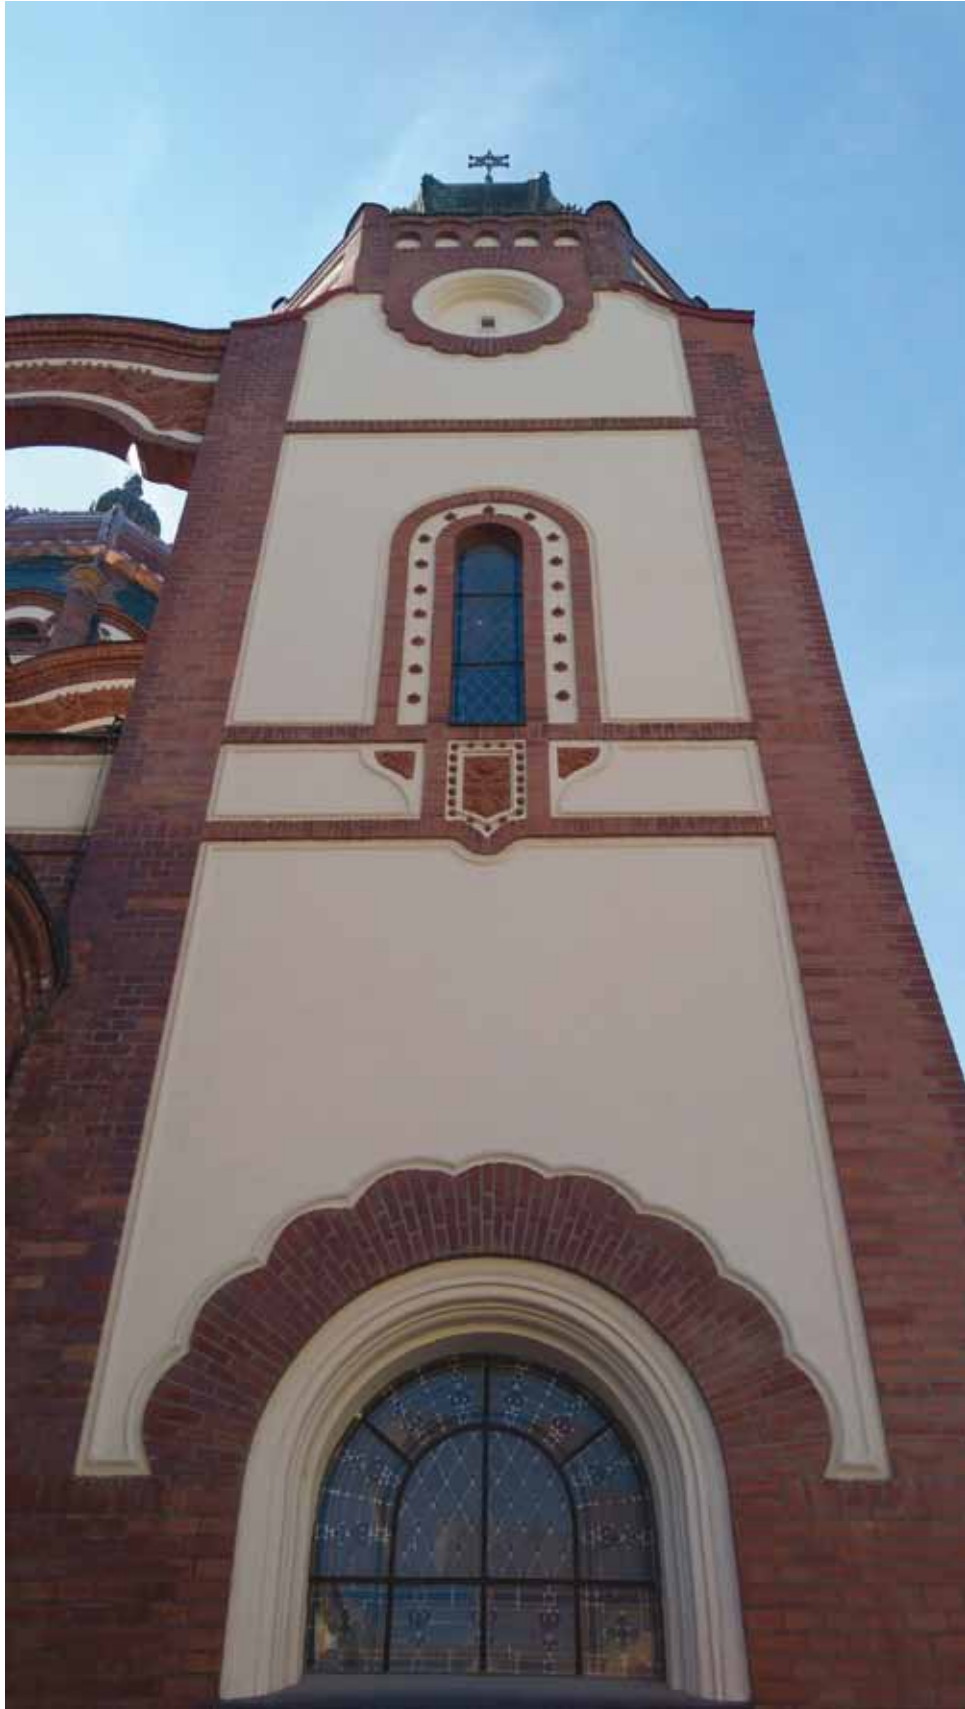
2. Northwest tower, restored in 1991

After this, a complete technical recording of the details of the terracotta elements was performed and molds were made of them, which due to the technical process of making the new elements, had to be enlarged by about 8.50%. In order to avoid the vitrification of the reliefs that had large areas and masses, the inside of the clay positives was given reinforced walls and a certain percentage of baked fire clay was added into the refractory mixture. After drying, the first firing of the elements was performed at 1250 °C, after which they turned the white color of fire brick. The elements were given a glossy finish with the application of a terracotta-colored glaze on the matte red clay and then the firing was performed at 1020 °C.¹⁸ (Fig. 2)

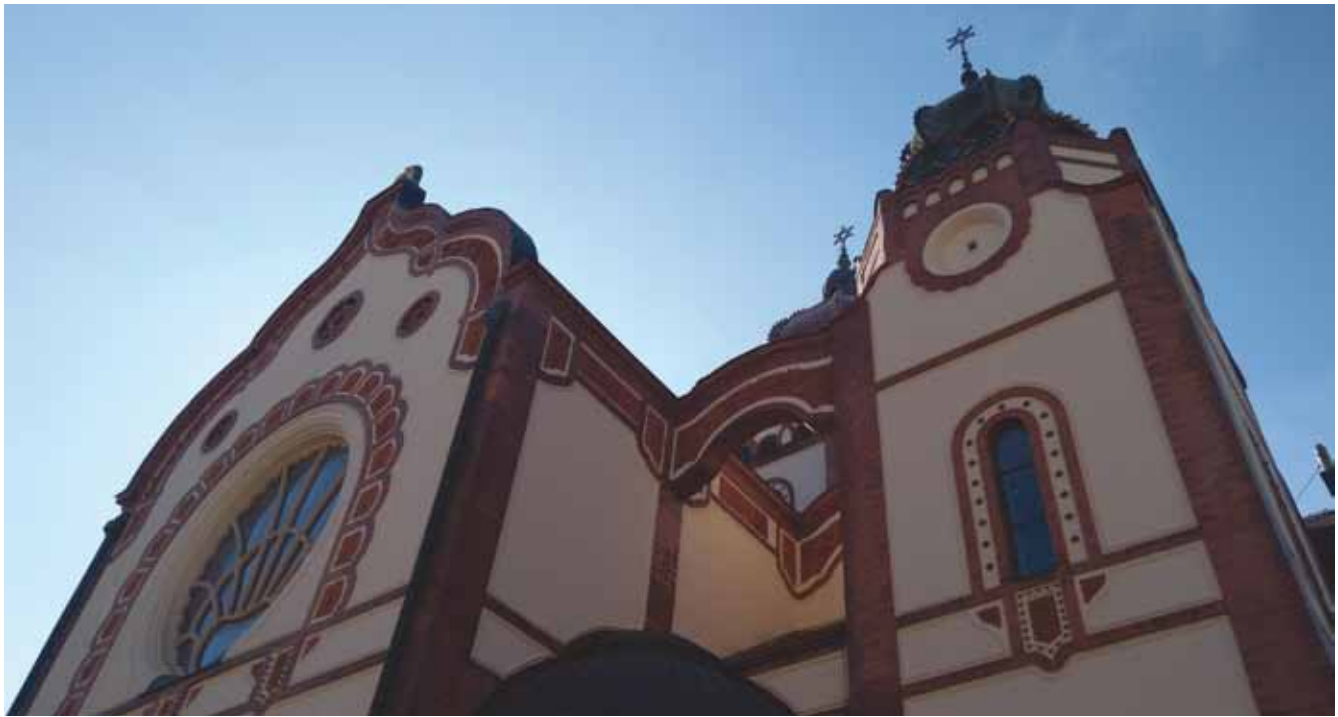
3. Northwest façade, restored in 1991

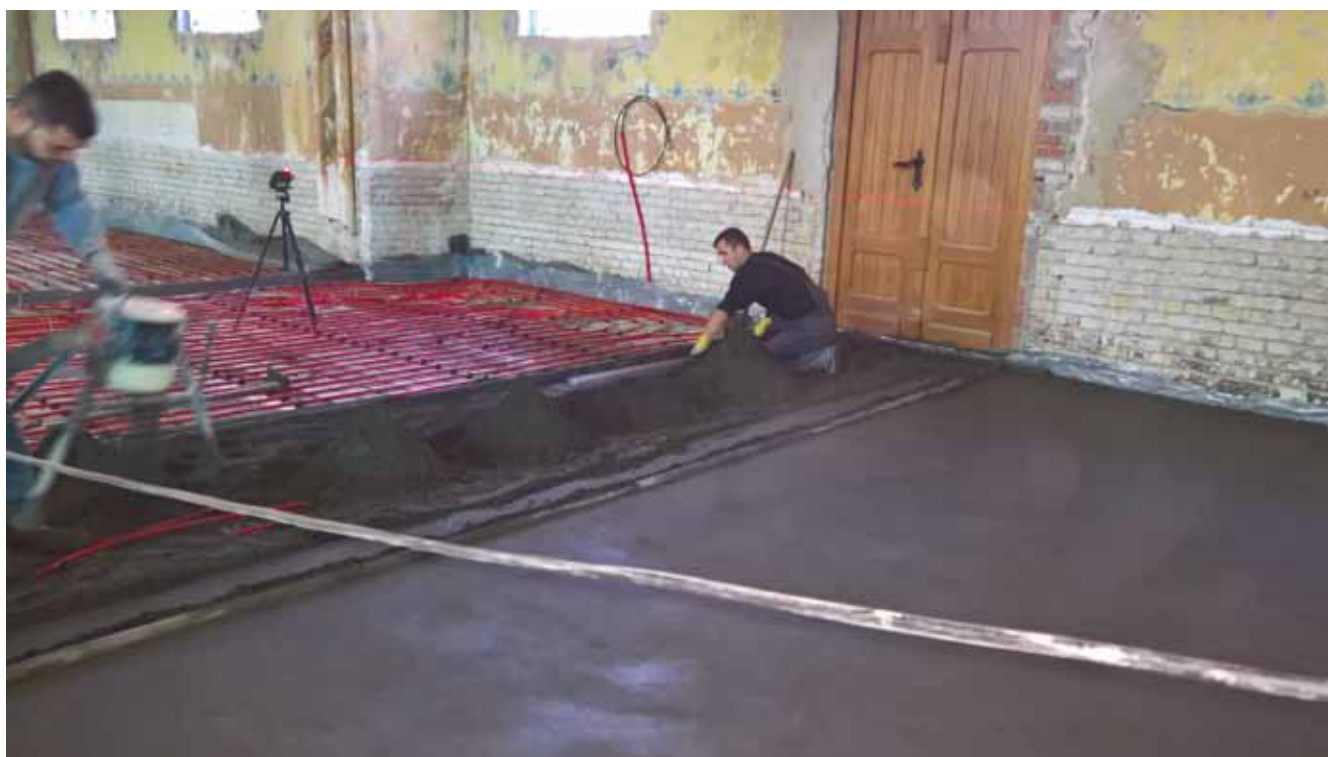
5. Under-floor heating through a system of pipes

clinker ceramic tiles. At the same time, moisture-proofing and thermal insulation have been installed around the foundation of the supporting steel pillars at a depth of about 1.20 m and a width of about 30 cm. This was a very important conservation measure because any absorption or penetration of moisture through capillary action or the air would damage the inner cement filling of the pillars and the external cement-plaster coating that is about 3 cm thick. (Fig. 6) The Mašinoprojekt Koprivica d. company from Belgrade working on the

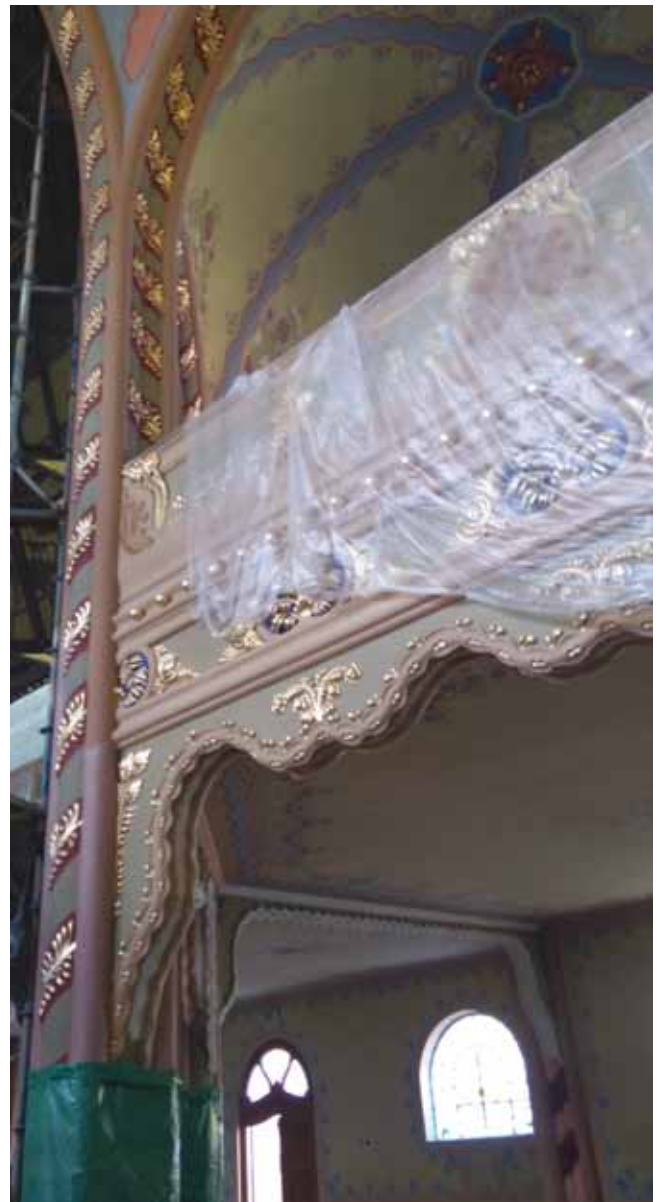
7. Gilt decoration, October 2017

Due to the visibly granular texture of the gilding it was established that it had been applied in powdered form. (Fig. 7) The decorative plaster motifs on the columns were similar to the motifs in terracotta, and crudely colored using red oil paint similar to terracotta. The stained-glass windows were set in lead profiles and some of the pieces of the glass were replaced or reinforced with steel due to the weight of the glass. Each and every small piece of plaster relief combines to make an exceptional artistic composition in relation to the surface and the ornamentation made of other materials. Wavy series of leaf forms alternate with flowers and fruits on parallel axes. The forms are characteristic of the Hungarian version of Art Nouveau and are folk motifs derived from the basic shapes of roses, flax, peacock feathers and leaves. By the end of October 2017, the final painting of the interior using the tempera technique was completed. (Fig. 8)

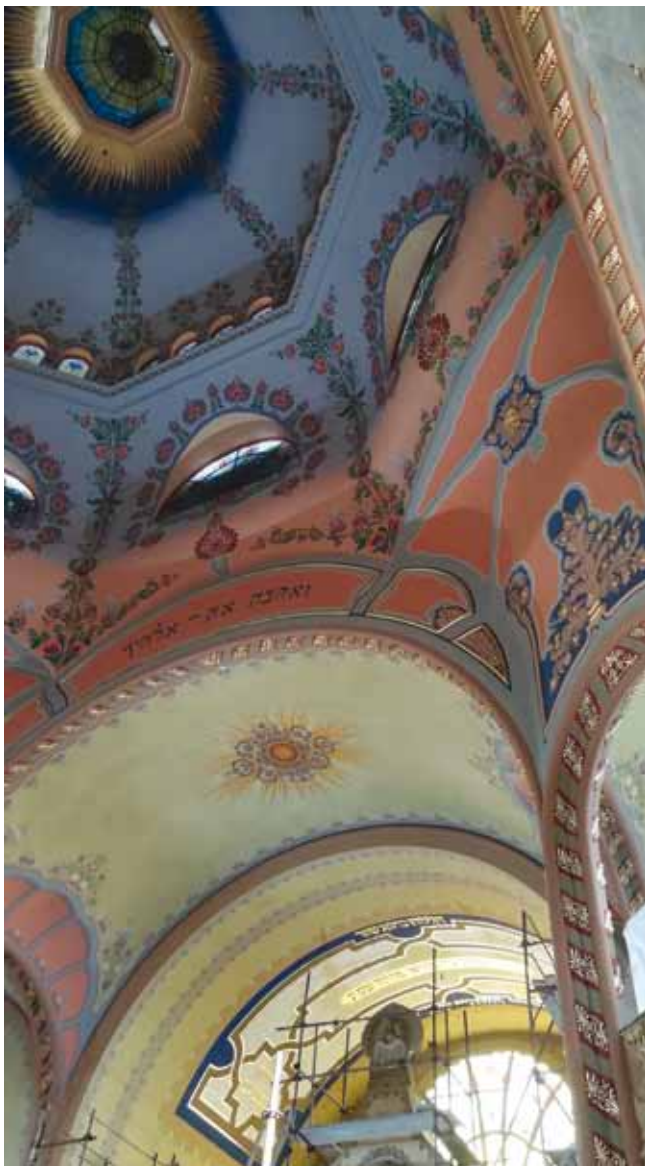
8. Secco tempera wall decoration (The plaster shell under the dome is about 7–8 cm thick)

According to the chronological work report submitted, color treatment of the walls had been performed on two occasions in the period between 1988 and 1992, which resulted in changes that deviated from the original tones. Lime tempera (*secco* technique) was used for the varied color treatment of the walls. Multiple layers were discovered, with the most authentic layer being a light green-grey color, on top of which layers of yellow

and orange had been subsequently applied. It was established that the colored ornaments on flat surfaces were applied using stencils, not a brush. The entire application of color was made on the surface of the lime hydraulic mortar and the walls with a tempera technique in accordance with the evidence from research and the fragments of the decorations.²²

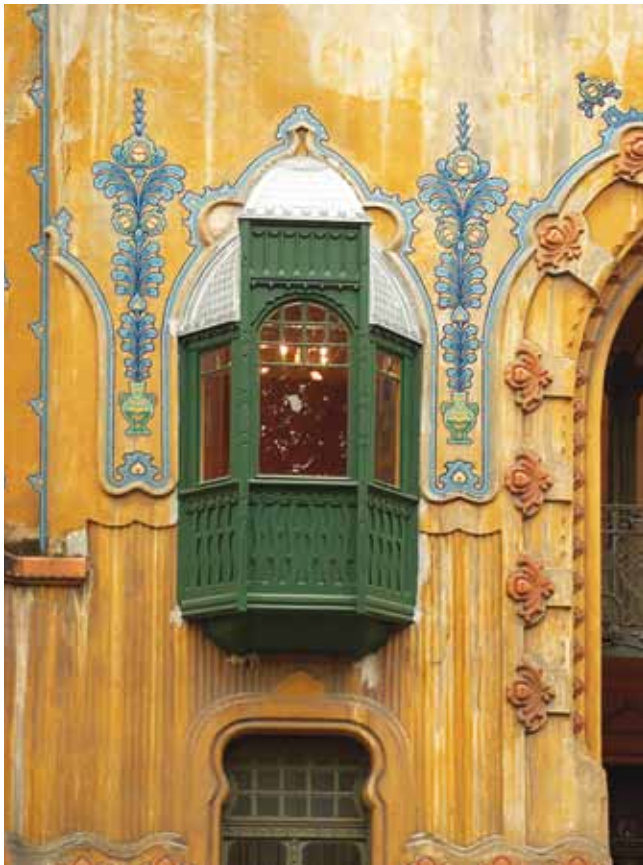
3. An oriel window before the restoration

Structural repairs to the oriel windows could no longer be delayed; their wooden structure was so rotten they had already begun to separate from the wall surface of the façade and threatened to fall on passers-by. Of course, the city's administration, which was the owner of the building, could not allow this danger to remain, so it agreed to finance the work. First, the experts from the Inter-municipal Institute for the Protection of Cultural Monuments of Subotica (hereinafter: the Institute) made a complete survey of the oriel windows, and all the details of their structures were carefully documented during the disassembly. The master carpenter was Ivan

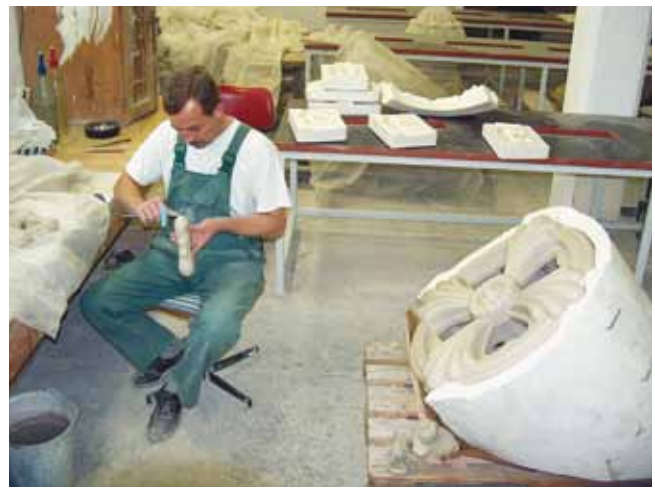
5. The production of the rosettes at the Zsolnay factory in Pécs, Hungary, 2003

the old tiles and elements no longer met the demands of modern building regulations or standards (water absorption was 18–20% and the deformation resistance was 0.38 kN compared to the reference value of min. 0.6 kN). Therefore, they were no longer resistant to fracture and needed to be completely replaced with newly manufactured identical copies. A contract was signed with the Zsolnay factory in Pécs (Hungary) for this. Some molds were taken in situ and the samples were disassembled from the building and transported to the factory, where they started the production of the new tiles and decorative elements. (Figs 5–6) The production process was supervised by Gábor Dömötör. During

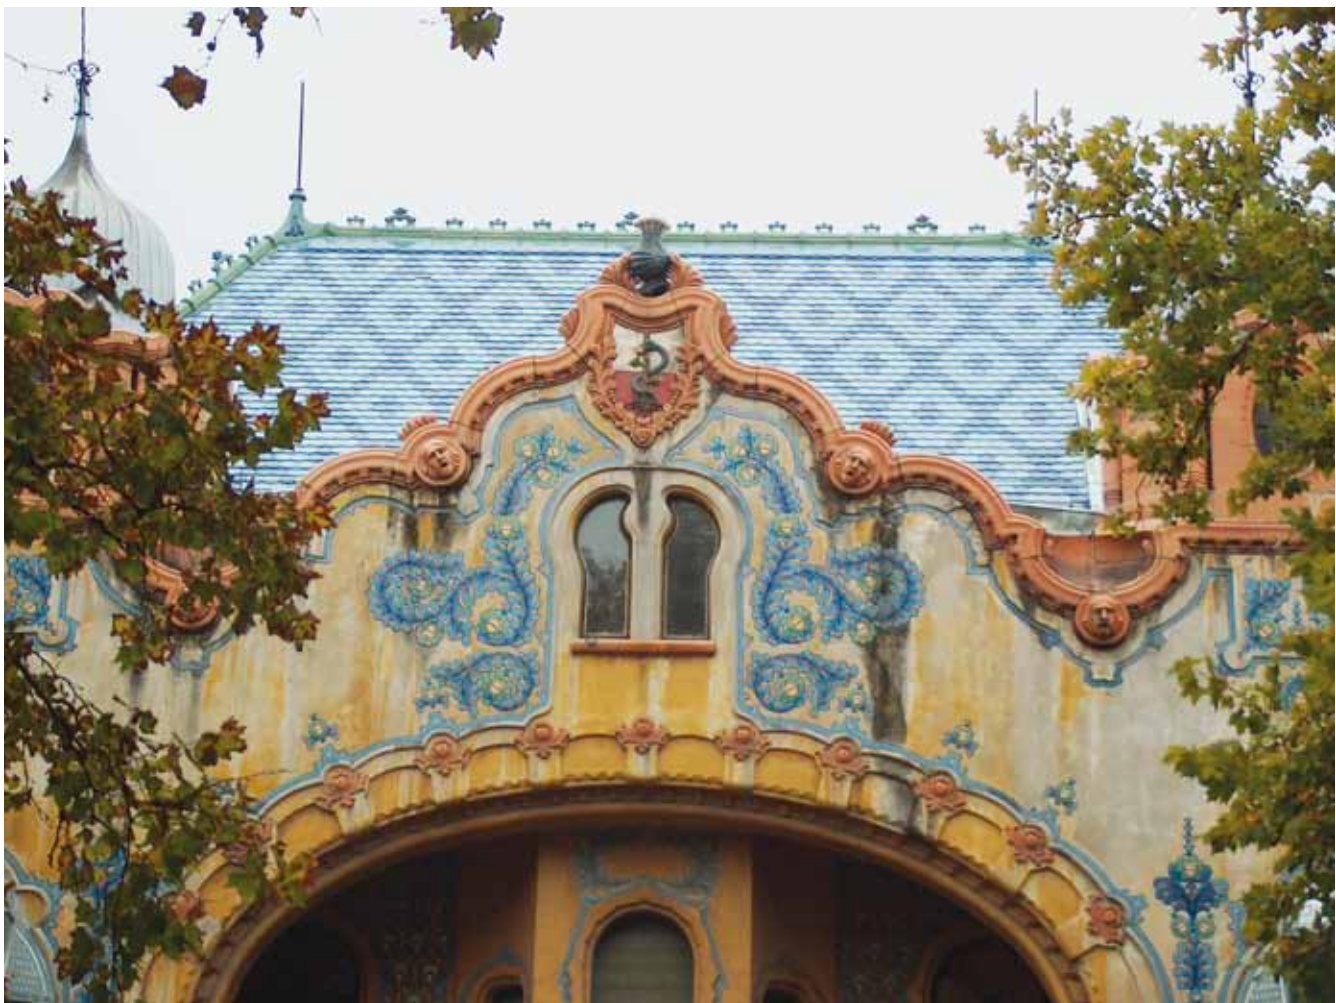
7. Detail of the roof after restoration

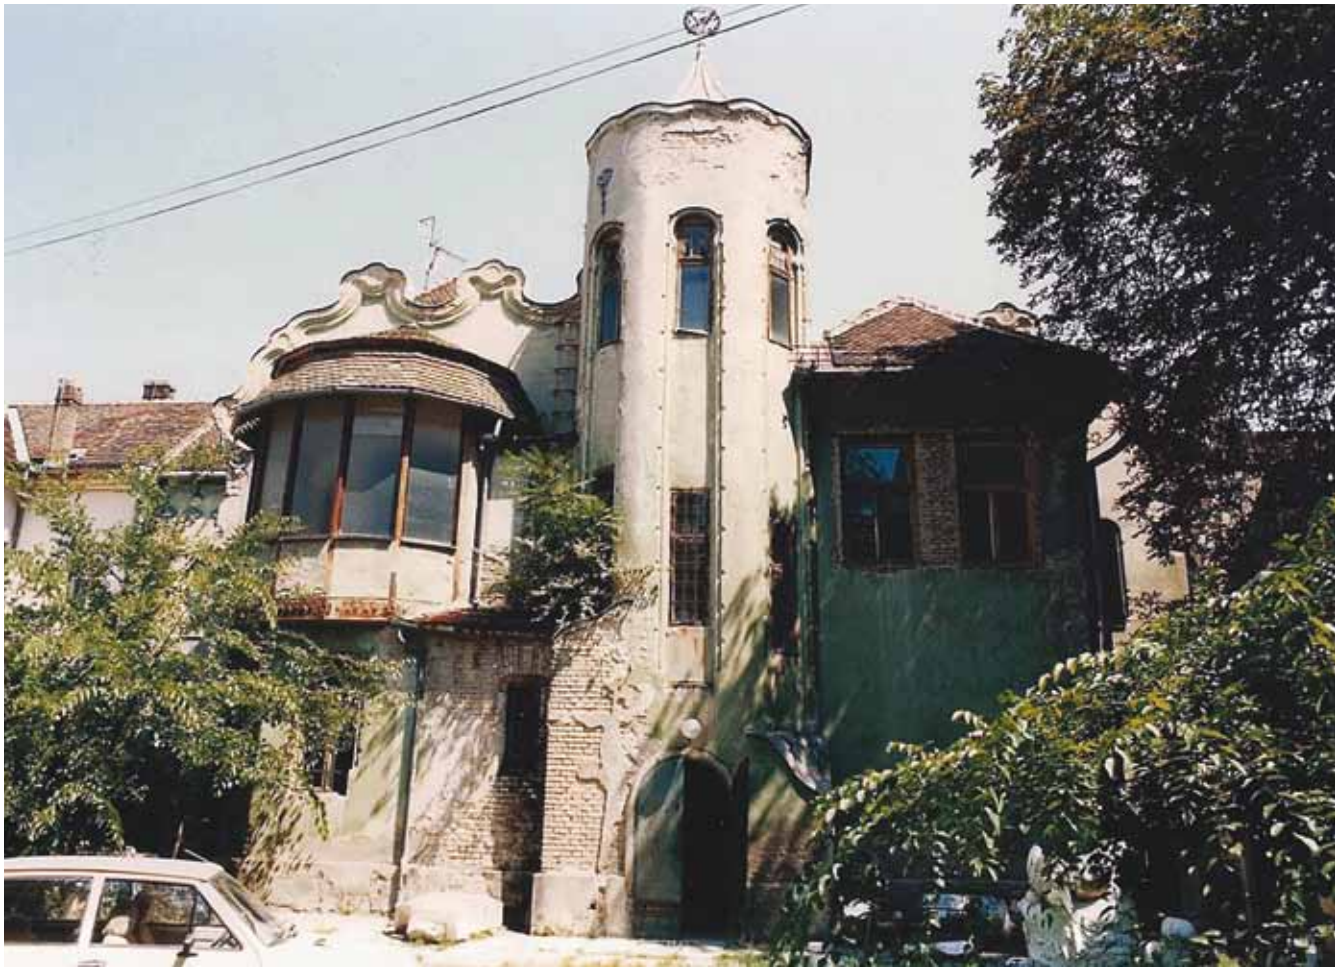
8. The courtyard façade before restoration

and thoroughly “purified” from “unnecessary” decorative elements. (Fig. 8) At the end of the 1970s, the golden yellow glass prisms, which had been used in the construction of the second-floor conservatory, were removed and replaced by ordinary, yellow, “Ornament” reinforced glass. Only one example of these special glass prisms has been preserved at the Institute, as a sample for eventual remanufacturing if an appropriate manufacturer can be found in the future. (Fig. 9) In 2004 the conservatory was partially reconstructed and glazed with yellow “Ornament” glass again, which is hopefully only a temporary solution. Previously, the *kibic fenster*¹¹ had been removed and replaced with two windows that did not belong to the original façade. Only a few samples of the blue-yellow glazed Zsolnay pyrogranite decorative elements remained, and the mortar along with the paint was falling off the monochrome olive-green façade. In the 1990s, this “spooky” court-

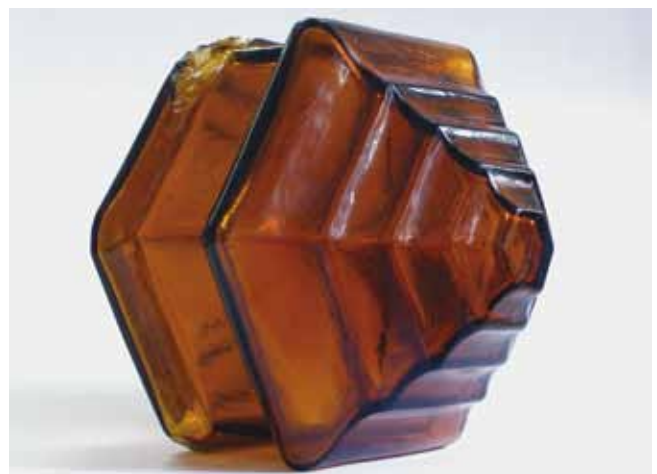
9. The only remaining special glass prism

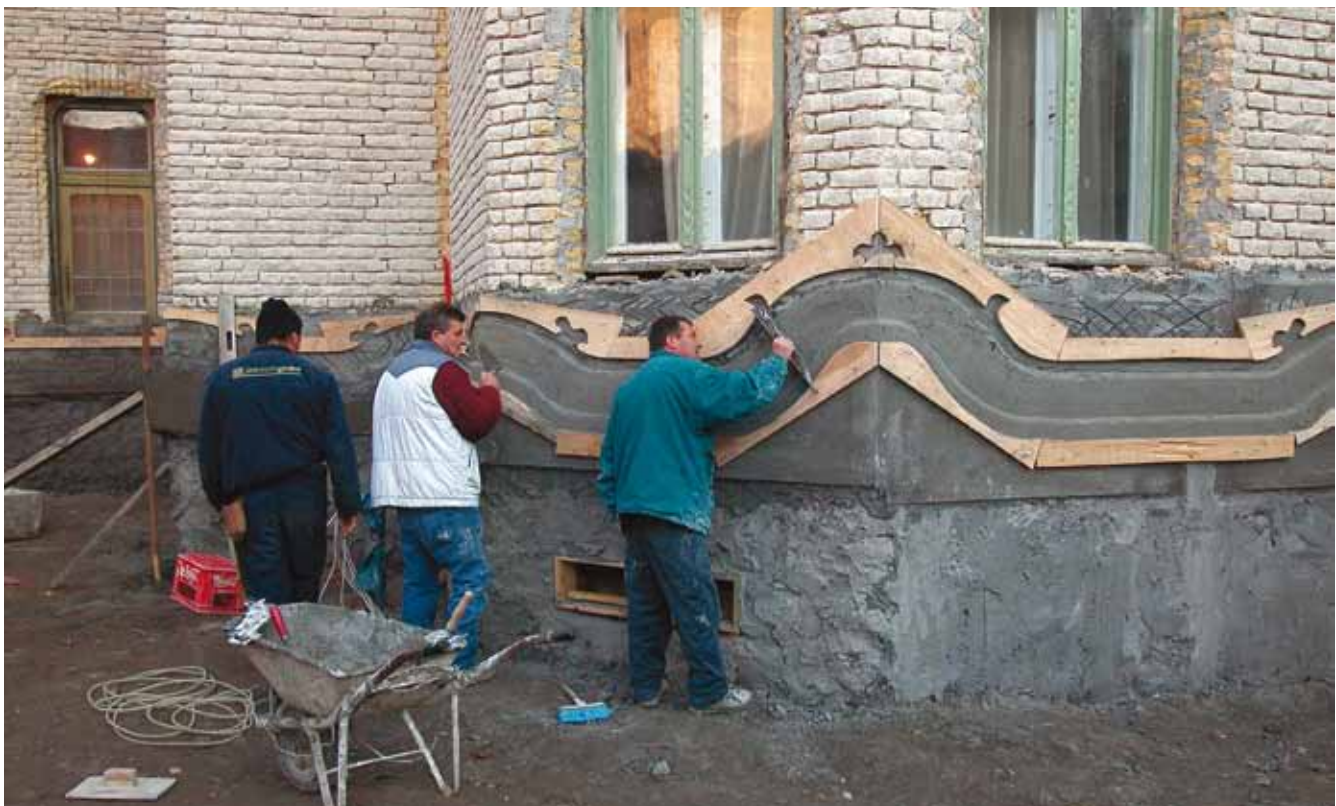
10. Restoration work on the courtyard façade using templates to make the undulating plaster forms

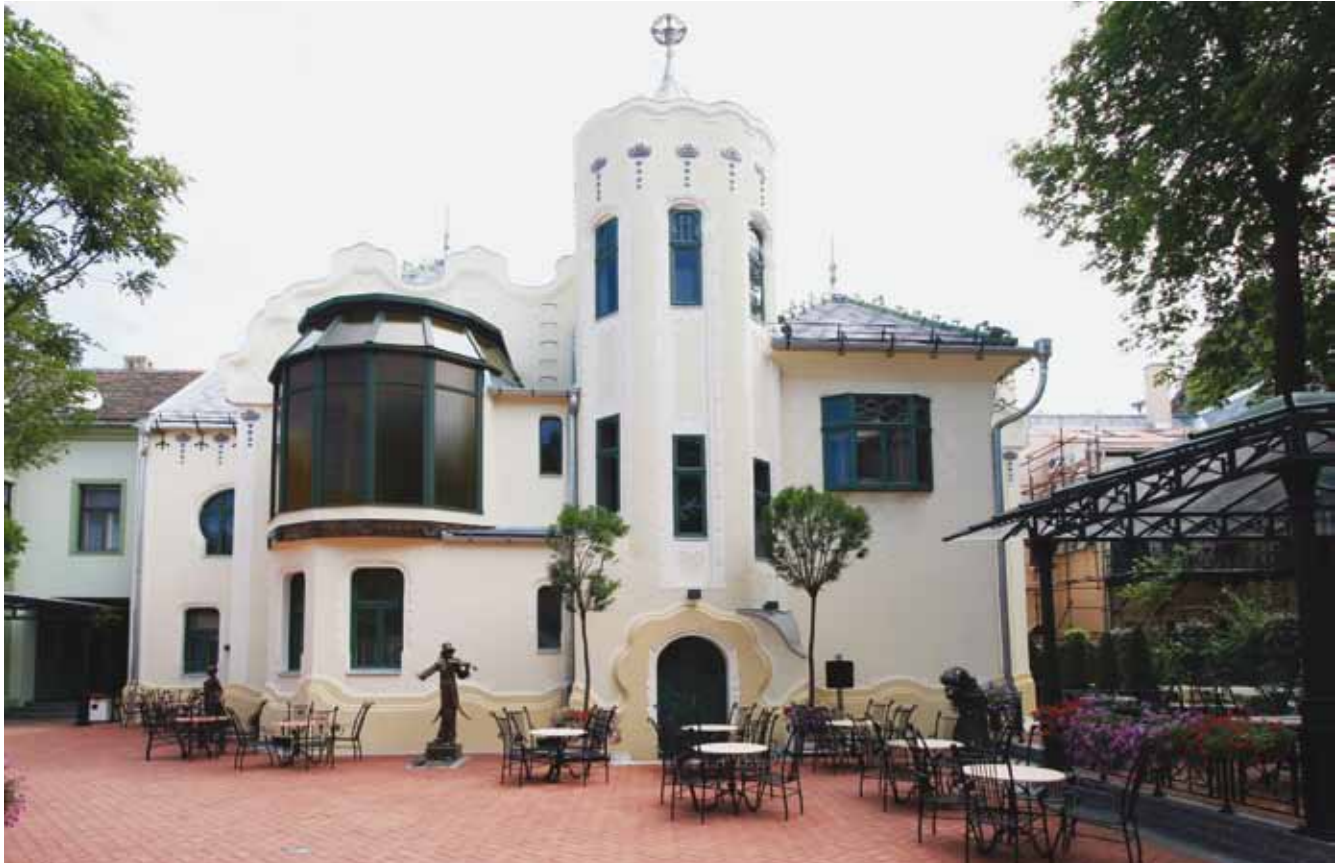
11. The courtyard façade after reconstruction and restoration

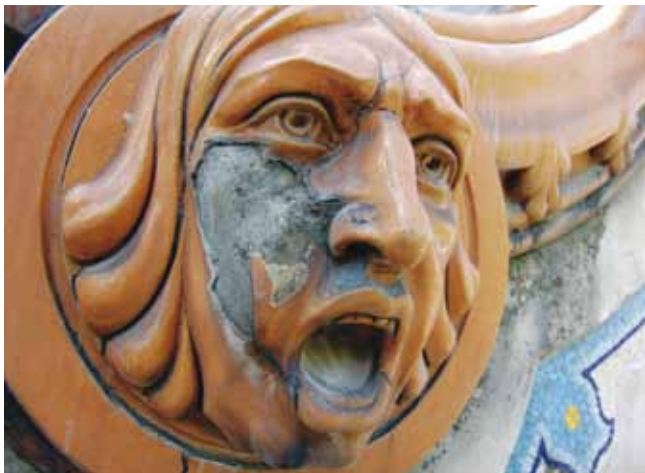
12. Damaged round human mask made of glazed ceramics from the gable of the building

already been repaired with cement mortar, had cracked into pieces and been embedded on the top of the gable. Each fragment was marked during dismantling and sketches were made as instructions for reassembly, and finally they were specially packaged and sent to the Zsolnay factory in Pécs. Some other elements with only minor surface damage and smaller cracks were restored in situ with a colored two-component epoxy resin, mixed according to the instructions of the engineer József Huszár. This protected the elements from further penetration of moisture and deterioration. At the same time, the surface of the façade was thoroughly examined, and it was determined which surfaces had to be completely removed, those that could be saved by injection, and those that should be retained without intervention due to the presence of decorative elements. The wall surfaces that had been repaired in the late seventies were uncovered. They had been re-plastered at that time with a repair mortar with a coefficient of thermal expansion (hereinafter: C.T.E.) of 1.456. These surfaces had begun to deteriorate most intensively, since the C.T.E. of the applied repair mortar did not harmonize with the C.T.E. of the original plaster or of the brick wall, so they had started to separate. Originally, Raichle's master builders had plastered the façade in three layers. The first layer of 25 mm was made with Danube River sand and had a C.T.E. of 1.068. The second layer was applied to the first in a thickness of 30 mm and had a C.T.E. of 1.115. The third layer was identified as a 4 mm thick scratch coat with a C.T.E. of 1.151. It was the color of butter due to brick powder

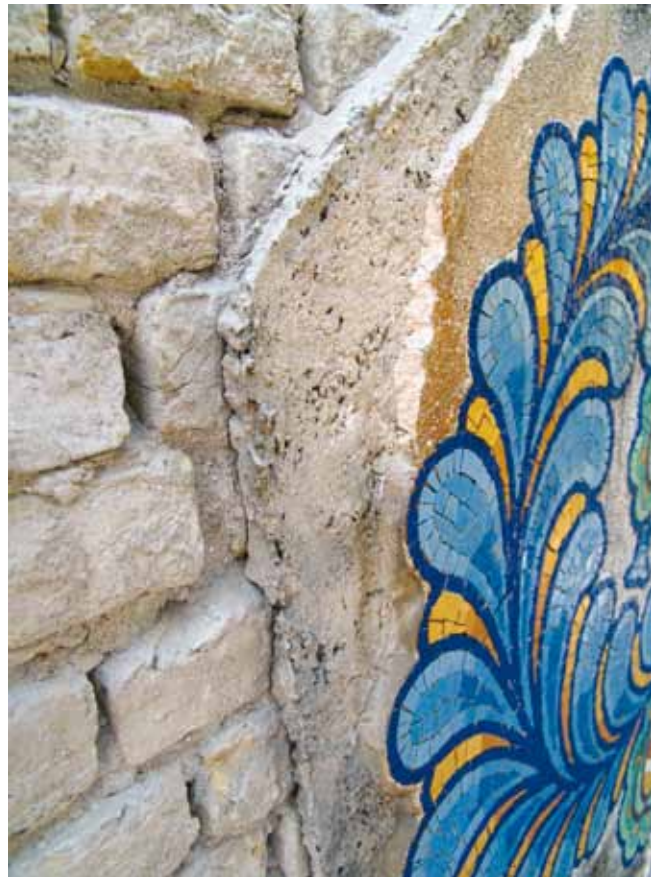
13. Layers of plaster on the primary street façade

from Raichle's brick factory, which he had added to it. That was also the finishing layer, indicating that the façade had not been painted originally, prior to the interventions in the late seventies when it received its characteristic yellow color. The sampled bricks had an identical C.T.E. as the finishing layer of the scratch coat. This method of plastering resulted in consistent behavior between all the layers of plaster through expansion and shrinkage at extreme temperature differences, while retaining vapor permeability. This was the principle that was to be followed during the restoration process when choosing a new repair mortar. (Fig. 13) A type of long mortar was chosen, with "Micropol" as an additive instead of slaked lime (see: calcium hydroxide). This had a C.T.E. of 1.10, and due to the micro-cavities it contained, it also had excellent vapor permeability. After 100 years the original mortar on the façade had become hard as stone, but in some places it had separated from its base – the brick wall surface. When the removal of the mortar had begun, it was noticed
