Restoring Art Nouveau

Architectural Decoration in the Danube Region

Proceedings of the international conference Restoring Art Nouveau,
Budapest, 6 November 2017

GÁBOR GYÖRGY PAPP: Foreword	7
LÁSZLÓ CZIFRÁK: Experience from the Conservation of the Zsolnay Architectural Ceramics in the Entrance Hall of the Budapest Museum of Applied Arts	11
ALEKSA CIGANOVIC: Decades of Restoring the Subotica Synagogue	23
GÁBOR DÖMÖTÖR: Restoration of the Raichle Palace in Subotica	33
RAMONA NOVICOV: Lost Beauty Rediscovered. The Black Eagle Palace and Adolf Moskovits Palace, Examples of Good Practice in Restoration	45
ASTRID HUBER: Architectural Surfaces and Plaster Façades around and after 1900 in Austria	57
DAVID MIŠIĆ and NINA NAHTIGAL: The Baroness House in Maribor. Sustainable Protection and Promotion of Art Nouveau Heritage in the Danube Region	69
EVA RADOLOVIĆ: Renovation of Two Zagreb Residential Buildings. Comparative Analysis of Two Façade Restoration Projects	83
IOSEFINA POSTĂVARU: Restoring Art Nouveau Buildings throughout Romania. The Lutheran School in Cincșor and the Sofian House in Botoșani	93

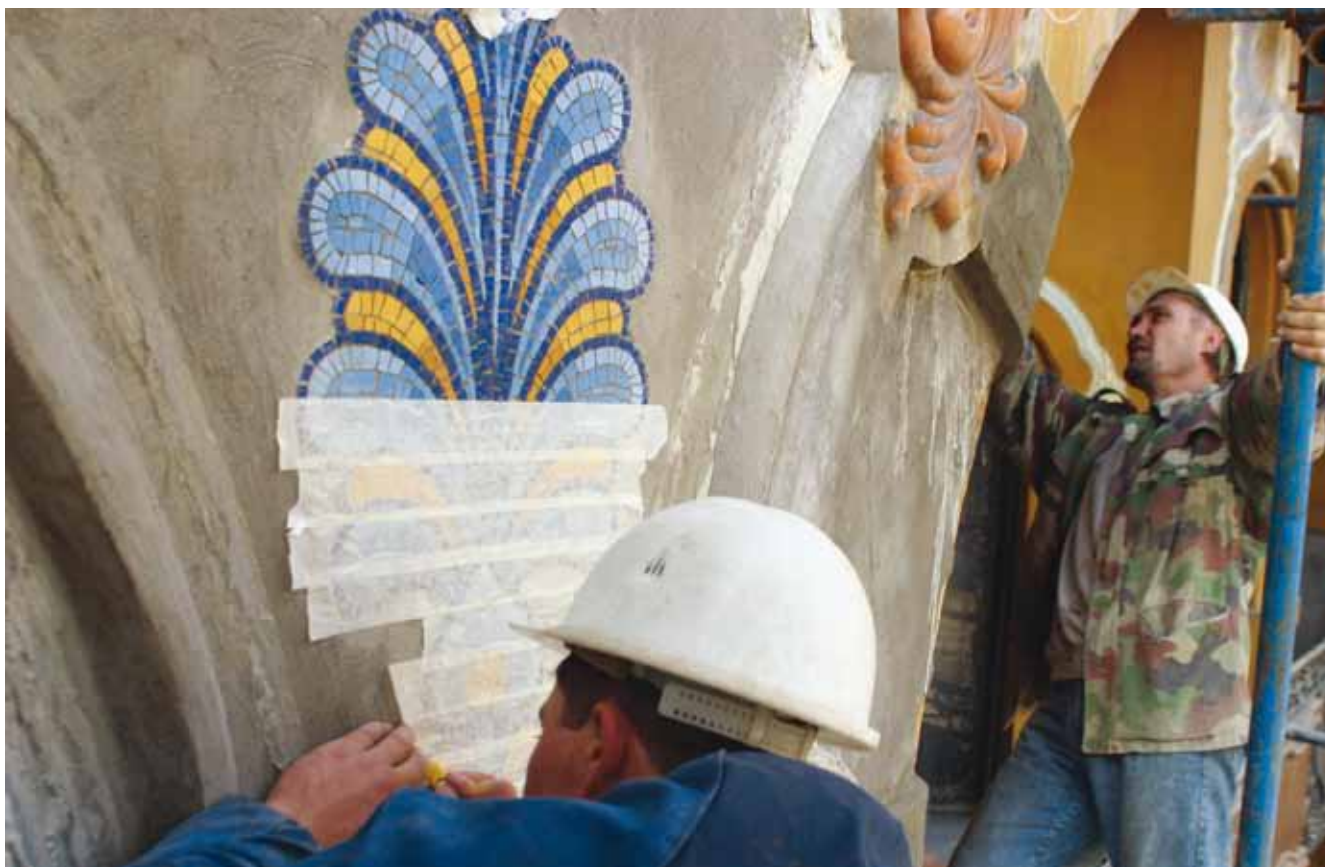
14. Façade restoration work

that the bricklayers supervised by Adolf Gály from the Town's Engineers Office had been negligent; they had not made the joints between the bricks deep enough (min. 3 cm deep), and therefore in these places the applied mortar had not adhered to the wall surface sufficiently, and had detached from it over time in large swathes. In fact, 80% of the mortar had to be removed as a result of the wall examinations, and where this was not possible due to the presence of Zsolnay ornaments or mosaics, it was necessary to inject the repair mortar through "needle pockets". The removal of the original mortar had to be performed very carefully, and this was made even more difficult by its exceptional strength. After considering the presence of capillary moisture in the wall above the marble base, it was repaired with "Hydroment" drying mortar, applied to the wall surface to a height of 1 m above the upper line of the base. (Fig. 14) In the meantime, the conservation of the Murano glass mosaics was also underway. Their stabilization was performed using a binder based on "Policem",

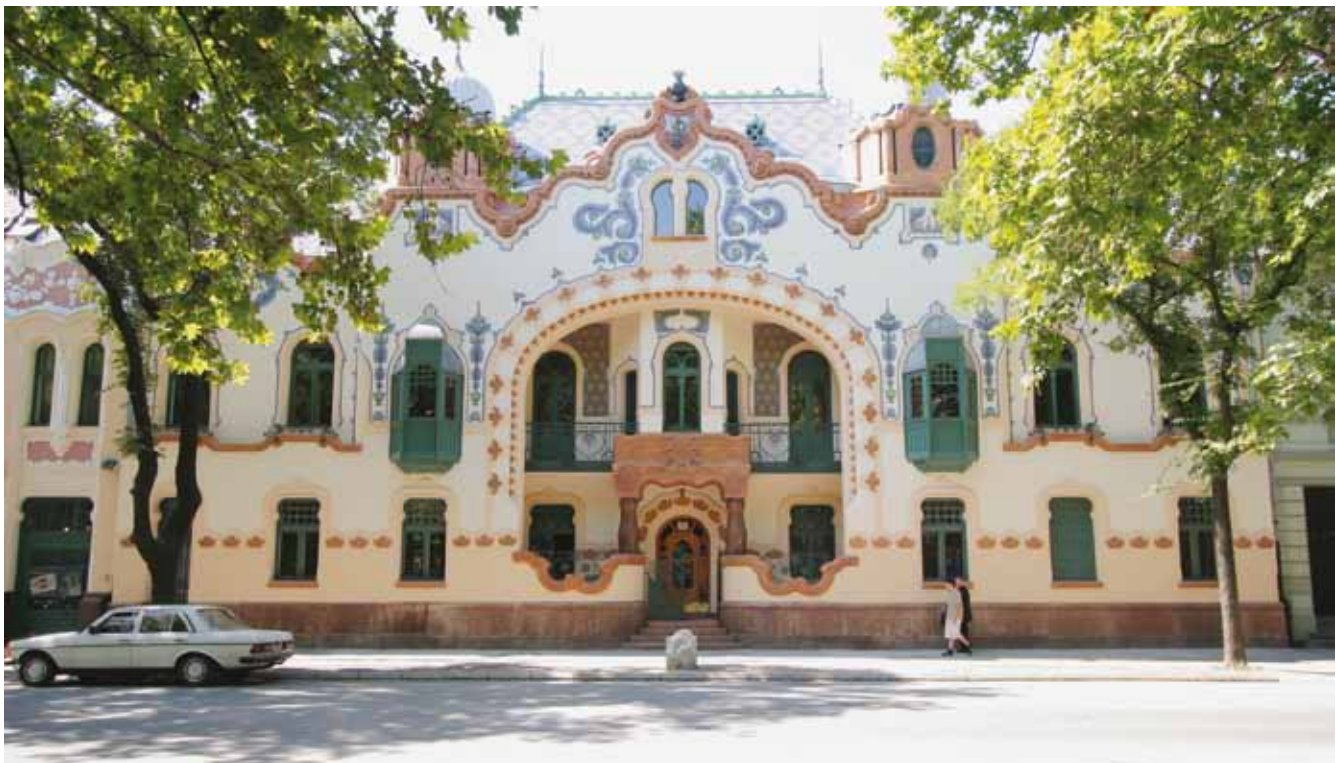
15. The primary street façade after restoration

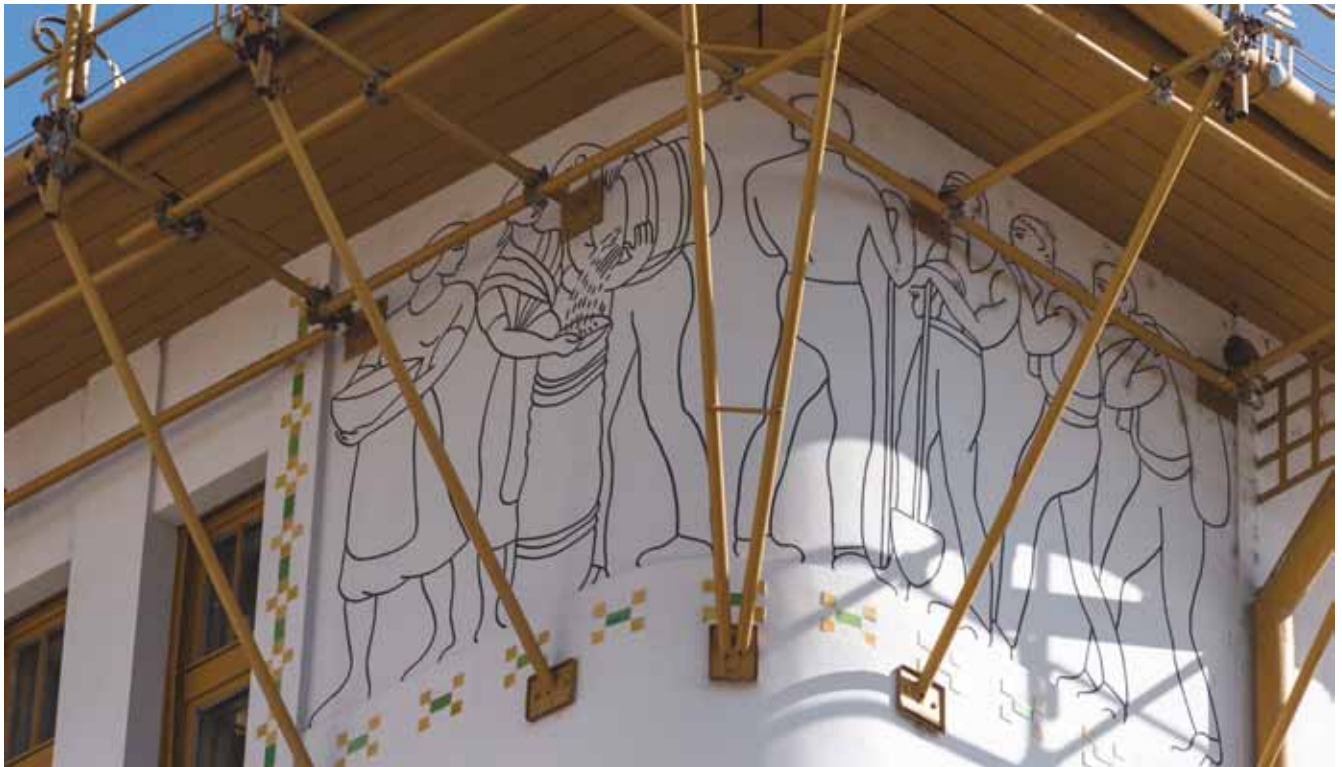
3. László and József Vágó, Adolf Moskovits Palace, Oradea, 1910–11

between 1910 and 1911. Here it can be noted that there is a completely new architectural vision, which is in the avant-garde of the geometric Art Nouveau⁴ that is actually the very opposite of Lechner's vision. The façade and attics of this building have been restored. The Zsolnay ceramic plate decoration was also restored, as well as the semi-sgraffito at the cornice. (Fig. 3) At present, the building has regained its original appearance for the most part.

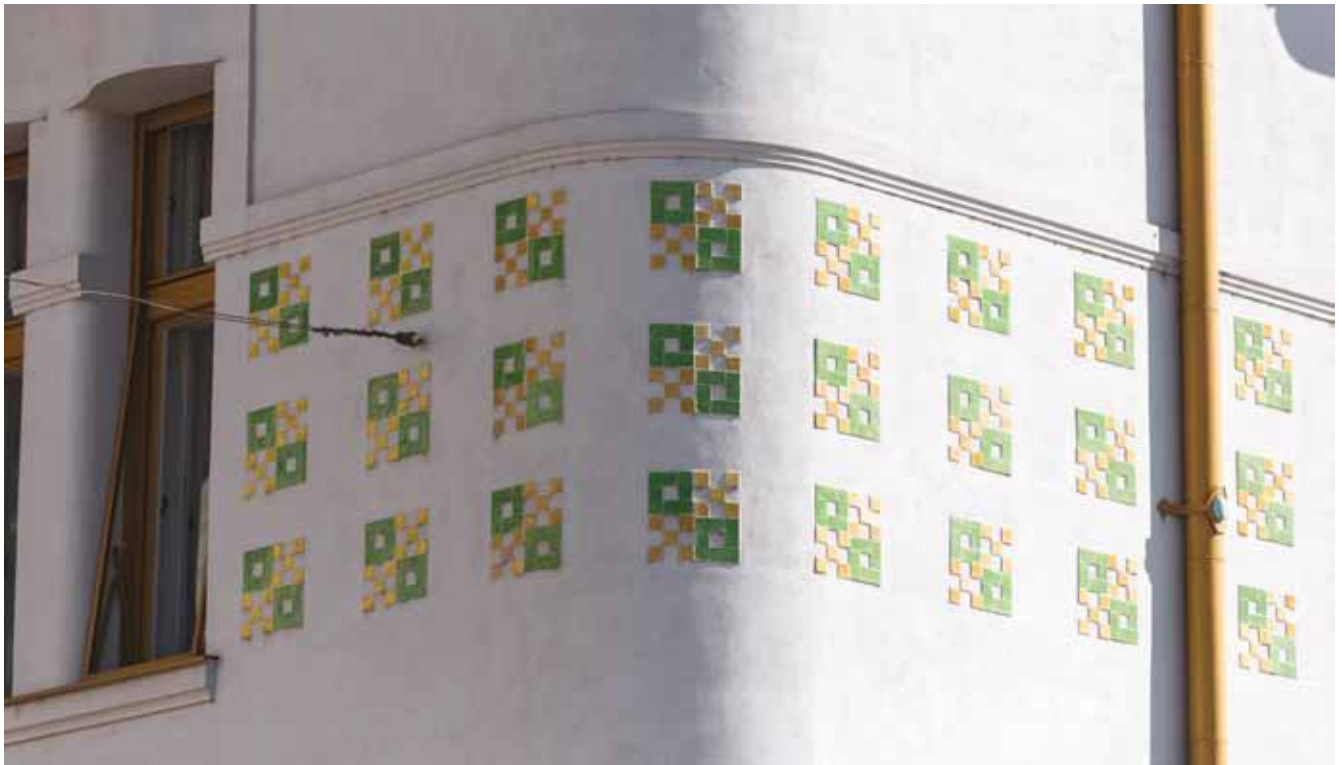
6. László and József Vágó, Adolf Moskovits Palace, modular surface, Oradea, 1910–11

a national tone. The palace provides an artistic expression of a minimalist spatial and formal geometry expressed clearly and absolutely, firmly and coherently in the spirit of the Viennese Secession.⁸ (Fig. 6)

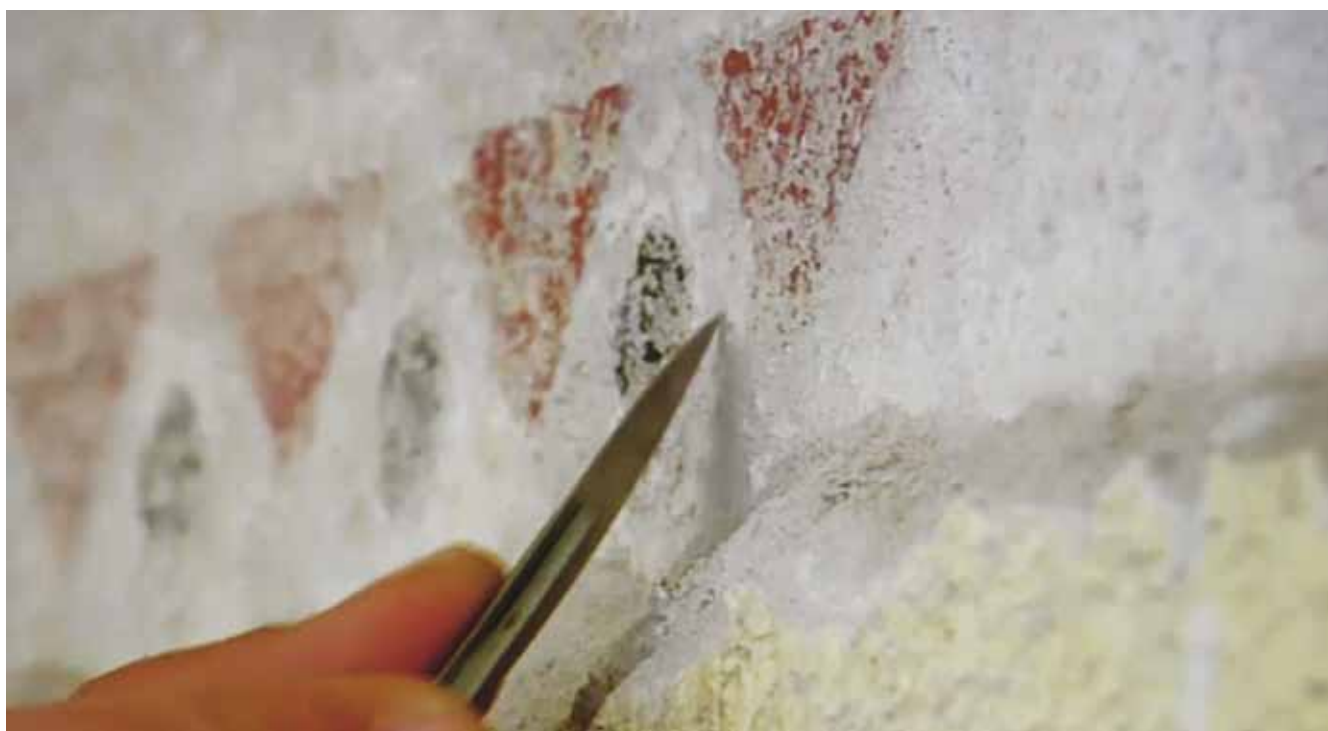
11. Restoring the Black Eagle passage, frame 3, 2016

vealed the existence of original wall paintings, consisting of repetitive floral motifs and rosettes adapted to the type of surface support. (Fig. 11) The documents and photographs of the period were analyzed and the original decoration with motifs inspired from Hungarian folk art was faithfully reconstructed. The method of highlighting the screed surfaces was chosen because the surfaces were very large. The transparency of the method gave maximum credibility to the restoration operations. Great attention was paid to the preservation of the metal sheets in the original restoration stages. To get to the original paint layer, successive layers of paint and plaster had to be removed. After thorough scraping, a better-preserved surface was chosen. This was a difficult operation because the original paint layer was scraped, so it was barely preserved, and it had become fragmentary and powdery. The decorations were like gems in a field of ash. The selected surface was cleaned, and this was supplemented by other specific methods, including UV rays. The sizes of these areas, preserved as screeds, are between 1 and 2 square meters. Templates were made based on these patterns for the newly restored surfaces. The painting was made on a coat of lime-based plaster (*kalkglett*). The colors

used were also lime-based (*al fresco*). All repairs to the plaster were made using lime-based mortars without any cement.¹⁶

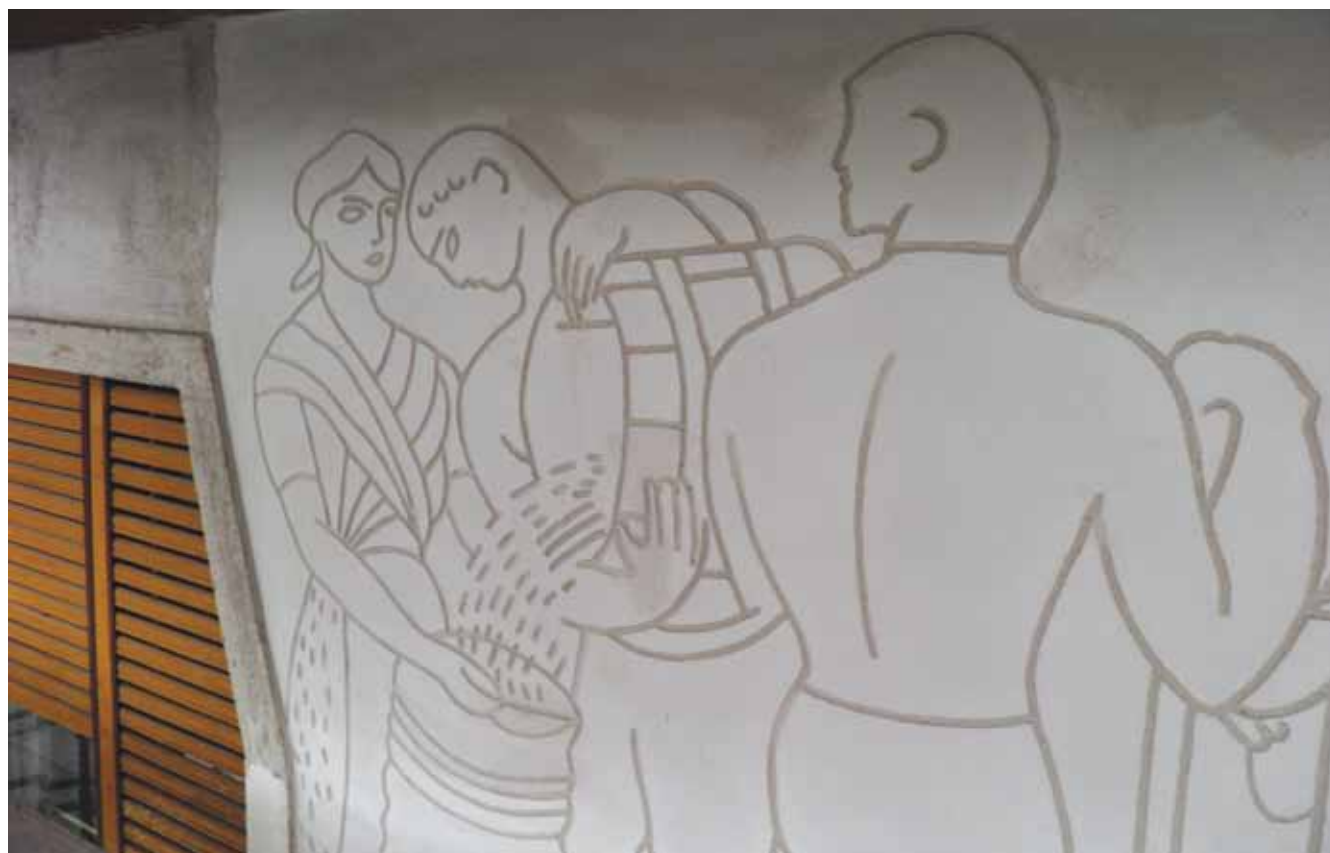
13. Adolf Moskovits Palace, sgraffito, after restoration

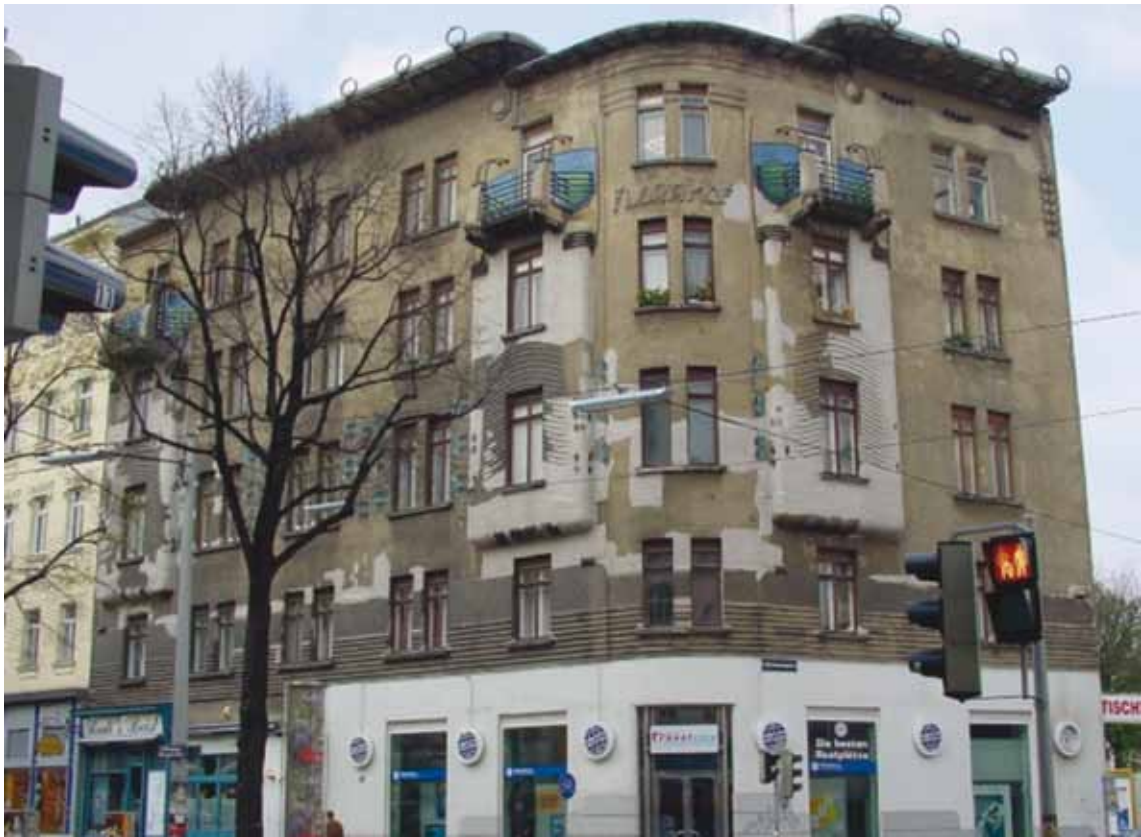
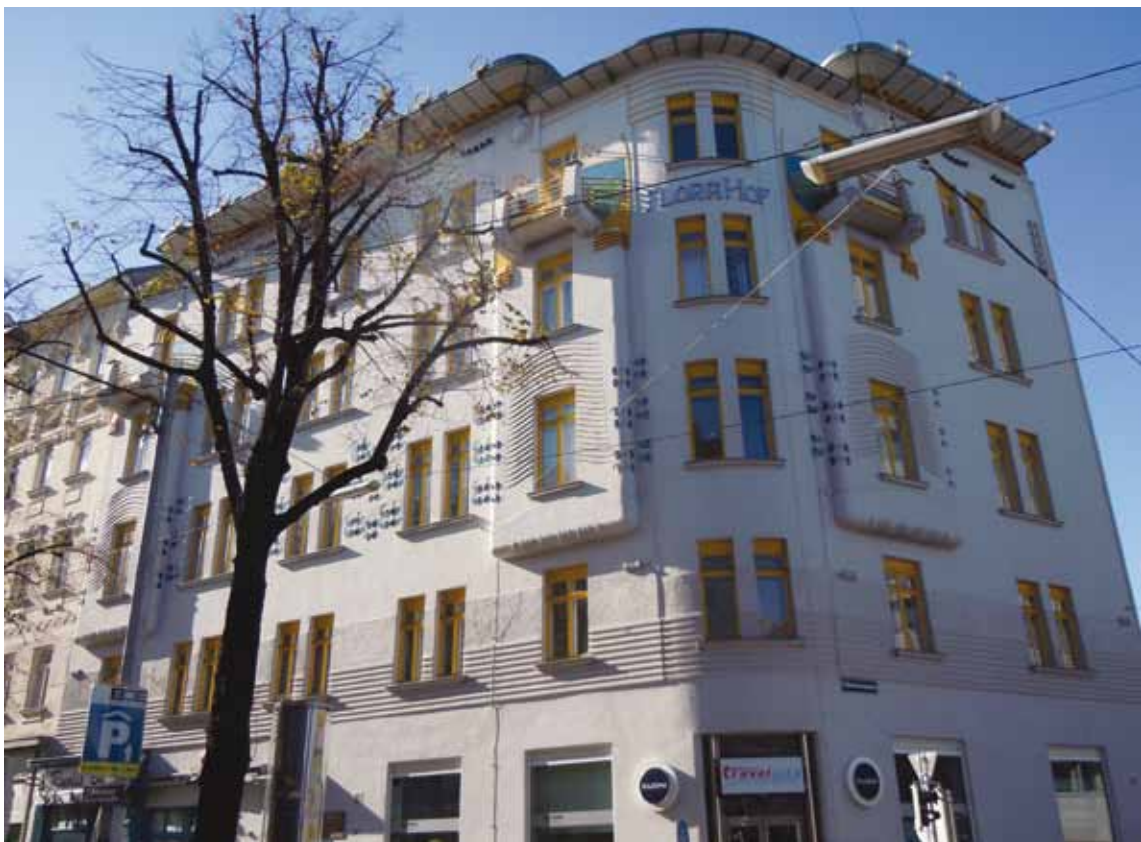
3–4. Oskar Laske, “Florahof”, 88 Wiedner Hauptstraße, 1040 Vienna, 1901, before and after renovation

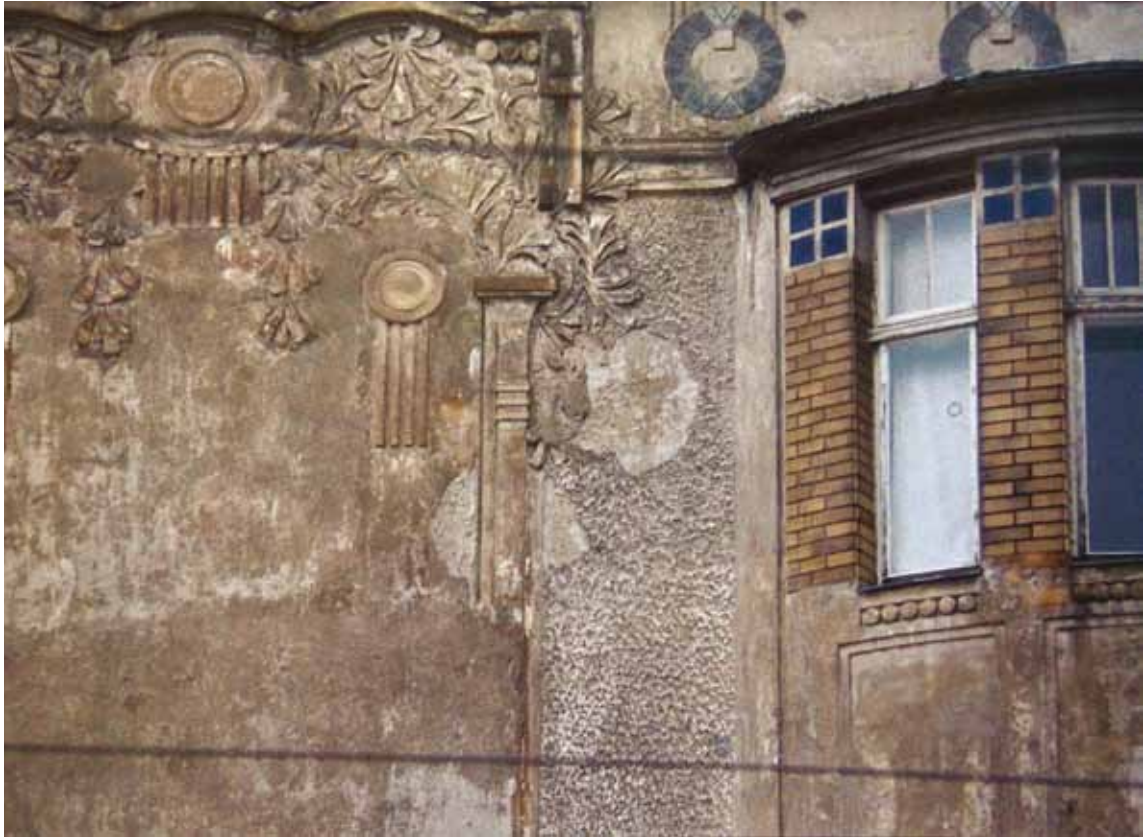
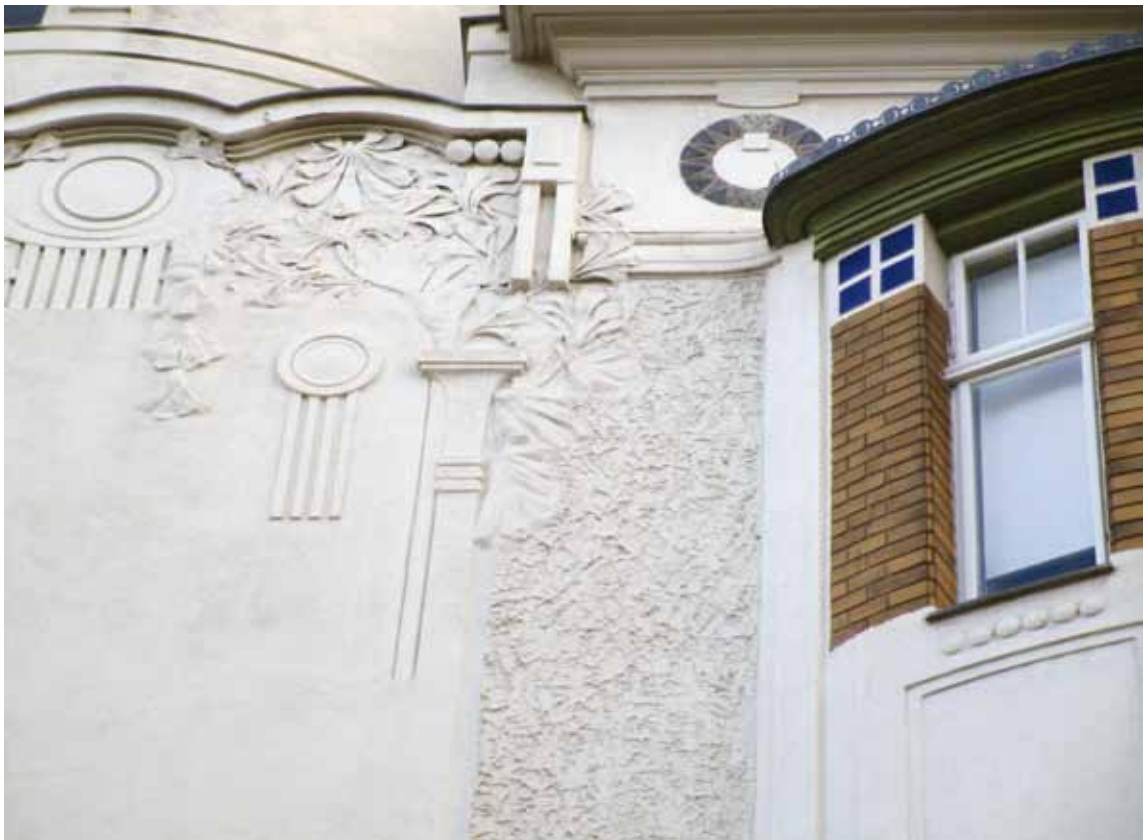
6.a-b Emil Reitmann, "Galileihof", 3-5 Lainzer Straße, 1130 Vienna, 1905, before and after renovation

A similar approach can be observed in Hietzing, at the so-called “Galileihof” at 3–5 Lainzer Straße by the architect Emil Reitmann in 1895.⁸ The façades are dominated by a combination of plaster finished in various ways and ceramic tiles, complimented by elements of brickwork cladding. These façades have been restored over the last ten years. Until this intervention, the surfaces had never been touched and preserved the original visual quality of the natural plaster without any more recent coatings. In particular the different finishes of rough-cast, smooth and so-called “squeezed” plaster, (*Quetschputz*), a decorative plaster achieved through pressure and suction, are easily identifiable on a photo from the 1990s. Obviously also in this case, the goal of the restoration was not to preserve the authenticity and its special surface qualities, but to paint it white, which it never had been previously. Moreover, the strong contrast today between the glossy white plaster and the

other elements, like ceramic tiles or brickwork cladding, does not correspond with the original effect of the façade. (Figs 5–6a–b)

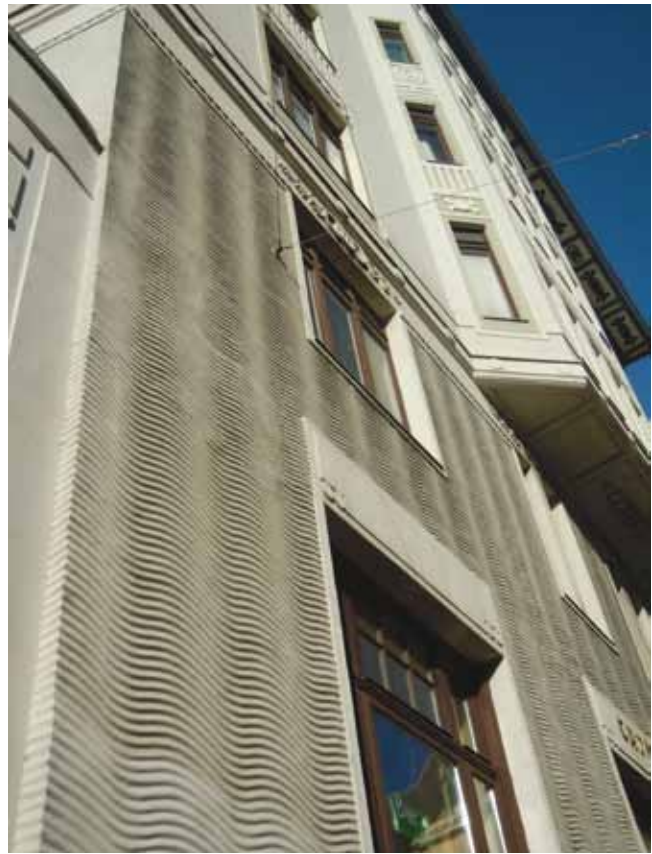
7. Oskar Marmorek, “Rüdigerhof”, 20 Hamburgerstraße, 1050 Vienna, 1902, combed plaster

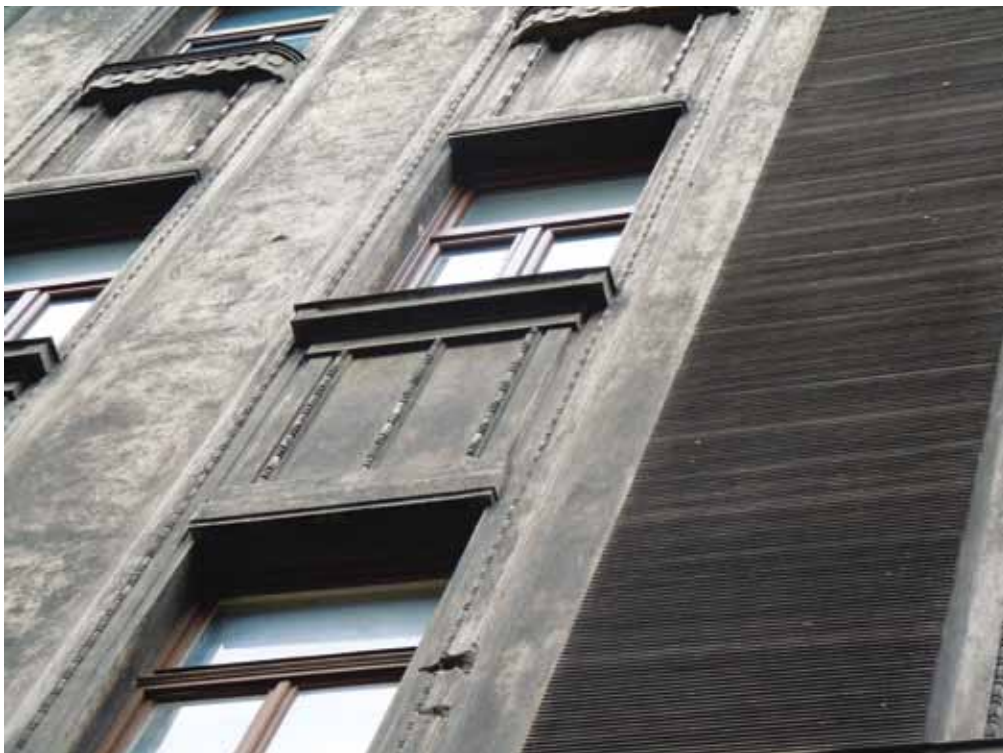
8. Apartment Building, 138 Margarethenstraße, 1050 Vienna, around 1910

Besides rough-cast and squeezed plaster, combed plaster executed using various techniques and consistencies was a consciously used decorative element in particular of the Art Nouveau style. In 1905, Friedrich Ohmann used a rough, “trickled” version of combed plaster at the Vienna River engineering structure at the city park in the 1st District of Vienna.⁹ A very precise form of combed plaster applied in waves characterizes the façades of the “Rüdigerhof” at 20 Hamburgerstraße, 1050 Vienna, by Oskar Marmorek in 1902.¹⁰ (Fig. 7) To get an impression of the original effect of Art Nouveau plasterwork, it is also worthwhile to study an anonymous building from this period in Vienna. There are only a small number of façades left in Vienna that still preserve their authentic appearance, such as the standard apartment building at 138 Margarethenstraße, 1050 Vienna, built around 1910. The combed plaster

elements are so finely and delicately executed that even a thin coat of paint would alter the effect of this decoration. (Fig. 8) One of the apartment buildings by Carl Wenz and Josef Leiker, at 19 Neulingasse, 1030 Vienna,¹¹ similarly has not yet been restored and covered with later paint so far. The façades are decorated by natural plasterwork with various finishes and cast ele-

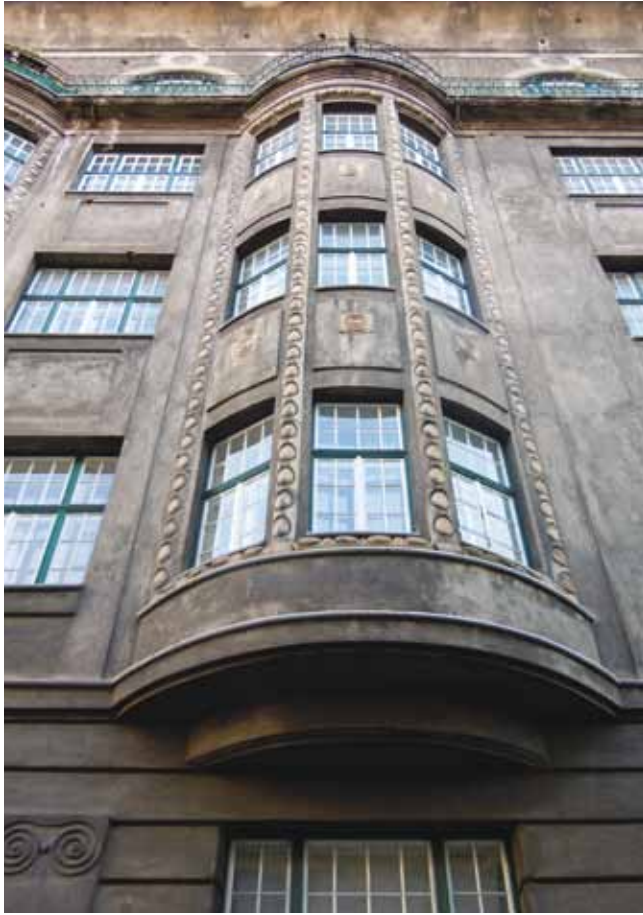
9. Carl Wenz, Josef Leiker, 19 Neulinggasse, 1030 Vienna, 1911

ments with volute and egg forms made of Roman cement. In particular the combed plaster in the upper parts of the façade creates a special, lively surface through its original visual quality. (Fig. 9)

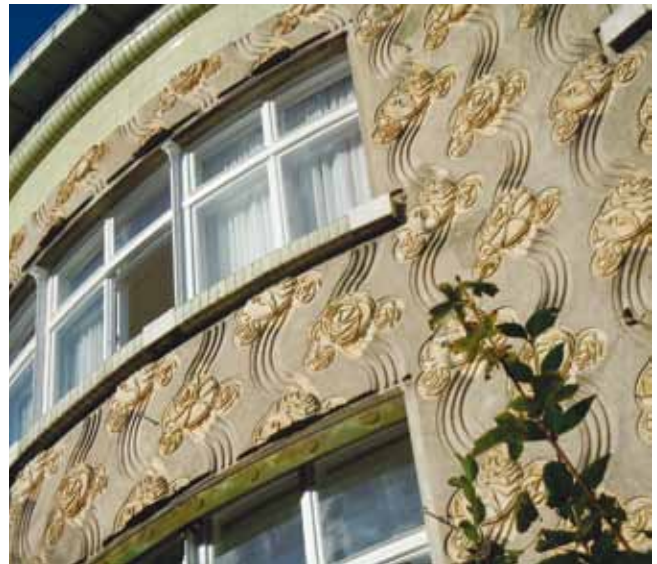
10. Josef Plečnik, “Villa Langer”, 30 Beckgasse, 1130 Vienna, 1900, detail

for historic, but also for technical reasons. The rose motifs are cast elements made of Roman cement, connected by curved lines that were molded into the fresh plaster. The areas between the floral motifs were covered with a fine “squeezed” plaster. The façade has never been treated up to now and still shows the authentic visual quality of the various finishes. Because of the

changes due to age and its patina, it is possible to discover the differences in materials and techniques. The rose elements, made of nearly pure Roman cement, were cast in models and mounted on the façade. The smooth surface still shows its characteristic color, the light brownish-red of the Roman cement in Vienna, which was also called “Viennese Hydrater”. The directly applied plasterwork is a mortar made of lime, Roman cement and sand. Plečnik designed this façade al-

most exclusively with plasterwork; only the main cornice and the window sills are made of light green ceramic tiles and on the back side of the building, at the garden entrance, it is possible to find elements of brickwork cladding. (Fig. 10)

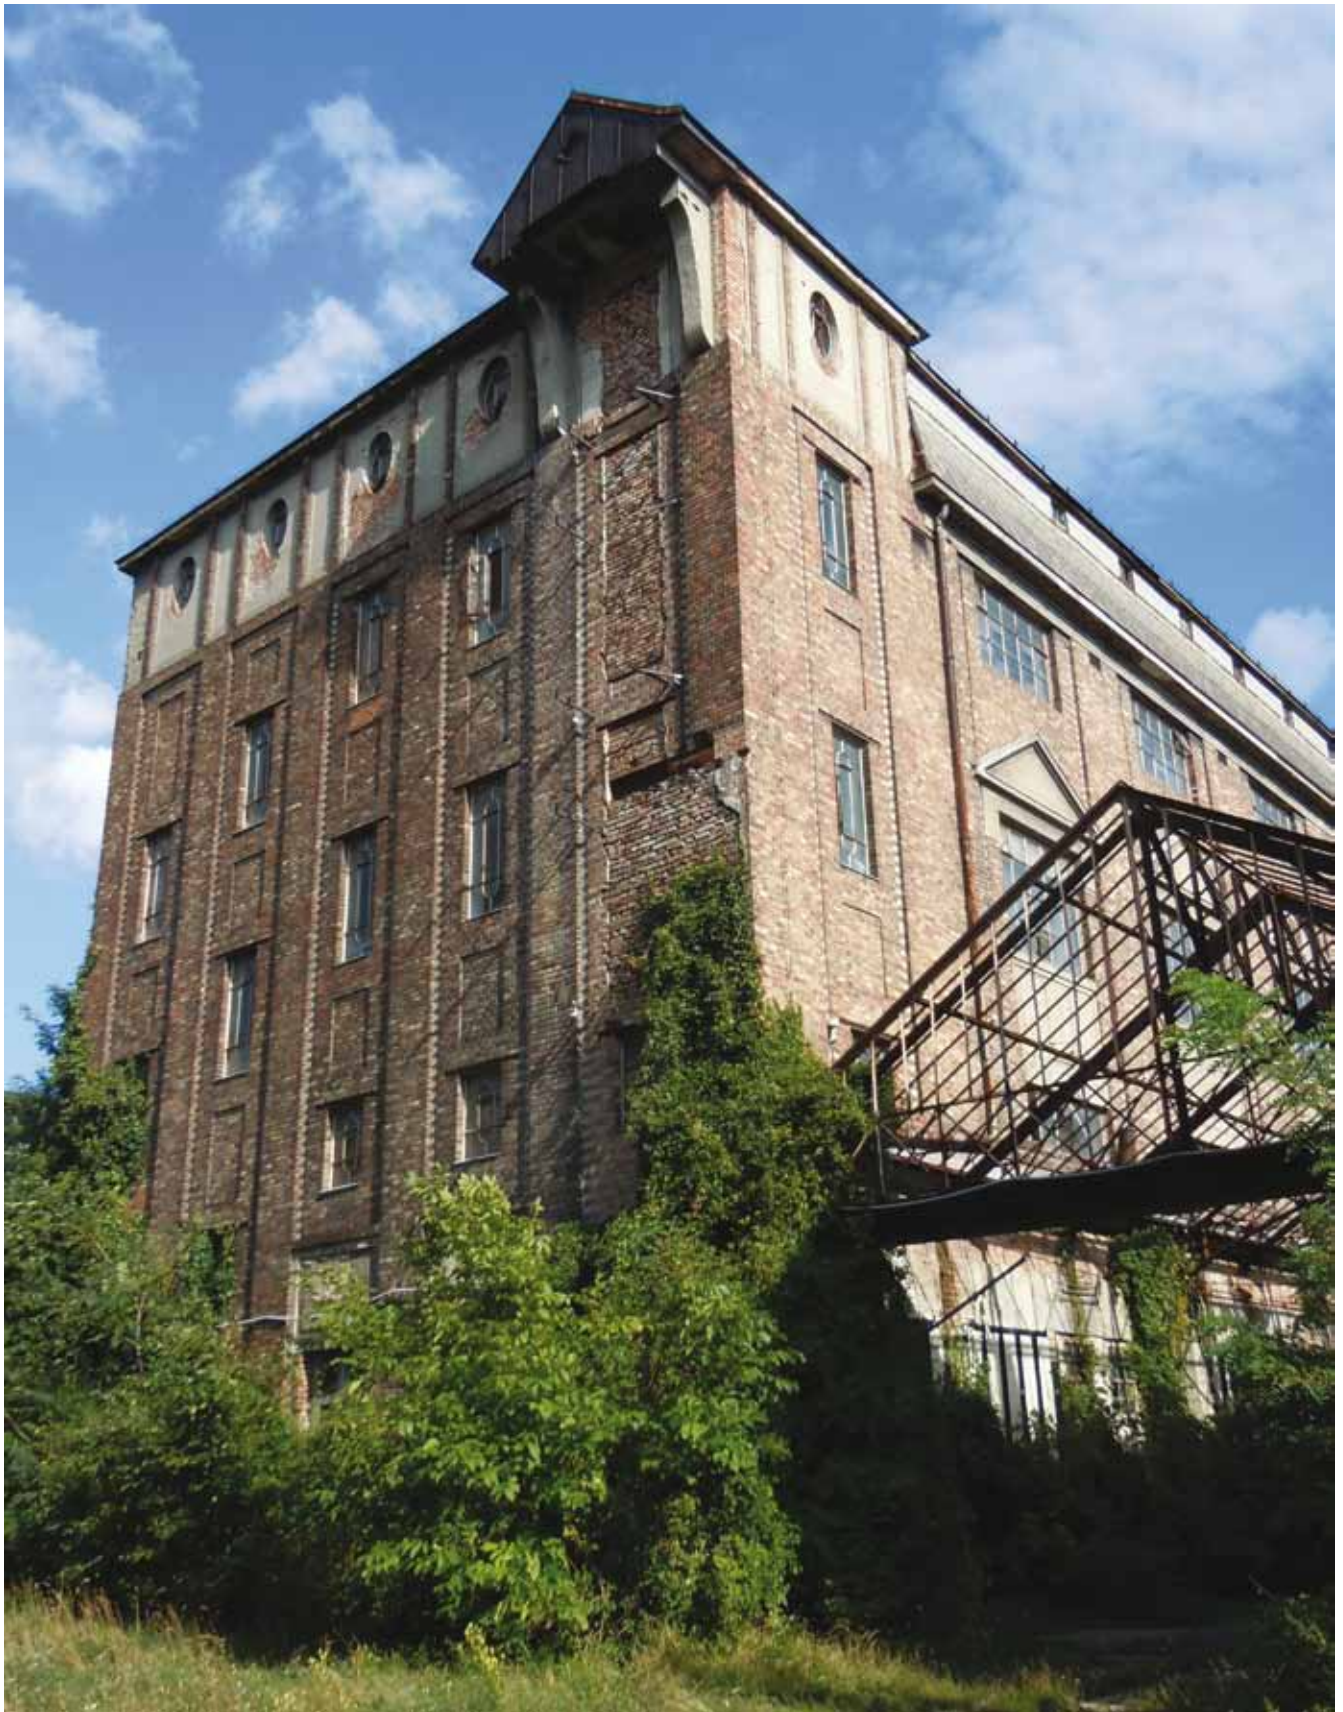
11. Hubert and Franz Gessner, "Hammerbrotwerke", 28 Innerbergerstraße, 2320 Schwechat, 1908–09, general view

remarkable examples is the “Hammerbrotwerke” in Schwechat near Vienna, a former bread factory designed in 1908–09 by students of Otto Wagner, Hubert and Franz Gessner.¹³ (Fig. 11) In September 2017, the Federal Monuments Authority of Austria’s (Bundesdenkmalamt) Information and Training Centre for Architectural Conservation at the Kartause Mauerbach organized a one-week workshop for conservation/restoration experts, craftsmen and architects at the Hammerbrotwerke in Schwechat dealing with the restoration of brickwork cladding and rough-cast plaster. This unique Art Nouveau building complex has preserved the original visual quality of its brickwork and natural plaster. The challenge was to restore the façade without losing the value of age and the patina of the brickwork and treated plaster forming a relief pattern. Brick additions were made with pigmented Roman cement mortar and the recessed joints were re-pointed with lime mortar that had equivalent material properties to the original mortar.

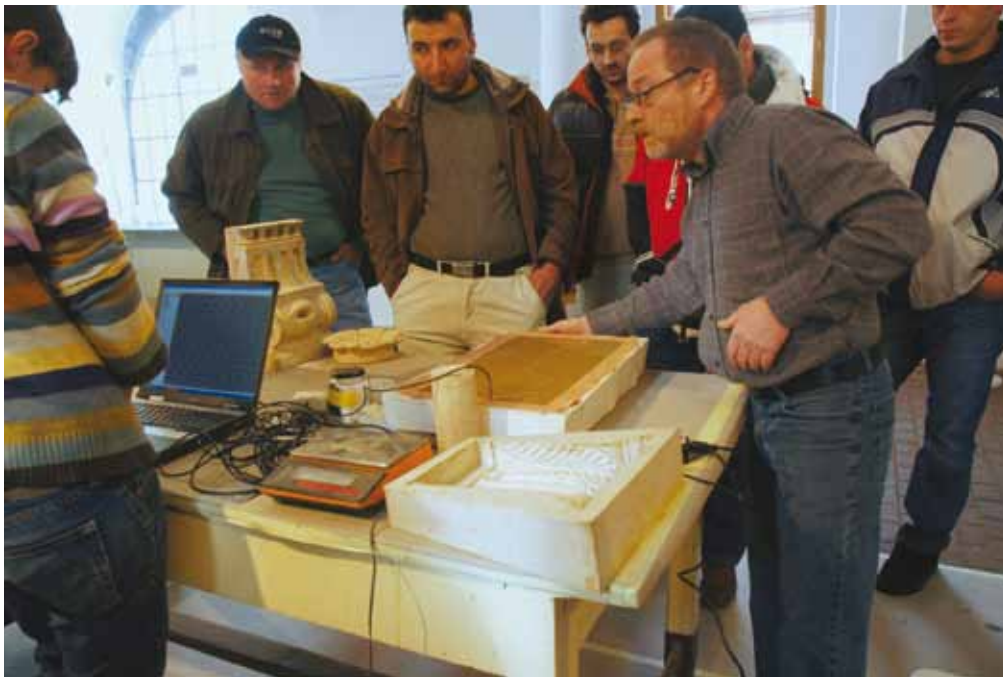
13. Kartause Mauerbach, practical course, cast elements made of Roman cement

First used for engineering work like the construction of tunnels, arches, sewage channels or fortresses, it was rapidly adopted for the stuccoing and rendering of buildings. The short setting time, yellow to brown colors that imitate stone, little shrinkage, water permeability and durability made Roman cement the favored material for the manufacturing of prefabricated cast ornaments for façade decoration. Architects in the periods of European Historicism and Decorative Art Nouveau used these prefabricated cast ornaments, which allowed for quick construction of their decorated façades. In accordance with the concept of materiality, Roman cement was also used by the Secessionist architects up to the early twentieth century, showing the aesthetic of the building material itself without coatings or paint covering it up. After 1920, Roman cement was replaced in the market by Portland cement, which was cheaper

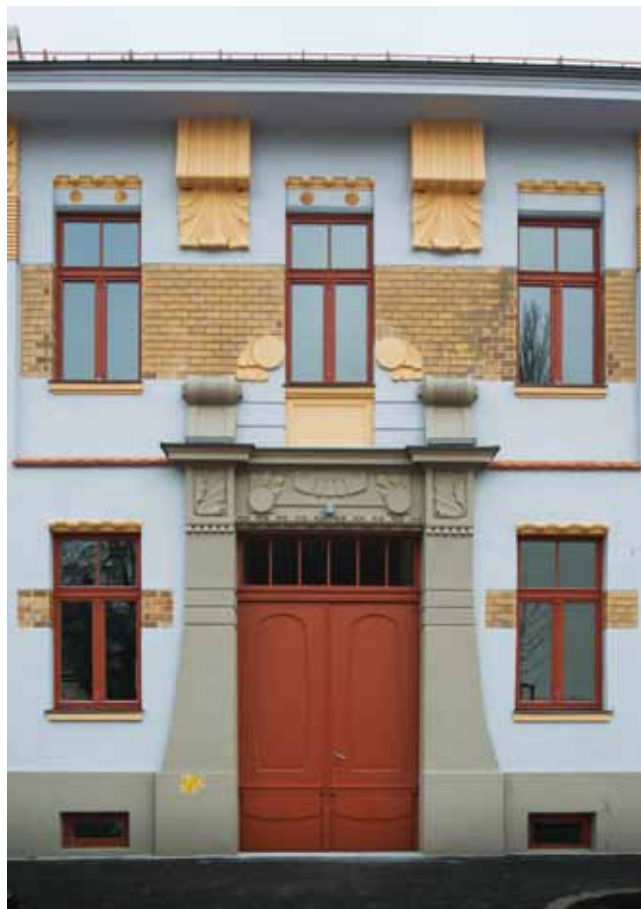
4. The projecting section on the northern façade, ornamented with decorative rectangular, floral and geometric motifs

The house has an L-shaped ground plan. A tile roof covers its street-front sides, while the courtyard side is covered with a flat tin roof. The corner of the building is truncated and highlighted with a segmental gable, which has a large semi-circular lunette topped by a female head. Each of the two street-front façades has an entryway with double wooden doors. (*Fig. 4*) On the western façade along Prežihova Street, there is a cor-

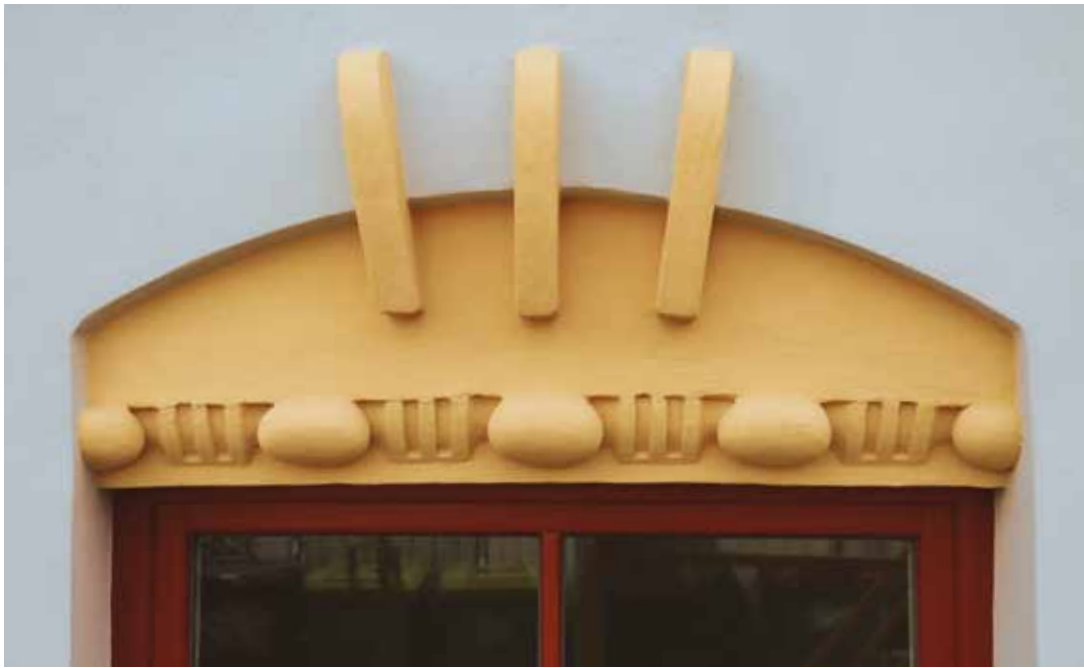
5. The façades and individual details are entirely decorated in the Art Nouveau style

The façades and individual details are entirely decorated in the Art Nouveau style. There are several types of Art Nouveau ornamentation on the façades – geometrical, floral and figural. The bands of yellow ceramic tiles and ceramic circles above the windows are also typical of the Art Nouveau style. Female figural masks provide the main decorative emphasis on the façade, and the architect used them to decorate the capitals of the pilasters, the corbels under the eaves and the top of the lunette. (Fig. 6) The window and door frames and the balcony are also richly decorated with both geometrical and floral ornamentation. (Fig. 5)

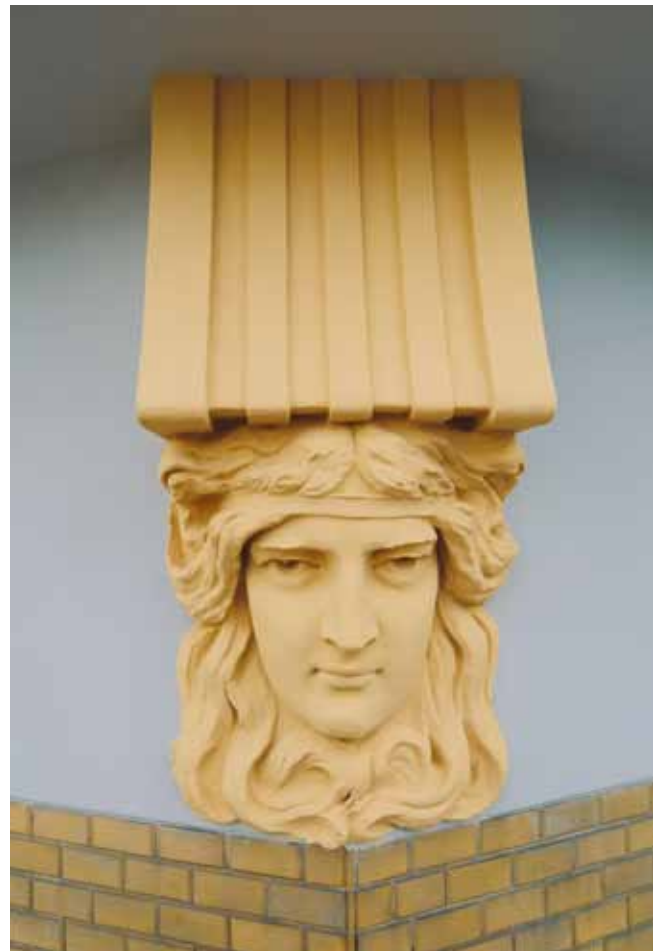
6. Female figural masks provide the main decorative highlights of the façade

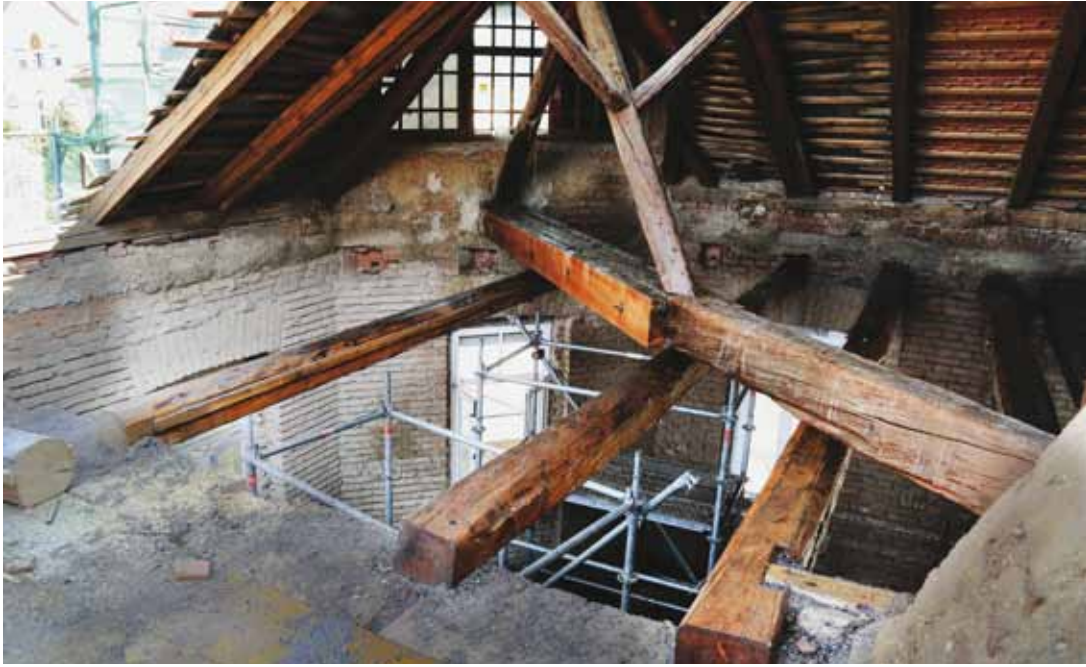
The wooden roofing was replaced by a steel structure, the plastering on all the façades was removed, and the architectural carpentry and joinery was replaced. In the interior, all ceiling sections that had deteriorated have been partially replaced with reinforced concrete. In addition, the ceiling has been renovated in part and some of the partitions have been removed. All interventions were needed to transmit additional static load and to provide secure structural stability. (*Fig. 7*)

7. The edge of the roof structure

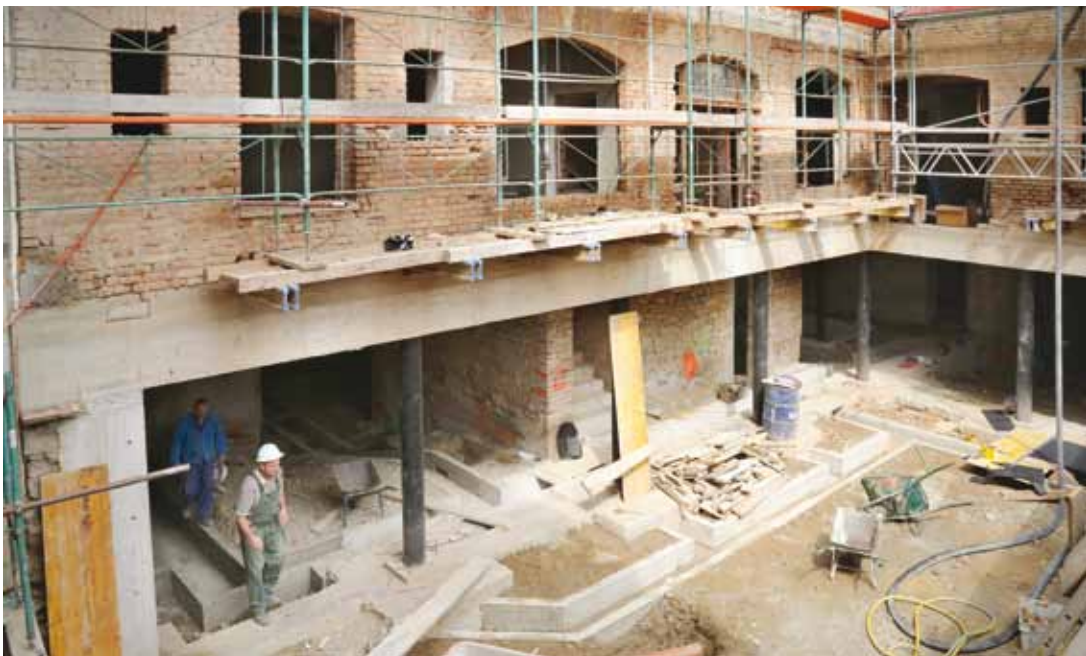
New elements required for the intended purpose have been added, in particular the glass atrium with a gallery in the courtyard area. The construction of the atrium was required in order to ensure additional space and communication between the Baroness House and the neighboring G2 building. The proportions of this new element are in accordance with the entire appearance of the historic property and the façades are visible through its glass structure. The former courtyard garden has been preserved by the architect in a highly innovative manner – as a vertical element with a green wall integrating Art Nouveau elements in a modern way. (*Figs 8–9*)

8. The entire basement level has been deepened and extended in order to incorporate the courtyard
