Restoring Art Nouveau

Architectural Decoration in the Danube Region

Proceedings of the international conference Restoring Art Nouveau,
Budapest, 6 November 2017

GÁBOR GYÖRGY PAPP: Foreword	7
LÁSZLÓ CZIFRÁK: Experience from the Conservation of the Zsolnay Architectural Ceramics in the Entrance Hall of the Budapest Museum of Applied Arts	11
ALEKSA CIGANOVIC: Decades of Restoring the Subotica Synagogue	23
GÁBOR DÖMÖTÖR: Restoration of the Raichle Palace in Subotica	33
RAMONA NOVICOV: Lost Beauty Rediscovered. The Black Eagle Palace and Adolf Moskovits Palace, Examples of Good Practice in Restoration	45
ASTRID HUBER: Architectural Surfaces and Plaster Façades around and after 1900 in Austria	57
DAVID MIŠIĆ and NINA NAHTIGAL: The Baroness House in Maribor. Sustainable Protection and Promotion of Art Nouveau Heritage in the Danube Region	69
EVA RADOLOVIĆ: Renovation of Two Zagreb Residential Buildings. Comparative Analysis of Two Façade Restoration Projects	83
IOSEFINA POSTĂVARU: Restoring Art Nouveau Buildings throughout Romania. The Lutheran School in Cincșor and the Sofian House in Botoșani	93

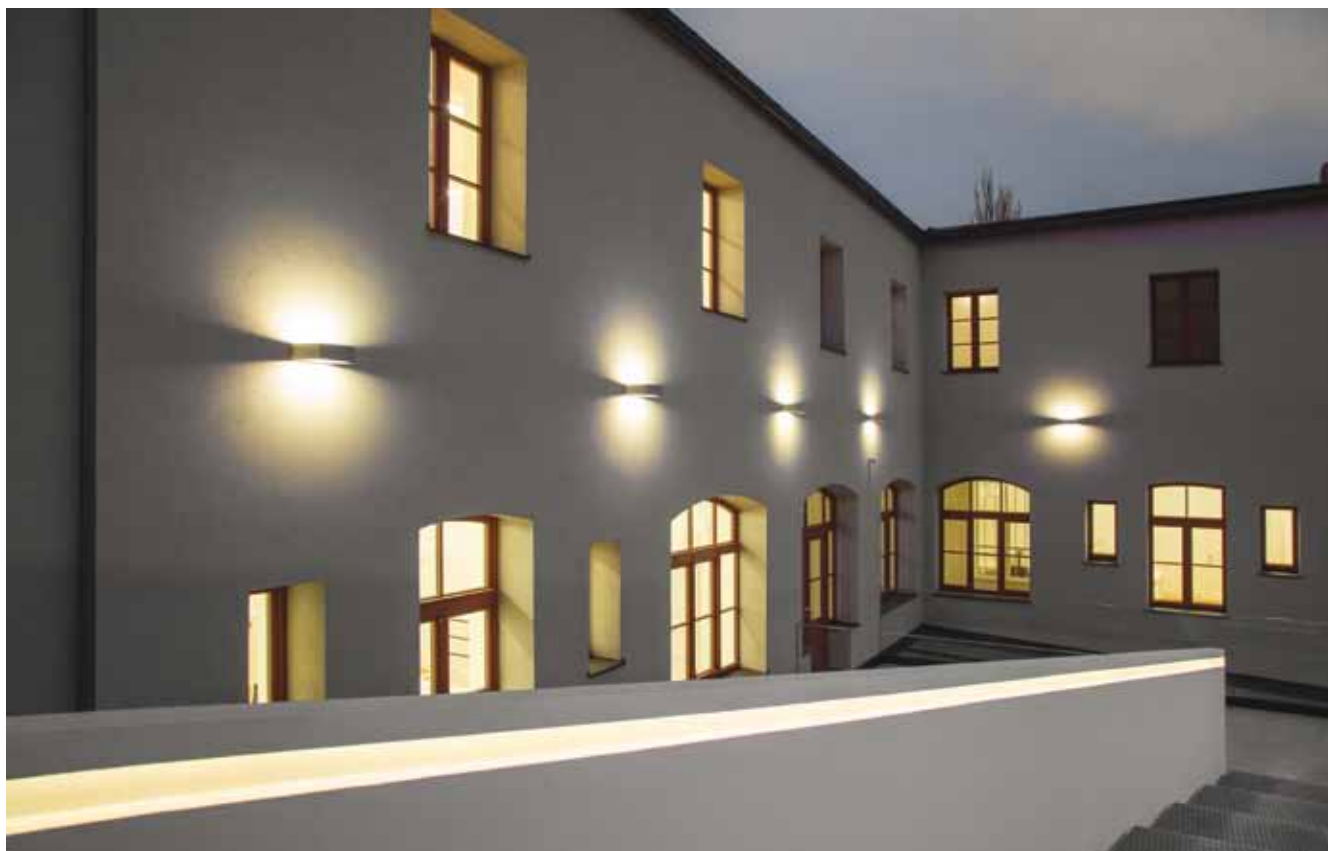
New elements required for the intended purpose have been added, in particular the glass atrium with a gallery in the courtyard area. The construction of the atrium was required in order to ensure additional space and communication between the Baroness House and the neighboring G2 building. The proportions of this new element are in accordance with the entire appearance of the historic property and the façades are visible through its glass structure. The former courtyard garden has been preserved by the architect in a highly innovative manner – as a vertical element with a green wall integrating Art Nouveau elements in a modern way. (*Figs 8–9*)

9. The courtyard connects the basement level, ground floor and second floor

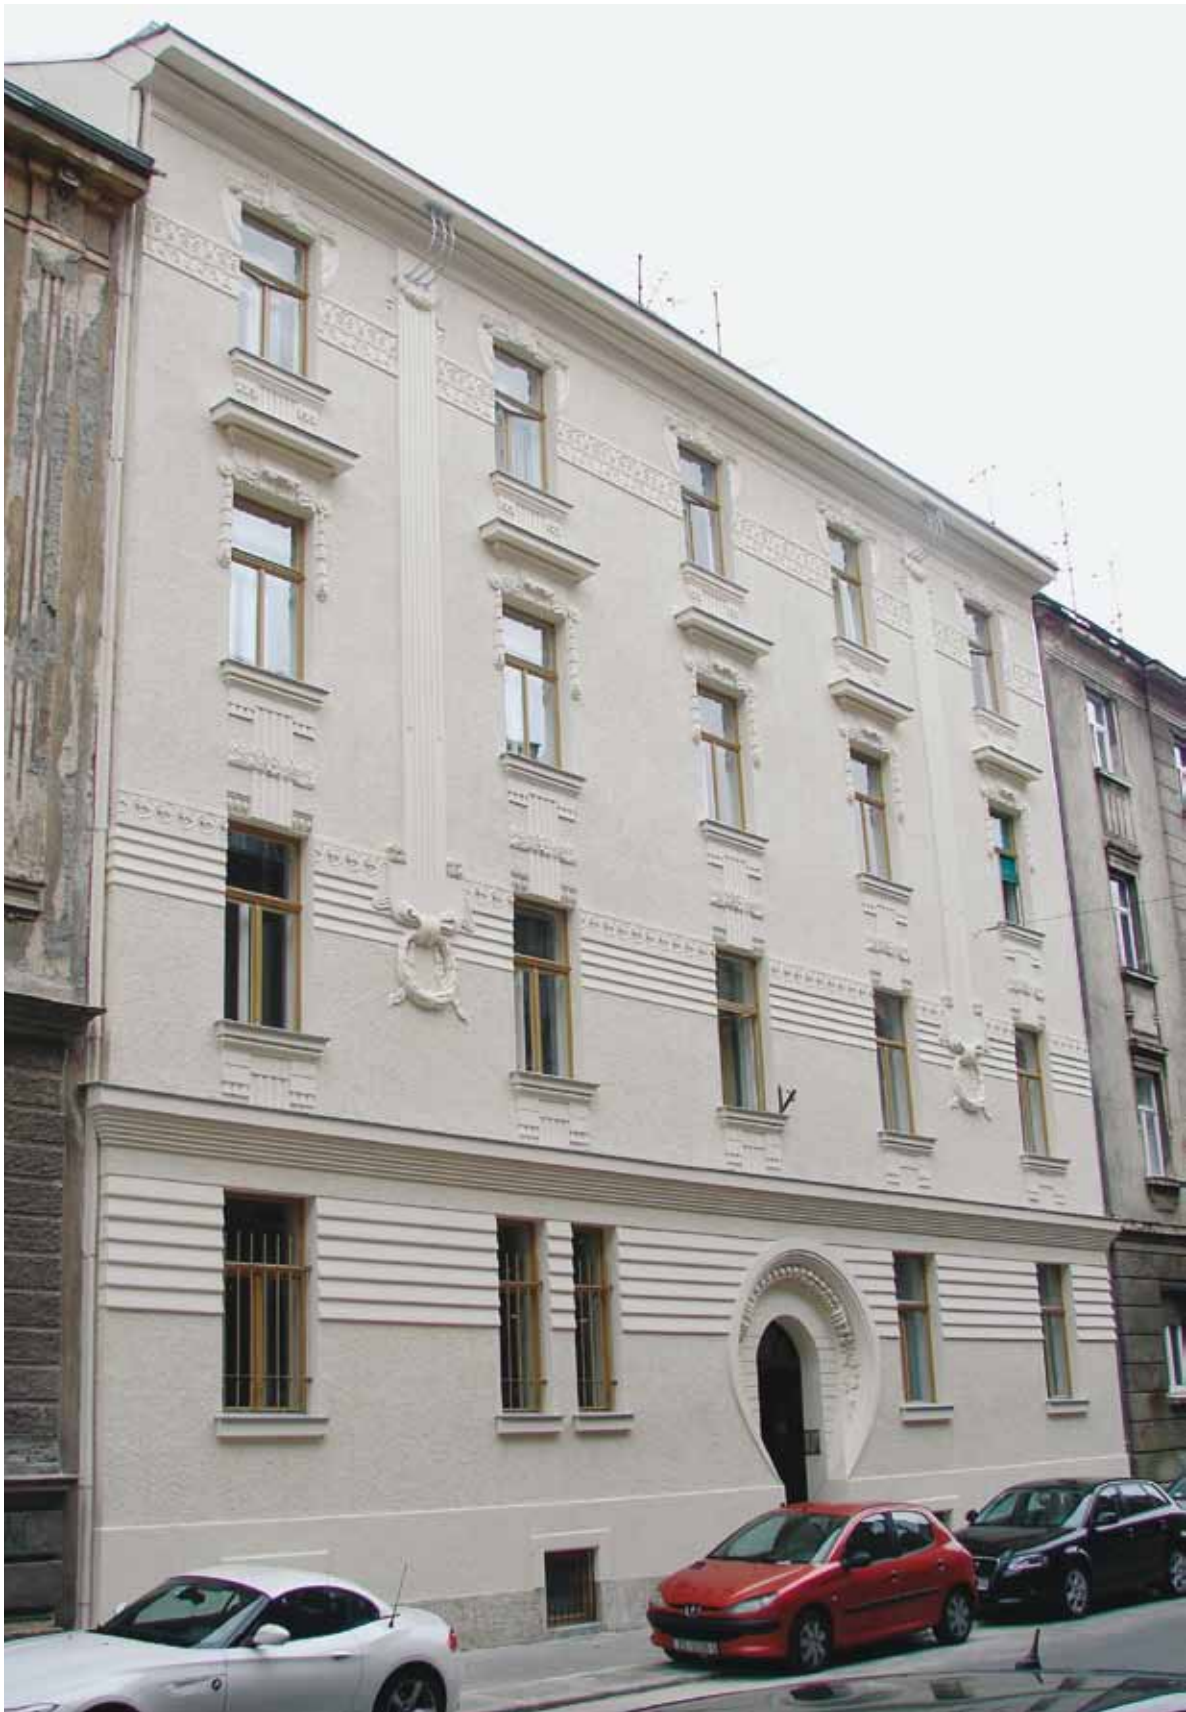
1. 20 Đorđićeva Street: Façade after the restoration

For example, for the roof and façade renovation at 20 Đorđićeva Street, (*Fig. 1*) the architect who designed the project and all the necessary documentation for it assumed that most of the cast elements (decorative stucco elements) were in good condition and well pre-

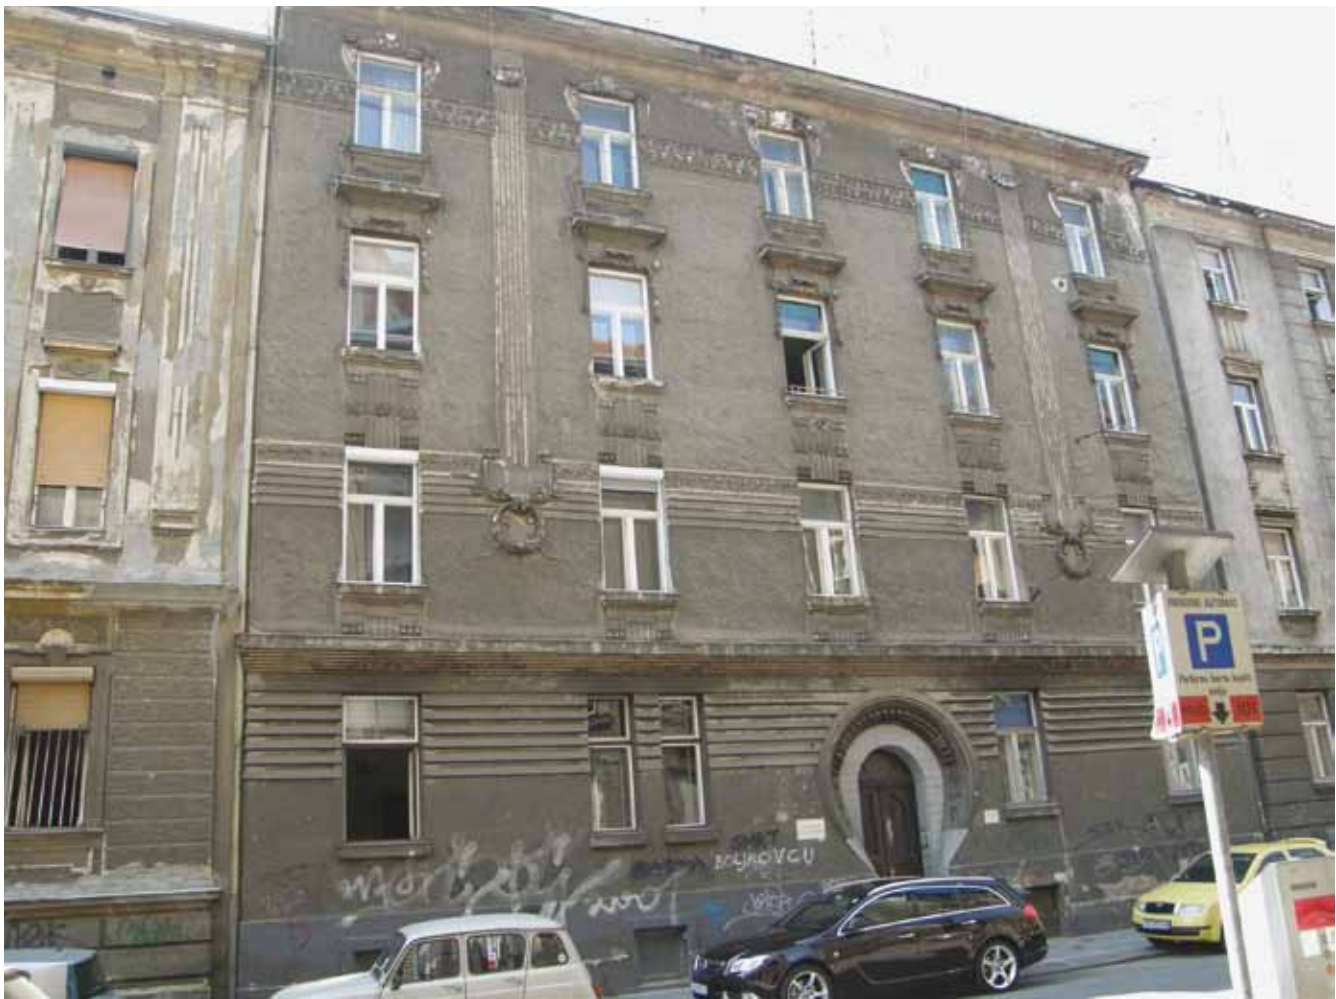
2. 20 Đorđićeva Street: Façade before the restoration

The façade of 20 Đorđićeva Street was in very bad condition. The entire façade was dark gray due to pollution and many layers of dust and dirt. These were not only on the surface of the façade but had also penetrated deep inside the plaster and stucco elements. (*Fig. 2*)

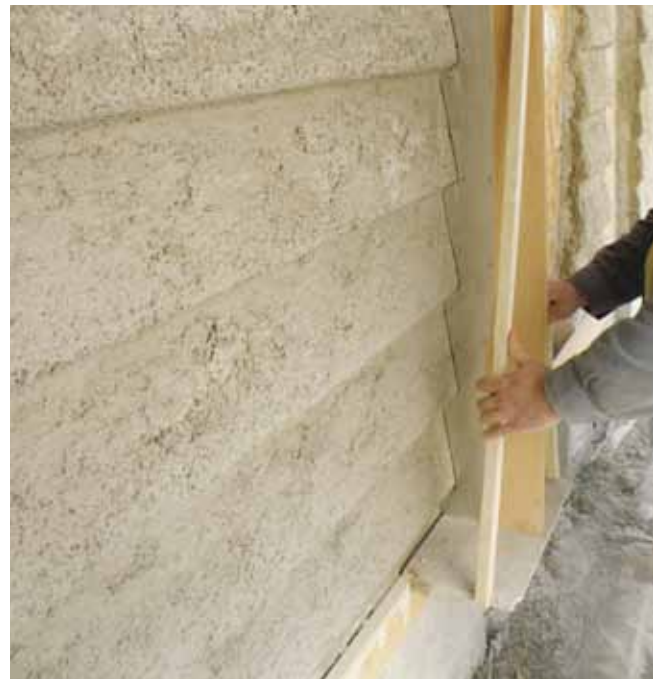
The flat surfaces of the walls were made of plaster that contained small grains of stone with varying levels of granulation (rough-cast plaster).¹⁰ This was traditionally made manually and applied to the façade with a trowel, demanding special knowledge for preparing the right mixture and for its proper application. First, a few samples were made with different mixtures of grain size, and in the end, we chose the sample that was closest to the original. (Fig. 4)

4. 20 Đorđićeva Street: Recreating the special plaster surface

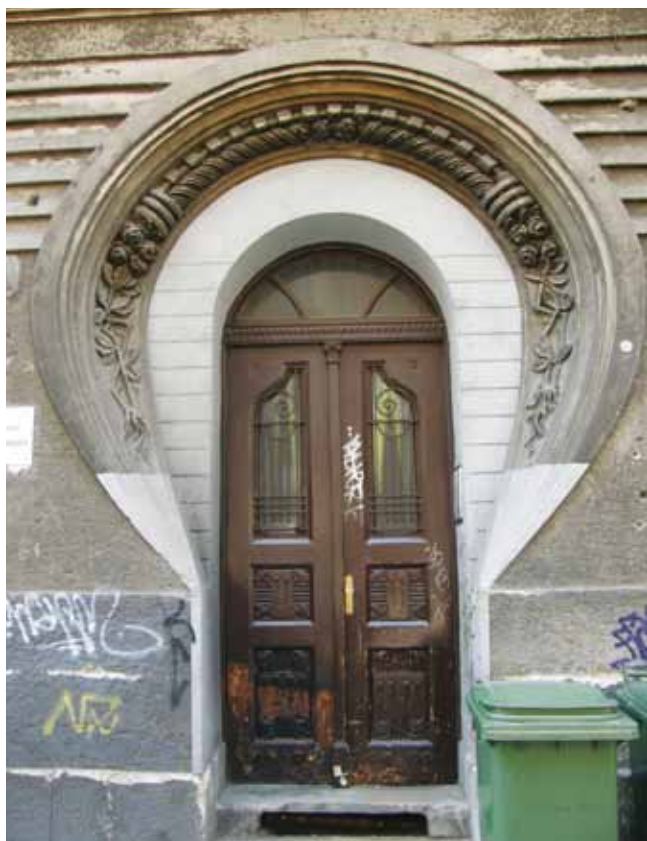
5. 20 Đorđićeva Street: Stucco decoration around the main entrance, before the restoration

The condition of the decorative cast stucco elements varied. The beautiful decorations around the main entrance had been made with high-quality materials so they only required cleaning and remediation carried out in situ. (Figs 5–6) Unfortunately, the rest of the cast decorations were in extremely bad condition and only the thin layer of surface impurities kept them from decomposing into dust. Another problem was the fact that the stucco elements had been attached to the façade with iron pins, and most of these were damaged due to corrosion. Therefore, they were all carefully removed from the façade and brought to the restoration workshop, where they were repaired and cleaned. Finally, restoration experts cast accurate copies of these existing stucco elements.

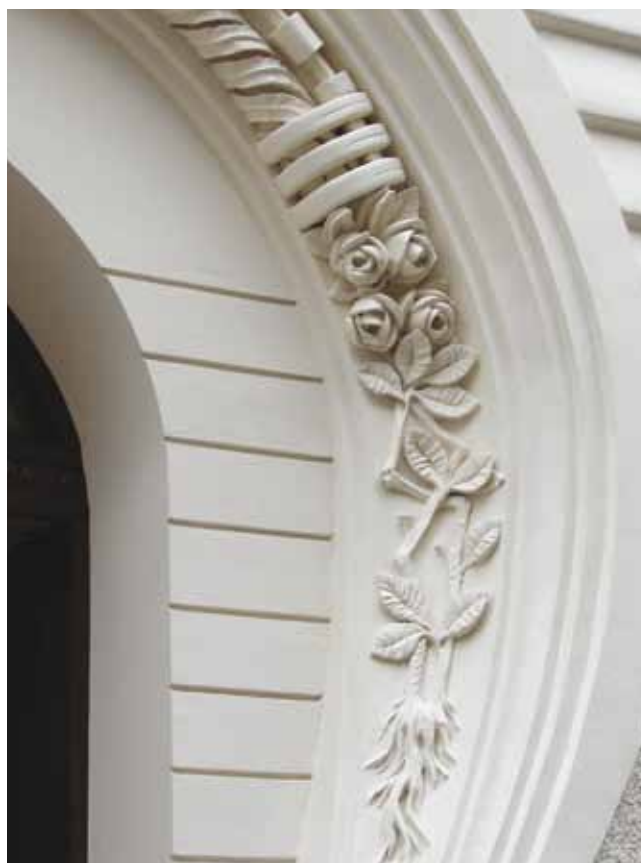
6. 20 Đorđićeva Street: Stucco decoration around the main entrance, after the restoration

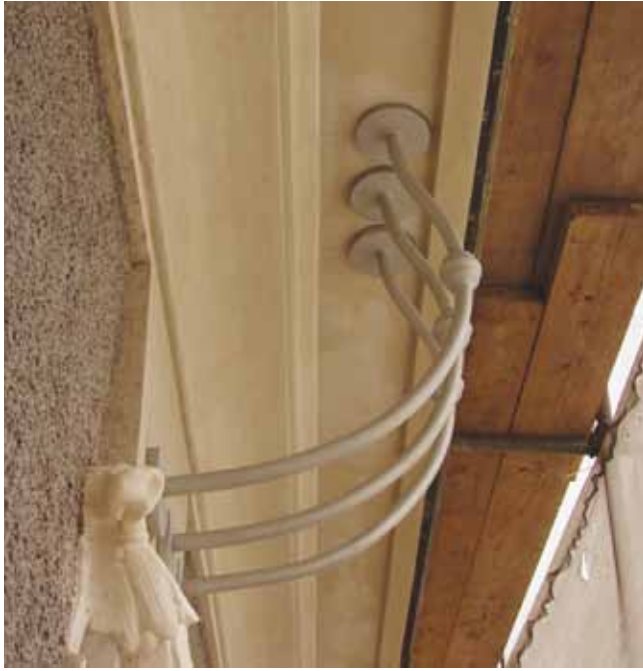
two photographs from 1956, which helped us to understand their former appearance. Later, we discovered one more photograph taken in 2006 that included the last surviving portion of this decoration still in place, hanging on the top of the façade. Due to this, we managed to reconstruct the missing parts of this metal decoration. It was comprised of six elements in total, and each of these consisted of three main parts: two metal plates and a tube/pipe. (Fig. 7)

7. 20 Đorđićeva Street: Reconstructed metal pipe under the roof

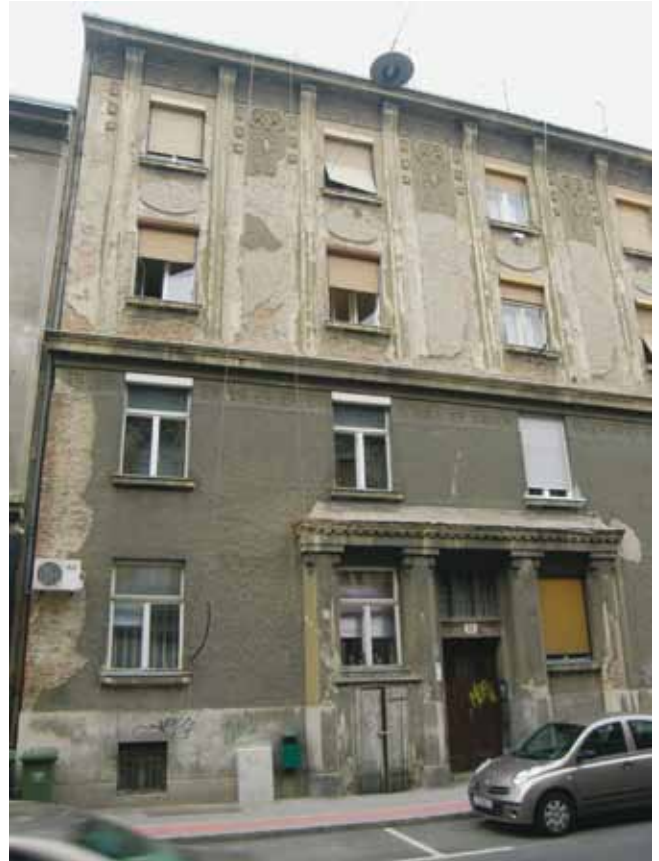
Apart from this, the tenants themselves had performed many inappropriate interventions on the façade, which included a ventilation pipe being put through the

9. 80 Palmotićeva Street: Façade before the restoration

wall beneath a window on the second floor, two wooden windows being replaced by plastic windows, and plastic roller shutters being put on all the windows. Even worse, the shutters were of different types and colors, so each window looked different. (Fig. 9)

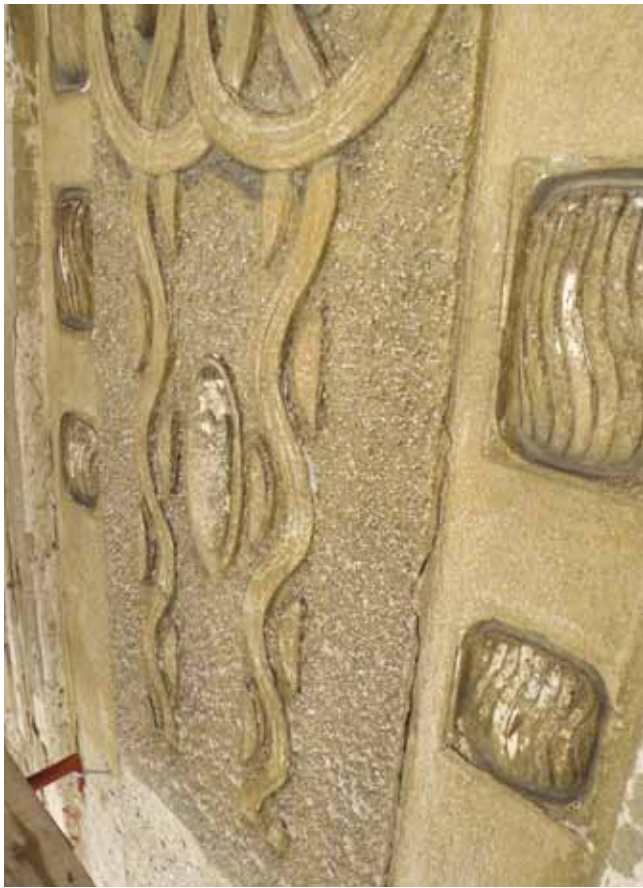
10. 80 Palmotićeva Street: Original stucco elements on the façade before the restoration

Surprisingly, most of the stucco elements were in relatively good condition. (Figs 10–11) However, the plaster was mostly ruined and falling apart, so it had to be completely removed from the wall. Some ornaments were also made from thin plaster and were originally hand-modeled in situ. Restoration experts made stencils of each of the decorative plasterwork elements and restored all the missing parts in the same manner as the original plasterwork had been made. The type of plaster varied from extra fine on the decorative plasterwork elements to quite rough on the flat parts of the walls, with sharp stone grains 1–8 mm in size. Only the series of oval elements beneath the main cornice were made with rough plaster. (Figs 12–14)

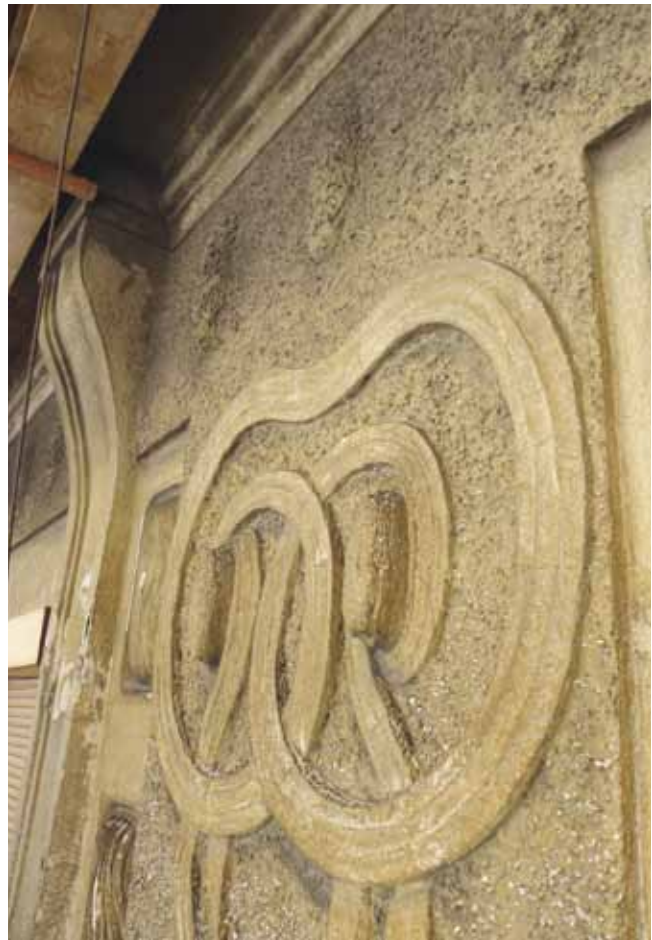
11. 80 Palmotićeva Street: Original stucco elements on the façade before the restoration

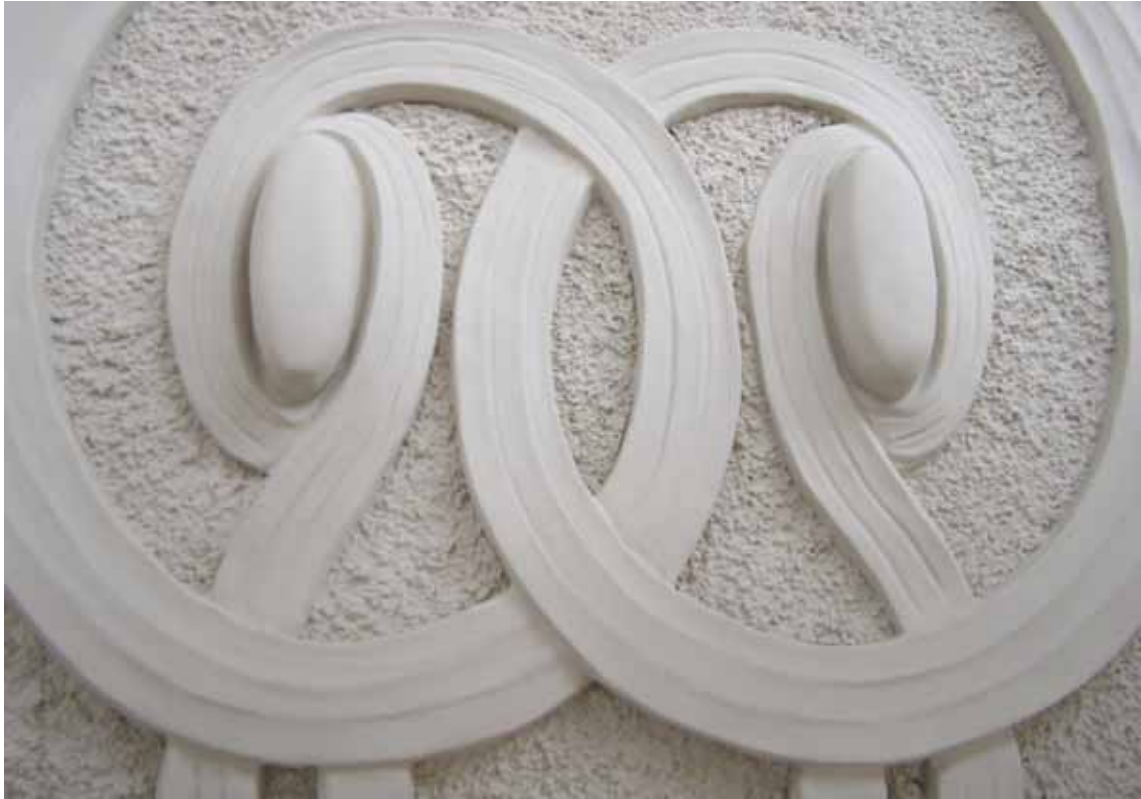
12. 80 Palmotičeva Street: Remodeled stucco elements after the restoration

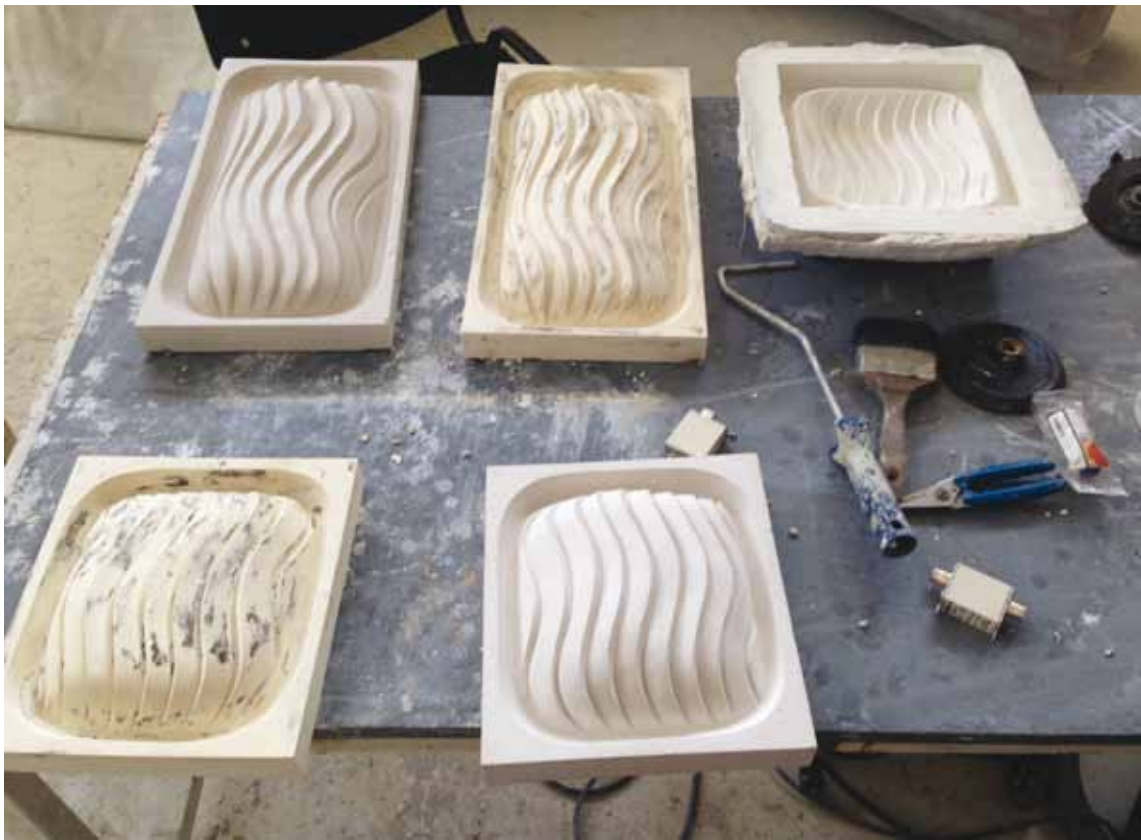
13. 80 Palmotičeva Street: Remodeled stucco elements of the windows during the restoration

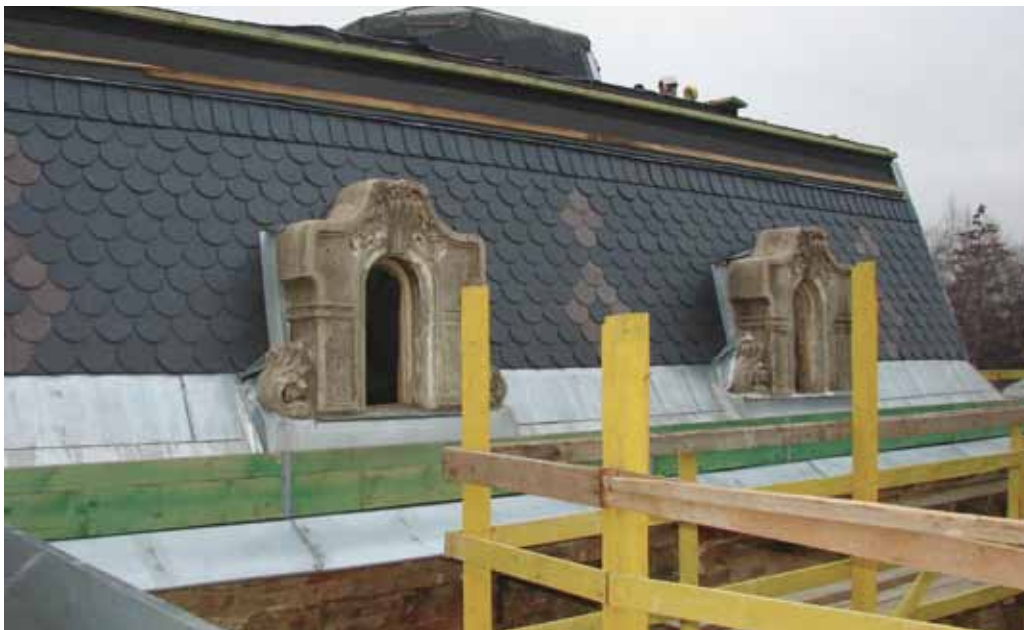
2. The Sofian House, Botoșani, roof restoration, 2016

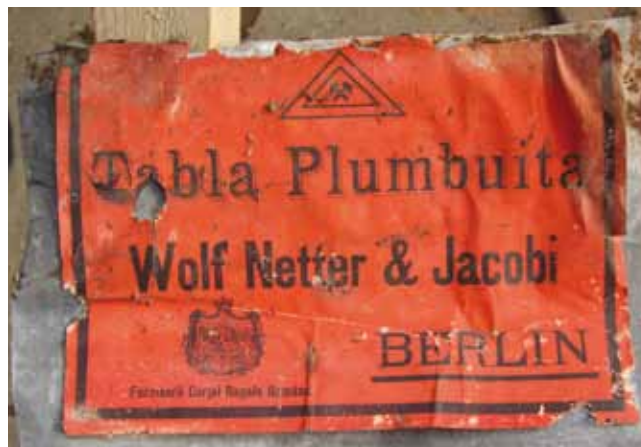
3. The Sofian House, Botoșani, original zinc sheet with the producer’s mark

zinc sheet against corrosion. The oxide formed on the surface of zinc is very resistant and will not stick to a soft metal mixture. The oxide cannot be removed with chemical materials. In the best case, when the material has not yet completely oxidized, the oxide can be mechanically cleaned. However, the result is a sheet only a few microns thick that cannot withstand the temperature required for soldering with a soft metal mixture, so it is not possible to carry out the quality bending processes.

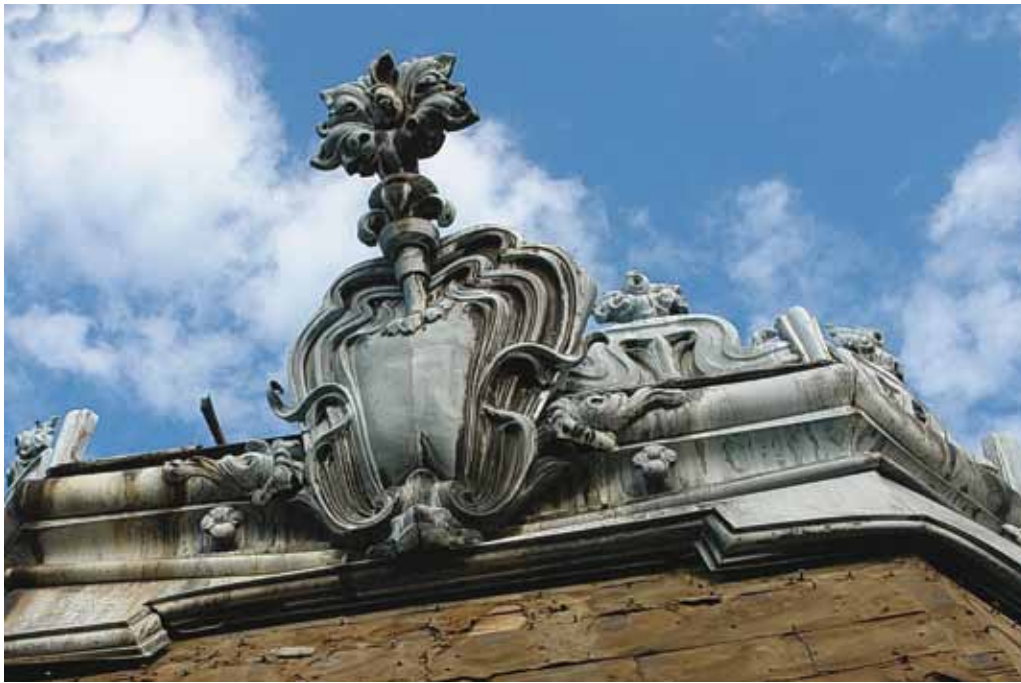
4. The Sofian House, Botoșani, Art Nouveau roof ornaments made of zinc sheets

ghieni,¹² which is dealing with the restoration of the titanium-zinc sheet flashing of the roof. The floral, fluid roof ornaments, molded from metal sheets are probably the purest Art Nouveau elements of the Sofian House in Botoșani. (Figs 4–5) The original zinc sheets of the roof’s flashing and ornaments have undergone a corrosion process caused by contact with airborne chemicals and vapors common in large urban areas such as Botoșani. In the first phase, the patina (the first layer of oxide formed on the surface of the material) protects the

It is possible to recognize the corroded, highly oxidized material because when it is warmed and bent, many very thin cracks result due to the expansion process. More serious problems arise when the material does not have the proper thickness and is not correctly mounted on the wooden support that provides the necessary rigidity against movements caused by expansion. Simply due to the lack of support, many of the zinc decorative elements of the Sofian House have contracted, tightened and cracked with time.

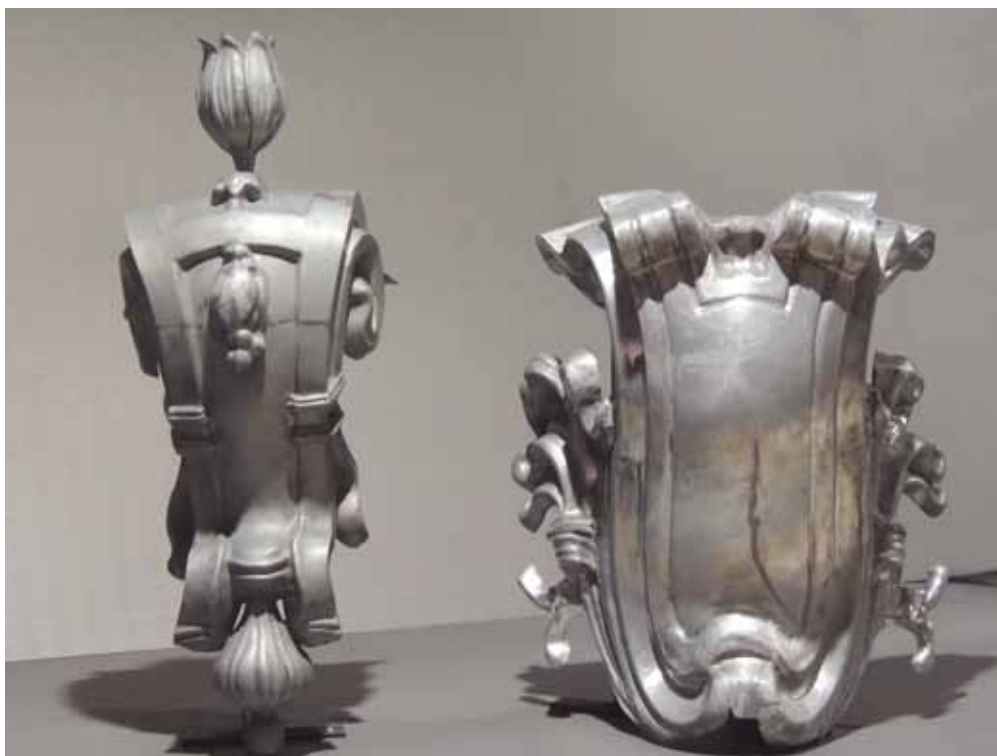
6. The Sofian House, Botoșani, Art Nouveau roof ornaments replicated from titanium zinc sheets, 2016

During the restoration, the zinc sheets were replaced with the more durable titanium-zinc sheets. The new flashing also solved the problem of the old, which had no expansion joints (the metal flashing is meant to withstand a temperature difference of up to 100 degrees Celsius, in which case expansion would be 2.2 mm / meter). Installing the new elements on the prepared lathing started from the bottom to the top, in the opposite direction of the flow of water. As for the ornaments, when they could not be mounted on a support, the chosen thickness was 0.7–0.8–1 mm (determined by the surface tension). The replicas were made in the workshop, including the following steps after dismantling the original pieces: (1) shaping, casting, and embossing (stamping), then molding the elements; (2) manufactur-

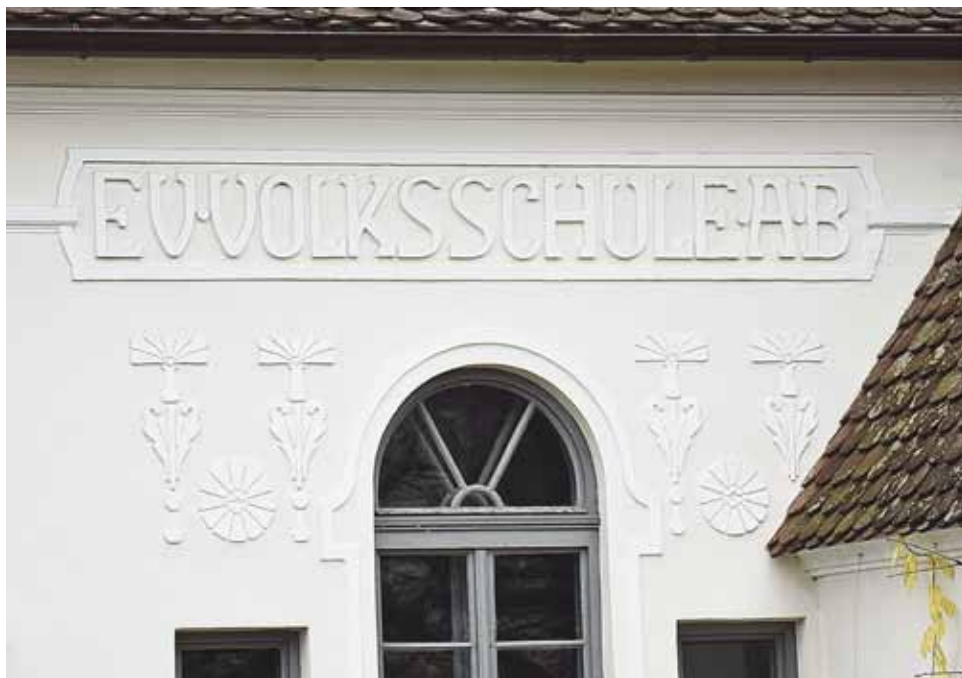
10. Former Lutheran School in Cincșor, now a conference hall, information center for rural tourism and guest house, restored Art Nouveau plaster decorations, 2017

During the restoration process, the problems were successfully resolved. The cellars were rehabilitated, and horizontal damp-proof barrier injections were made to control the rising damp in the masonry. The roofing and drains were completely repaired, after which the façades were restored. Recipes of lime-hydraulic and lime-brick-sand powder were used for the plastering. Particular attention was paid to decorations, window frames and cornices. Roman Cement (natural hydraulic lime mortar) and epoxy resin were used as materials. For the cornices, a metal sheet pattern was attached to a wooden frame. Rail guides were fastened on the wall to draw the patterns uniformly. For decorations, patterns were drawn of the original shapes at a 1:1 scale. After applying the material, with a palette knife, the small gaps in the material were corrected, and the edges were then brushed smooth. (Fig. 10)

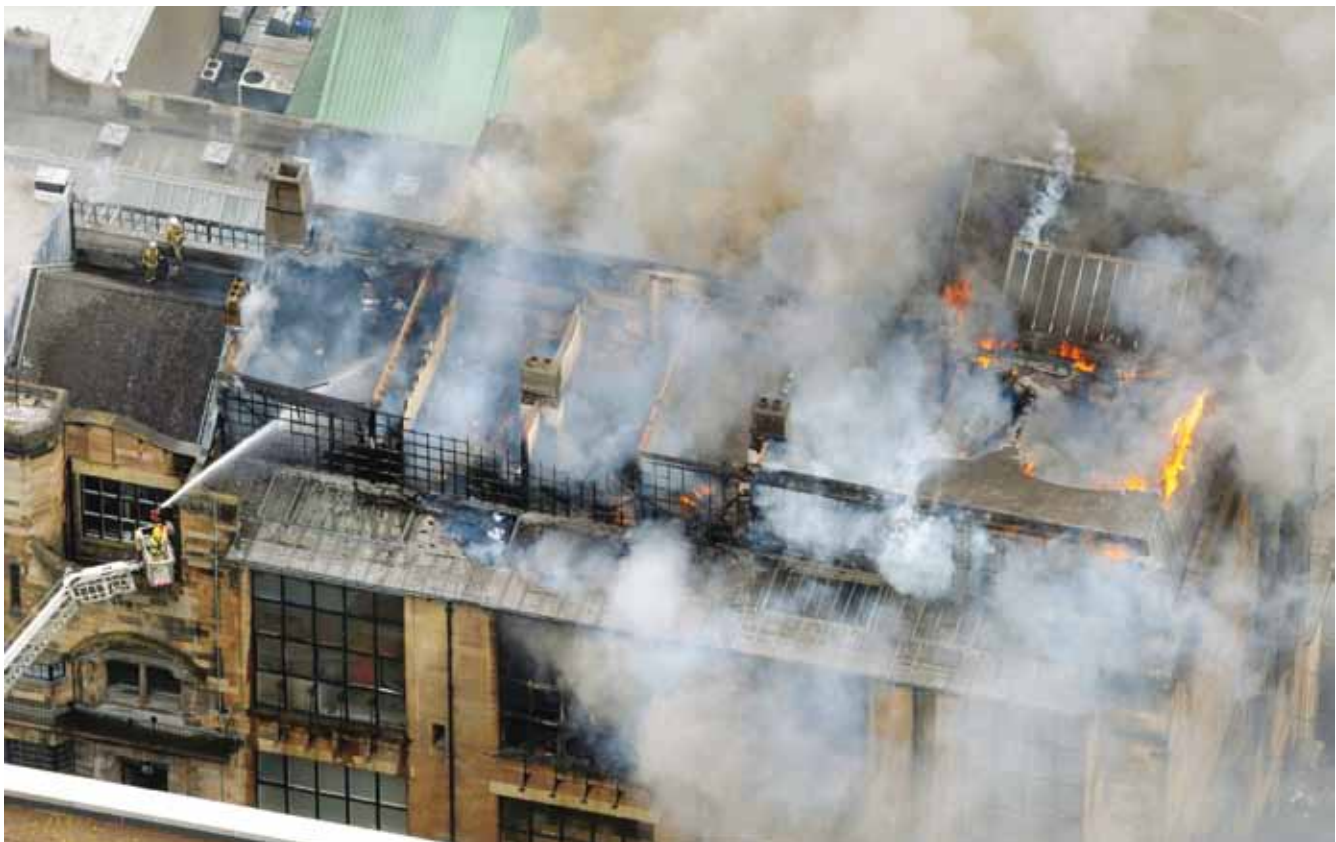
1. The fire-ravaged Mackintosh Building, 23 May 2014

As Curator of Glasgow School of Art's Charles Rennie Mackintosh Building for over twenty-five years I was pretty confident about what I knew about the building. I had after all walked along every corridor, climbed every stair, opened every door and peered into every corner of the building and during past periods of restoration had accessed scaffolding to view the original construction and condition of the roof, walls, windows and even the external ironwork. However, that confidence was severely questioned when on 23 May 2014 the Charles Rennie Mackintosh Building suffered a catastrophic fire, a tragic event that made news headlines around the world in the same way that the devastating blaze at Windsor Castle in 1992 attracted global attention. Sadly such disasters are far from uncommon and in 2015 the UK's National Trust were faced with a similar tragedy when Clandon Park, an eighteenth-century Palladian mansion in Surrey, south of London, suffered a serious fire which left the building as little more than a burnt out shell. (Fig. 1)

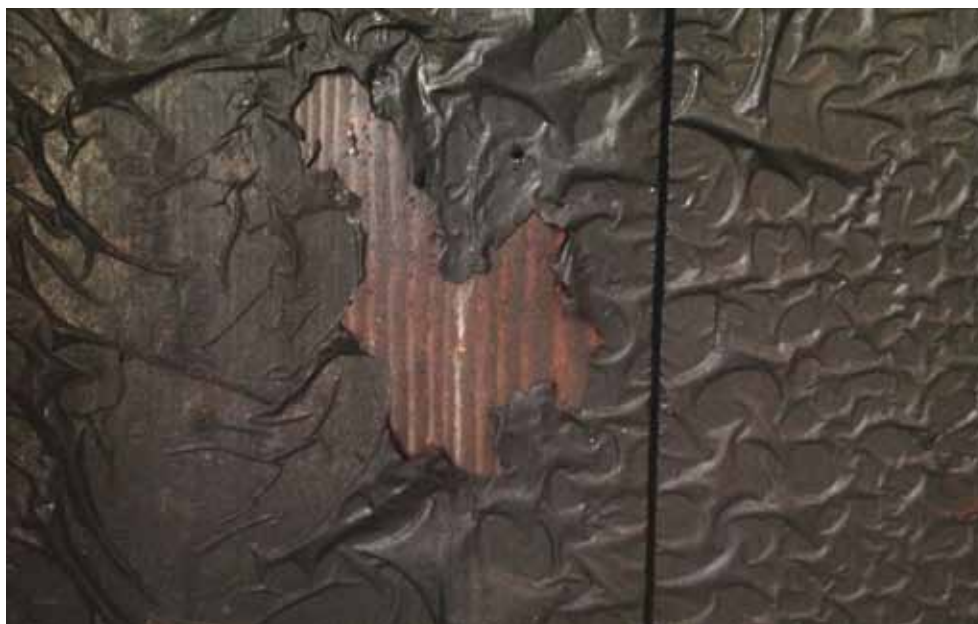
5. Blistered timber panel, first floor corridor, Mackintosh Building, May 2014

The loss of original timber panels in various locations across the building has also exposed previously hidden structural elements that were last seen over a century ago. Elsewhere, there is evidence of the impact of heat on other parts of the building. The wood-lined corridor leading to the destroyed library survived remarkably intact but the impact of extreme temperature is all too apparent. Here the more recently overpainted wooden panels are blistered and bubbled to the extent that the original timber, with its reddish/brown grain, is now partly exposed. (*Fig. 5*) What is now known from detailed paint and stain analysis taken from this area is that the colour of these walls pre-fire is completely wrong. Therefore, the plan is to restore this wooden panelling back to what it would have looked like originally. So whilst it will be noticeably different, it will be historically correct and although some people may question or object (based on what they remember the walls looking like) the School now has the evidence to prove otherwise.

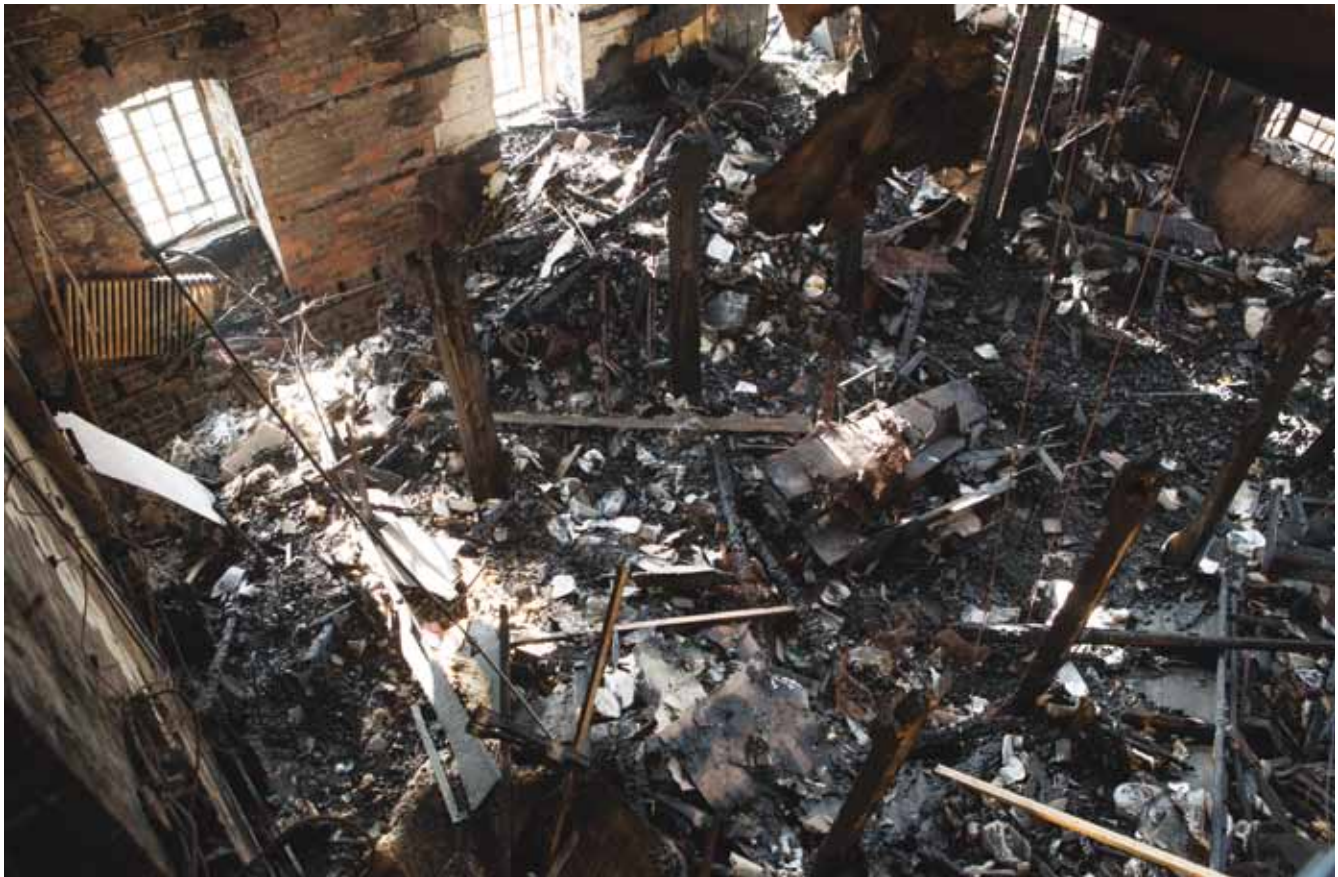
6. The Mackintosh library, completely destroyed, May 2014

The real tragedy is that this one room suffered the greatest damage; in fact, almost total destruction, leaving just the four outer walls standing. A balcony around three sides of the library had all but disappeared. In addition, the intensity of the fire was so great that the famous metal-framed oriel windows on the west elevation were so twisted and contorted that they had to be removed and the load-bearing stone piers in between the windows had also crumbled leaving behind a mass of dusty fragments. Above the library, a large store room containing paintings and other examples of Mackintosh furniture was ravaged by the fire and eventually the

floor of this room collapsed and its burnt contents simply ended up on the library floor below. In total, a pile of charred debris almost 1.5 m high consisting of books and magazines, furniture, light fittings torn from their ceiling mounts and bits of concrete, plaster and wood were all heaped together in a soggy mess. (Fig. 6)

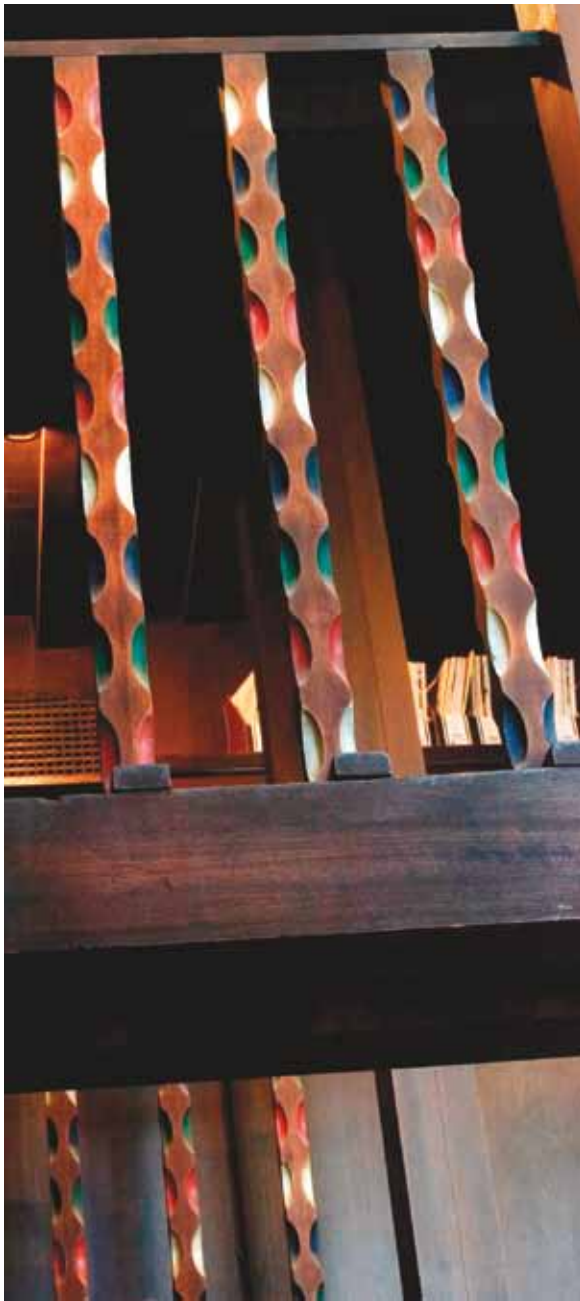
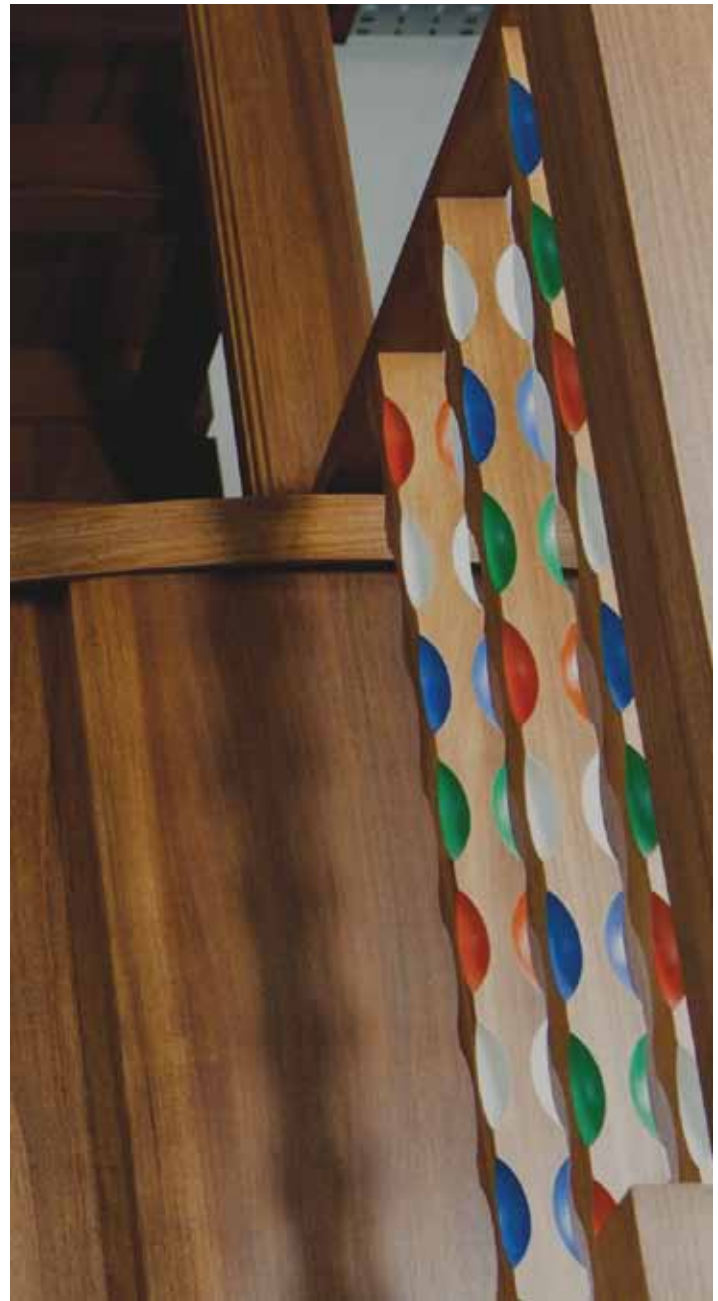
8a-b Detail of chamfered spindles, Mackintosh Library balcony (left: pre-fire c. 2012; right: Laurence McIntosh prototype model, 2017)

artist paint and then rubbed with beeswax and it was thought that a burnt umber colour was the closest match. Crick-Smith's view was that the original colour had darkened naturally over time and that this colour change had been exacerbated most probably by air pollutants such as sulphur (Glasgow was a highly industrialised city throughout most of the twentieth century), and even nicotine would have had an impact. It is all too easy to forget that smoking in the building was endemic for over 80 years until a ban was finally implemented as late as the 1990s. Not surprising then that just about every interior surface would have been affected in some way. (Figs 8a–b)

A similar scientific approach has also been taken with the brightly coloured chamfered spindles which adorned the library balcony. Although only one small, badly damaged fragment survived the fire, the School had extensive (and recent) photographic evidence to

confirm that these spindles had been decorated in a strict sequence of bright blue, green, red and white.¹⁶ Now seen against the lighter coloured timber of the library prototype, these 'spot' colours are even more dramatic. Discussions are still at an early stage as to how the library will be populated with new replica furniture as everything in the room was destroyed. This included a large, central periodical desk decorated with coloured glass insets.¹⁷ Early in 1910, Mackintosh designed a small
