Restoring Art Nouveau

Architectural Decoration in the Danube Region

Proceedings of the international conference Restoring Art Nouveau,
Budapest, 6 November 2017

GÁBOR GYÖRGY PAPP: Foreword	7
LÁSZLÓ CZIFRÁK: Experience from the Conservation of the Zsolnay Architectural Ceramics in the Entrance Hall of the Budapest Museum of Applied Arts	11
ALEKSA CIGANOVIC: Decades of Restoring the Subotica Synagogue	23
GÁBOR DÖMÖTÖR: Restoration of the Raichle Palace in Subotica	33
RAMONA NOVICOV: Lost Beauty Rediscovered. The Black Eagle Palace and Adolf Moskovits Palace, Examples of Good Practice in Restoration	45
ASTRID HUBER: Architectural Surfaces and Plaster Façades around and after 1900 in Austria	57
DAVID MIŠIĆ and NINA NAHTIGAL: The Baroness House in Maribor. Sustainable Protection and Promotion of Art Nouveau Heritage in the Danube Region	69
EVA RADOLOVIĆ: Renovation of Two Zagreb Residential Buildings. Comparative Analysis of Two Façade Restoration Projects	83
IOSEFINA POSTĂVARU: Restoring Art Nouveau Buildings throughout Romania. The Lutheran School in Cincșor and the Sofian House in Botoșani	93

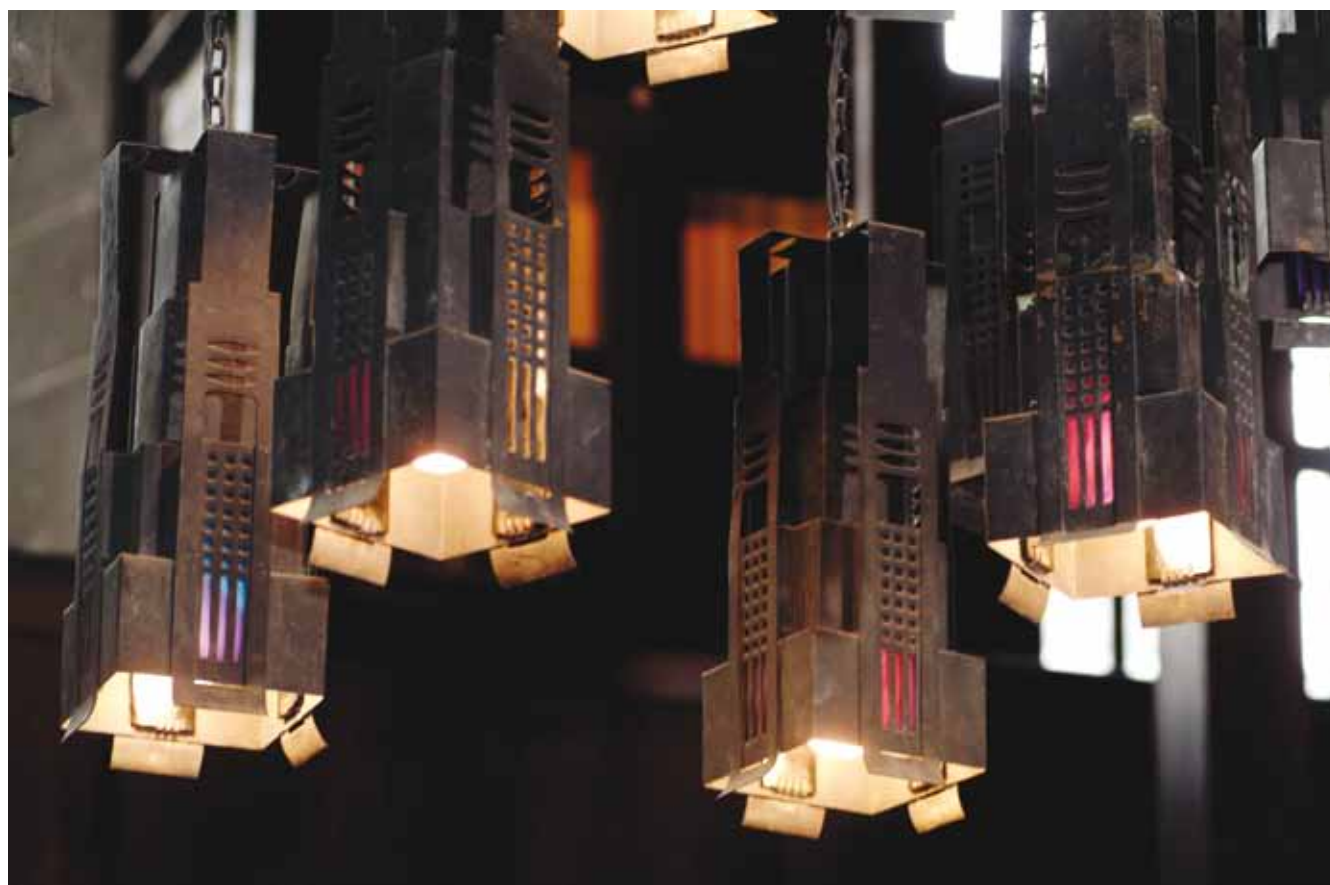
9. Detail of central light cluster, Mackintosh Library, c. 2012

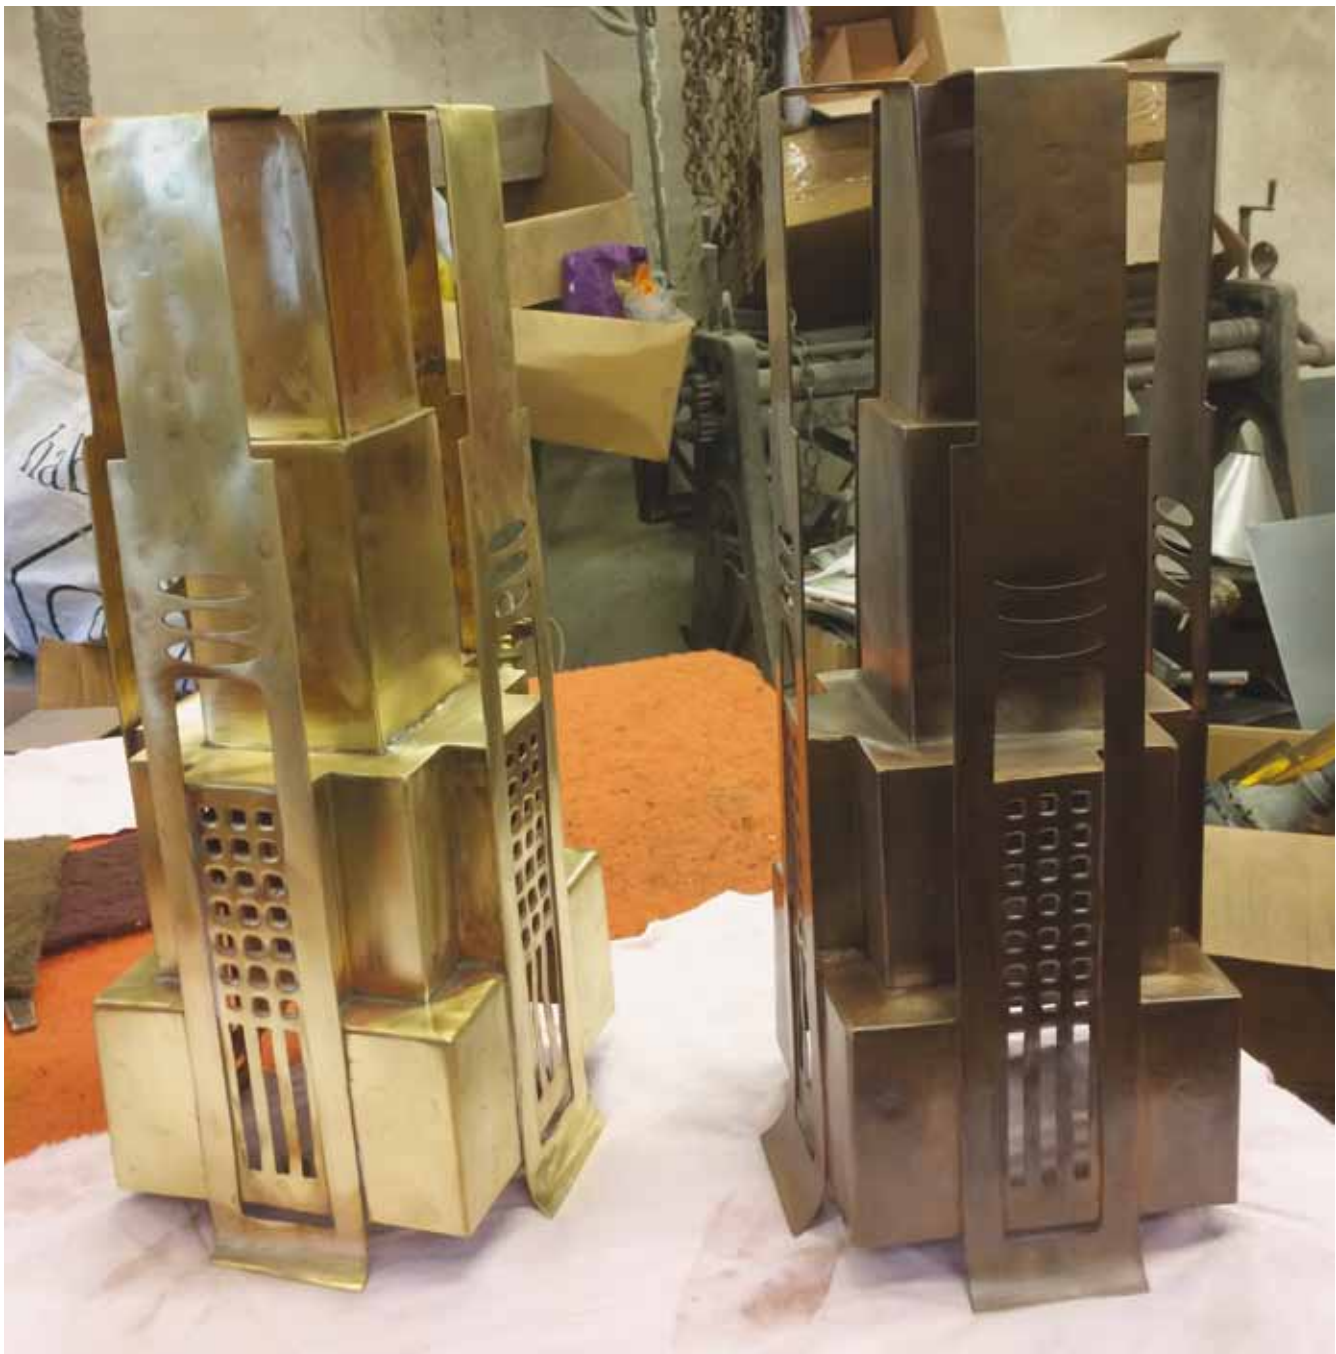
11. Two of the rebuilt Mackintosh library lights, 2017

School identified a traditional metalsmith based in Edinburgh, Rodney French (of Lonsdale and Dutch) who was confident that once cleaned and flattened (as many of the pieces had been badly twisted as they fell), these fragments could be reassembled into new light shades. His opinion was that there were enough recovered pieces to rebuild in the region of twenty-eight shades in full.¹⁸ A further seven shades could be rebuilt using a majority of original fragments but with some new parts added, and the remainder would have to be made completely new. (*Fig. 11*) Given the scale of the disaster and the total destruction of the library, it is remarkable that so many pieces were not only recovered but that these fragments can be faithfully reused. It is a time-consuming task but the early results are stunning and not surprisingly the School has learnt much from the process. There was clear evidence that the shades had been crudely overpainted but quite why and when this happened is still unclear. Early photographs of the library were examined in great detail and it would appear that the original shades were installed in their

original antique brass finish. It is now recognised that this paler tone of metal would have been more appropriate given the new lighter coloured timber that is now thought to have existed in the library from the outset.
