### RADAR

## O.T.3.1.h Pilot Actions on 4 (6) Road Safety Thematic Areas

TA5 COVID-19 - HUNGARY

RADAR – Risk Assessment on Danube Area Roads

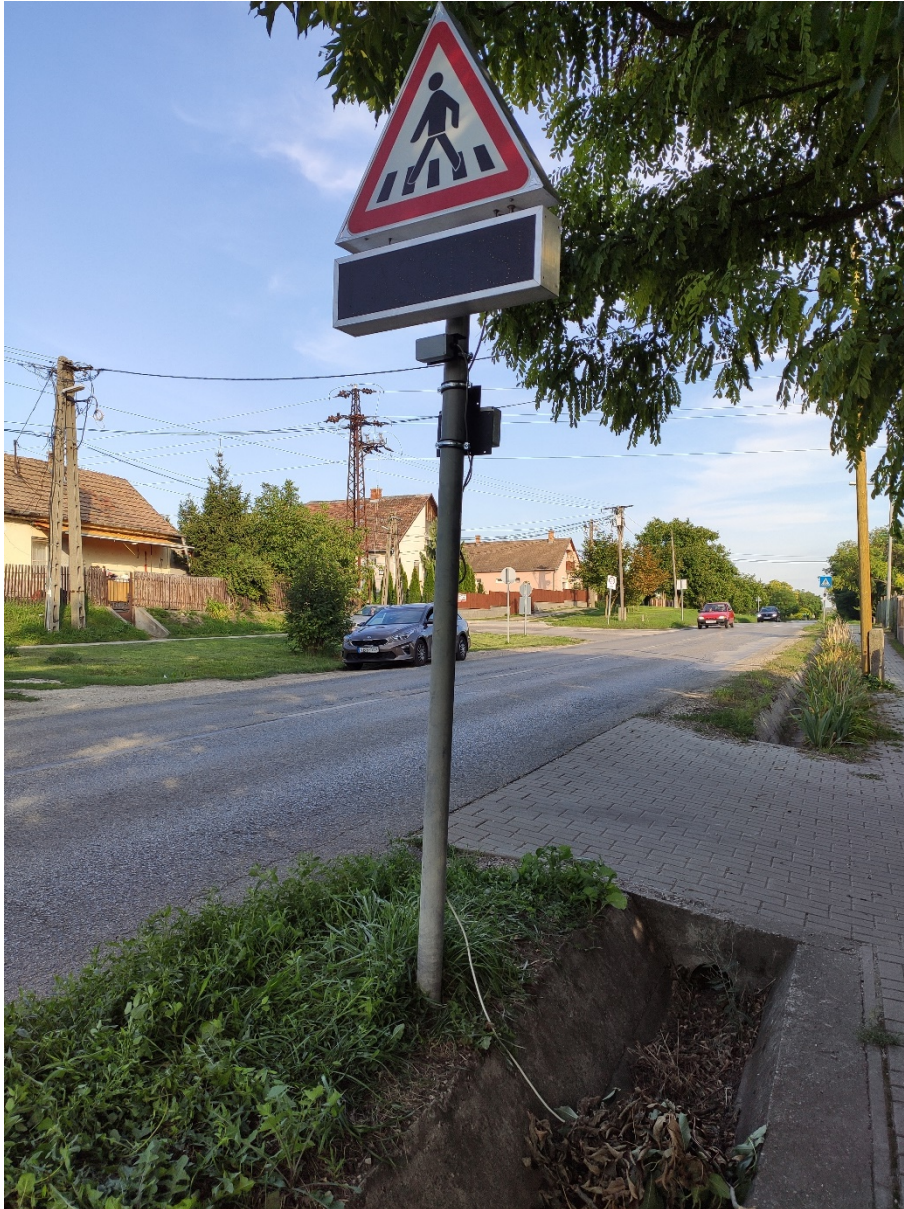
Figure 1: The pedestrian crossing warning sign with interior lighting, the LED text (Lassíts!), the first radar (looking at the same direction as the signs), and the WiFi transmitter (at the back of the pole)

The first radar of the device is a BX-946 microwave detector. The measurement principle of this detector is based on the Doppler effect. The detector unit is bouncing a microwave signal off to a desired target and analysing how the motion of the object has changed the frequency of the returned signal. Calculations of the Doppler effect accurately determine the velocity of the detected objects. This radar is able to detect arriving vehicles, and measure their speed within its range, which is about 20-25 meters (depending on weather and visibility conditions). This radar is not applicable for continuous data recording by tracking the vehicles.

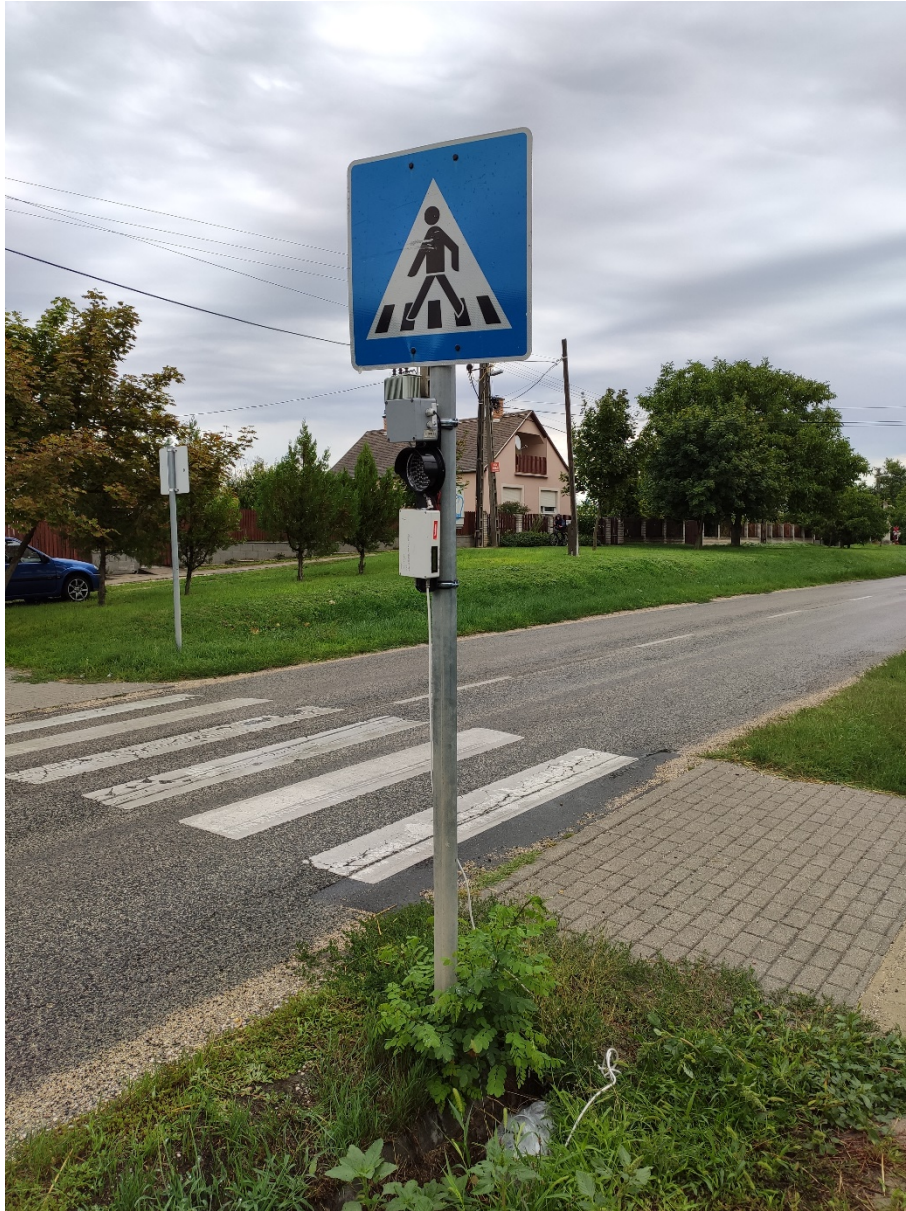
Figure 2: The yellow blinker, the second radar (above the blinker) and the WiFi transmitter (under the blinker)

The second radar of the device is a digital Falcon Plus II intelligent microwave detector, together with an ARM<sup>3</sup> based computer (self-developed by KTI's subcontractor). The measurement principle of this detector is also based on the Doppler effect. However, this unit has both a counting and tracking function. The equipment can also detect if the vehicle is arriving or leaving, therefore it is able to detect movement either uni- or bidirectional. During the measurement, the computer is recording the exact time and location of the measurement and the time vs. speed data continuously in microsecond intervals from the first moment the vehicle is within the range until it is detectable. Several speed samples are available for each vehicle, therefore speed vs. time or distance curves can be also generated. The radar unit is also equipped with a sophisticated communication module to provide the data remotely even during the measurement

real time or afterwards. The range of this radar is about 50 meters (depending on weather and visibility conditions).

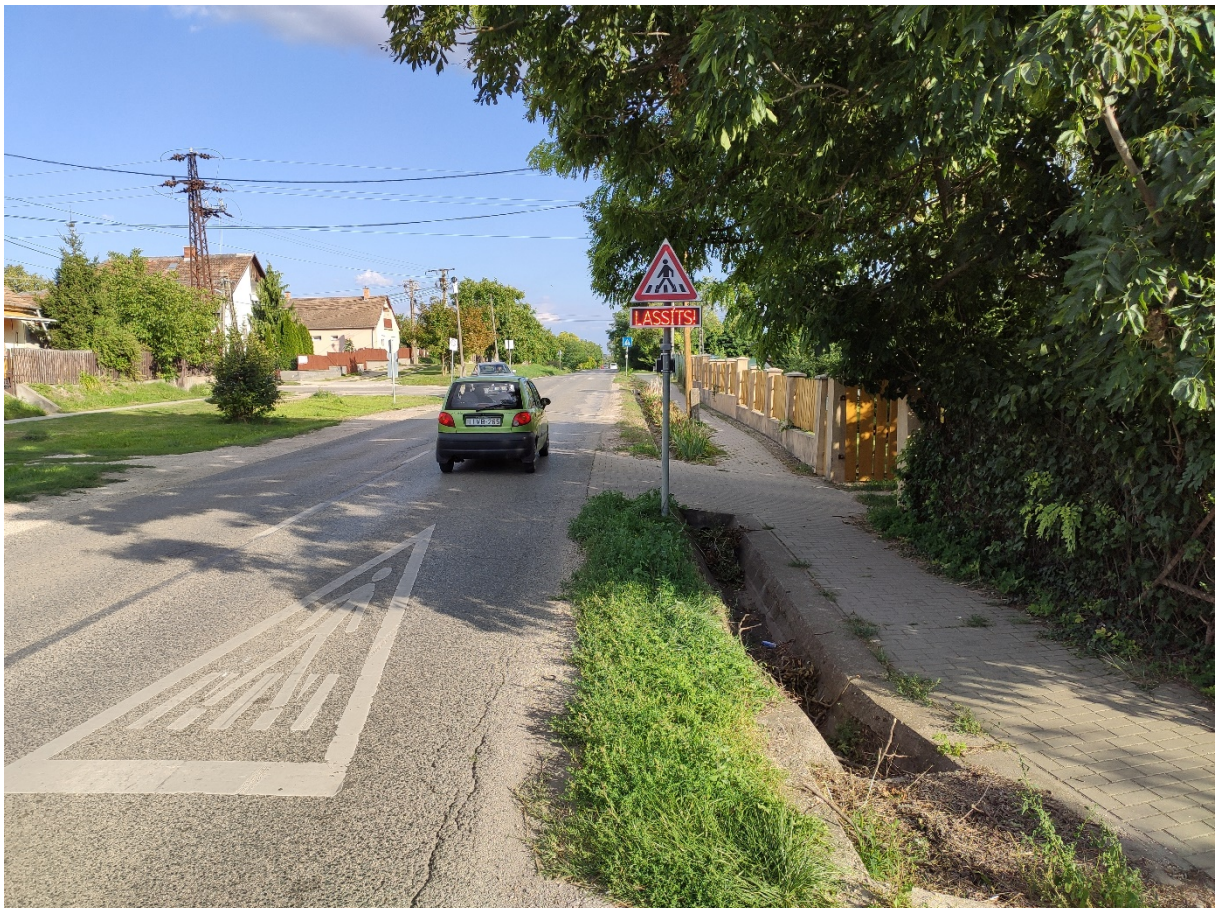
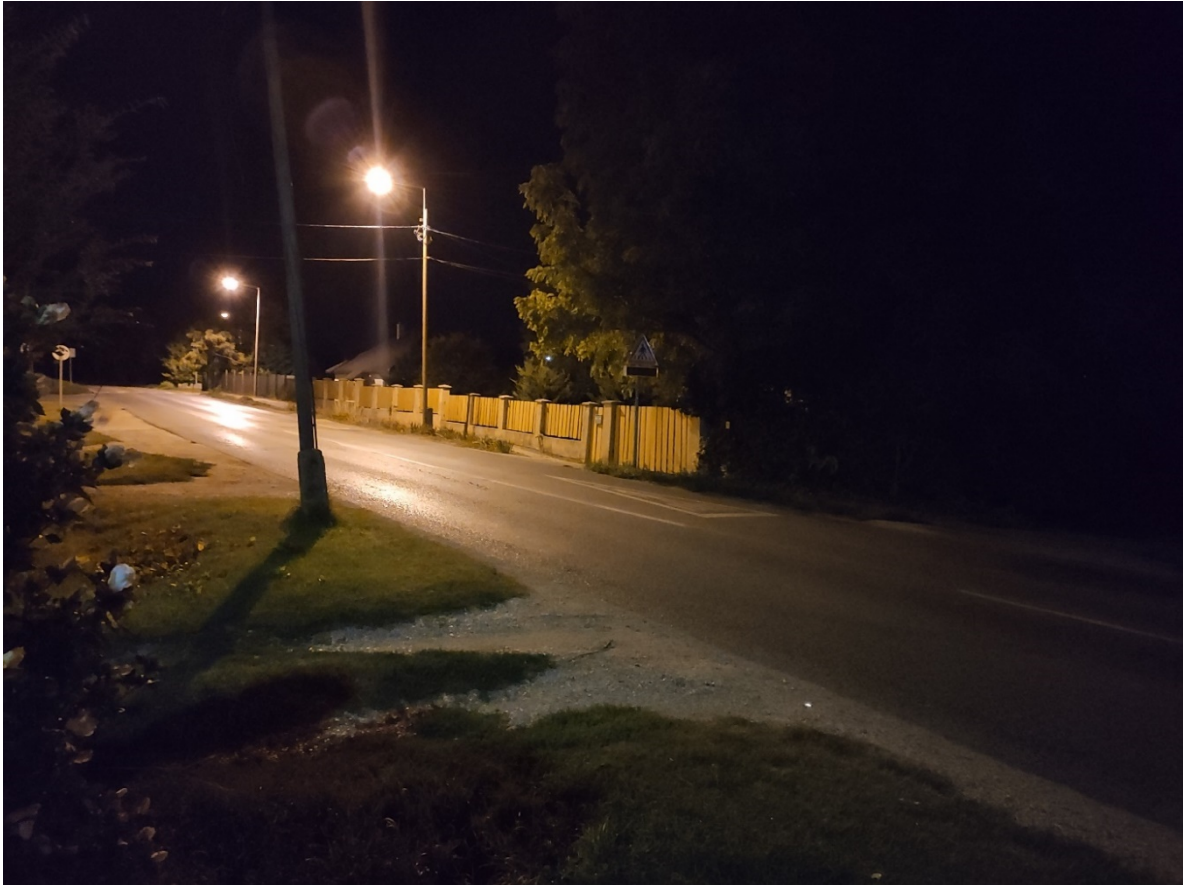
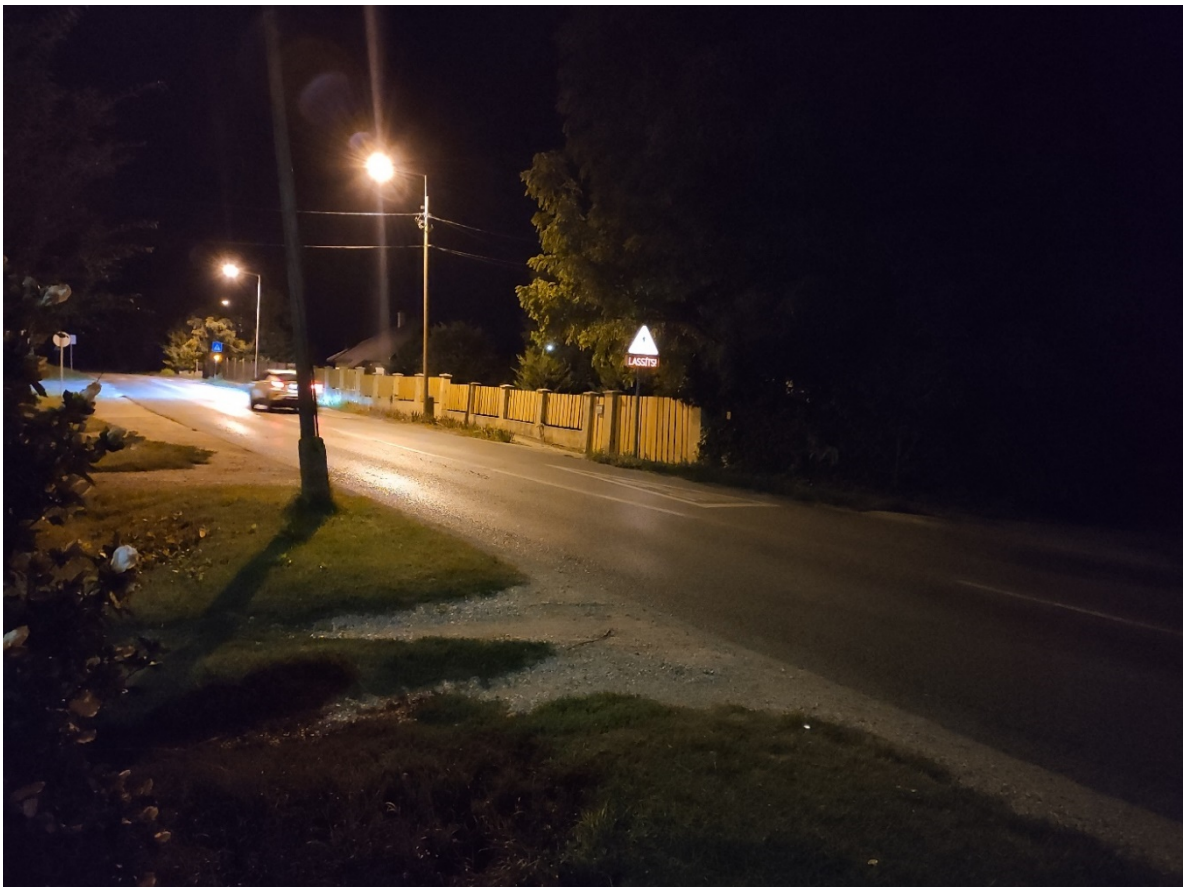
Figure 3: Illustration of the operation of the ITS device (great differences of visibility of the warning sign can be observed in dark)

The first radar detected incoming vehicles and measured their speed. When an incoming vehicle was detected, the interior lighting of the pedestrian crossing warning sign was turned on (regardless of the vehicle speed). If the vehicle arrived at a speed higher than the speed limit, the text “Lassíts” was also displayed. If no new vehicle has arrived, the lights turned off after 5 seconds.

When detecting an incoming vehicle, the first radar also activated the yellow blinker located on the column of the designated pedestrian crossing sign (regardless of speed). It switched off after 10 seconds without a new vehicle arriving.

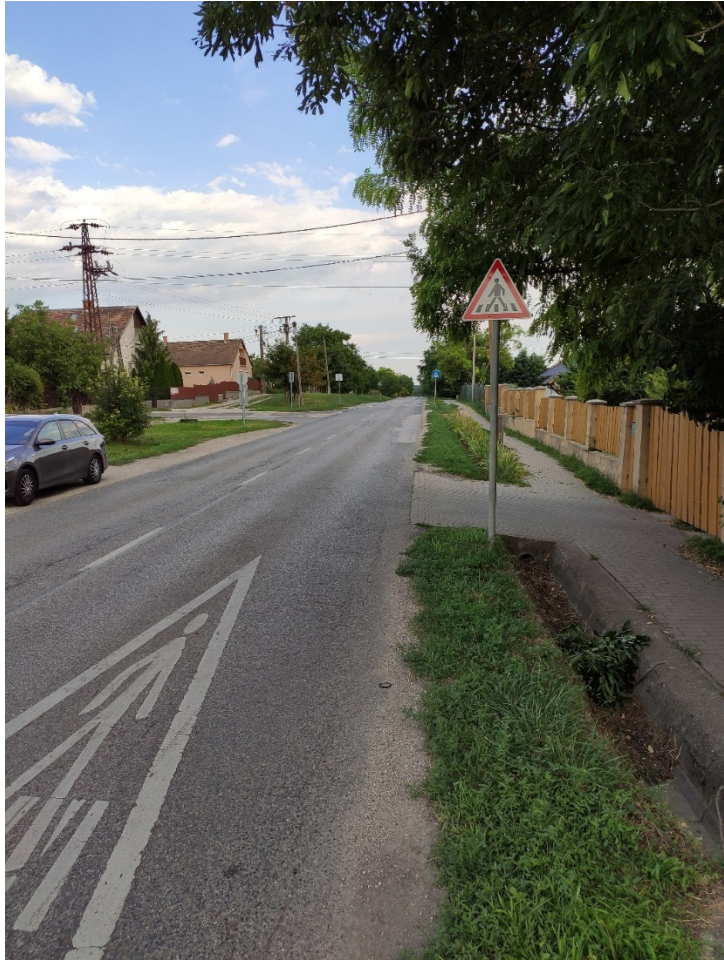
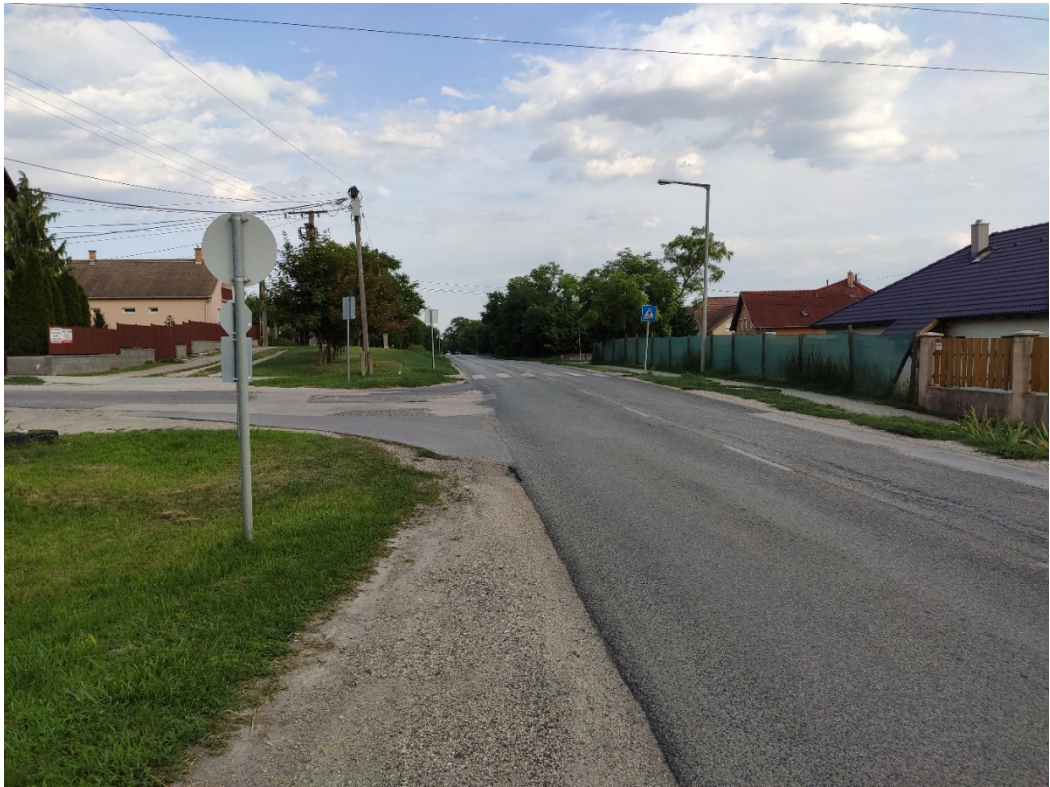
Figure 4: Measured section on road 6204

The investigated section is located in an urban area close to the border of Martonvásár city, on road 6204 at the 11+150 km section. The section is on a 2x1 lane road. Approaching the pedestrian crossing in the measured direction, there is a speed limit of 40 km/h, which ends at the intersection in which the pedestrian crossing is located. The speed limit sign is placed 350 meters in front of the crossing, after which the drivers have to pass in front of the gates of many houses, so the effect of this restriction can be assumed to be quite low at the pedestrian crossing. The operational speed is also negatively affected by the fact that after passing the pedestrian crossing, the drivers reach a road section with rural nature (with only bushes and trees near the road). The sign indicating the end of the settlement is located 400 meters after the pedestrian crossing.

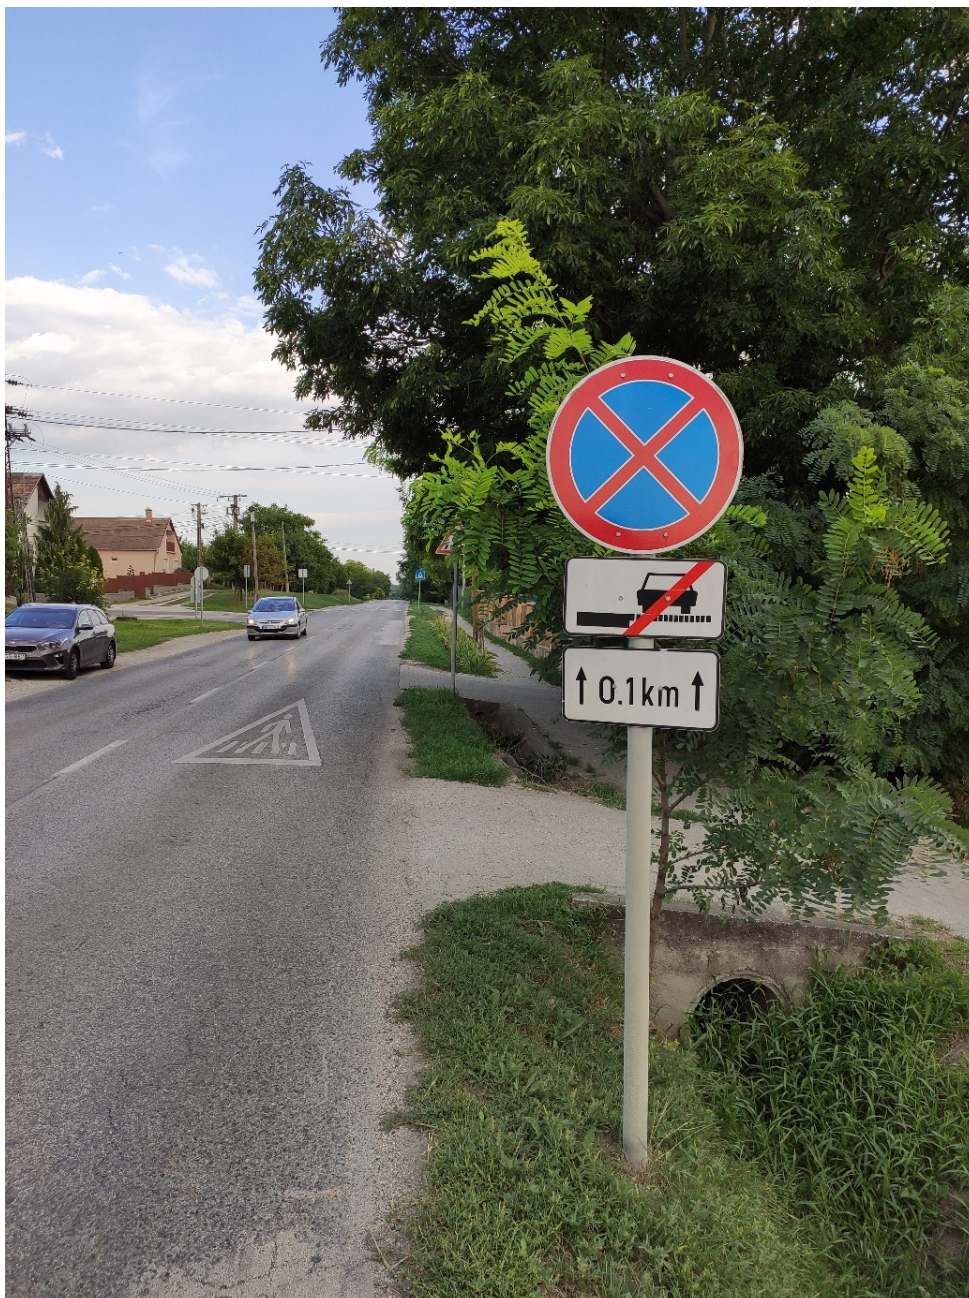
Figure 5: Prohibition of stopping in front of the pedestrian crossing

In the measured direction, stopping on the right side of the road is prohibited by a sign on a 65-meter-long road section in front of the crossing. On the left side, cars can stop by pulling up on the gravel bench (see the picture below).

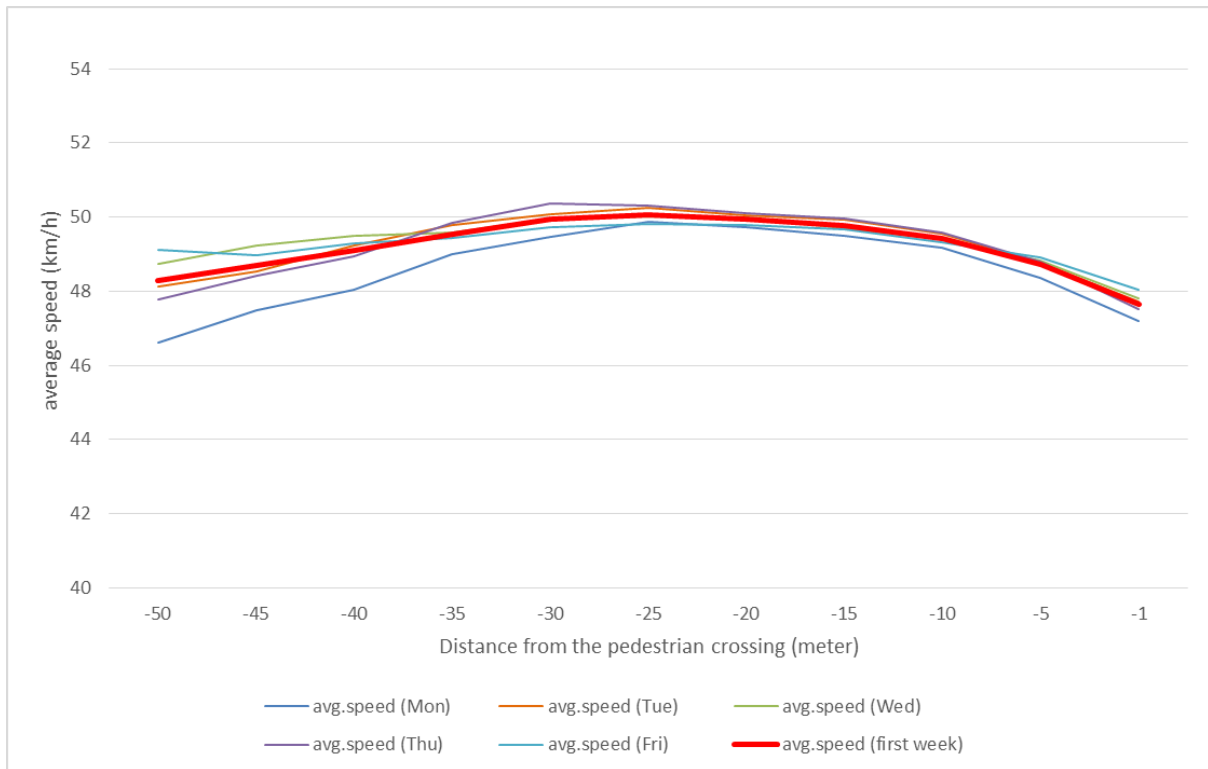
Figure 6: Average speed in front of the pedestrian crossing (first week - without ITS device)

To highlight the volume of deviation of the measurement data between the different measurement days, the following two figures show the daily average speeds. We illustrated the results of the first week (without ITS device) and the second week (with operating ITS device) separately. The number of the recorded vehicles was around 400 cars per day. In the first week, a total of 2099 vehicles, and in the second week, a total of 1986 vehicles were recorded (this applies to the 20-meter section in front of the pedestrian crossing, but the sample size was lower at more distant points due to the operational characteristics of the radar). In order to perform the further analyses using an appropriate sample size, our conclusions were drawn based on the aggregated results of the weekly measurements.

The positive effects of the ITS device can already be seen based on the differences in the weekly average speeds. This will be analysed in detail later.

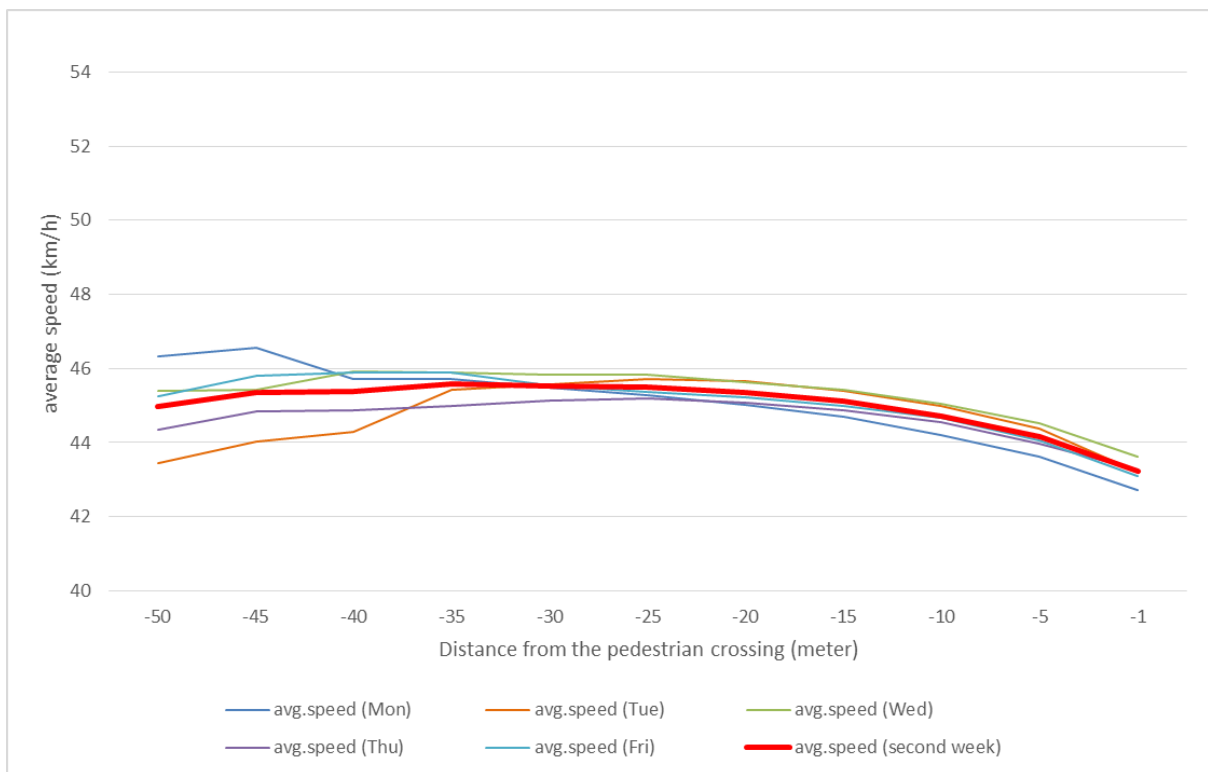
Figure 7: Average speed in front of the pedestrian crossing (second week - with ITS device)

At the 25-meter-long section in front of the pedestrian crossing, the results didn’t really differ depending on the days of the week. This was also the case in the second week. The larger deviations observed at the beginning of the measured road section (between -50 and -35 meters) may also be due to the fact that the measured sample size was much lower at these distances (e.g., in the second week, only 751 vehicles were recorded 50 meters away from the pedestrian crossing, out of the total 1986 vehicles).

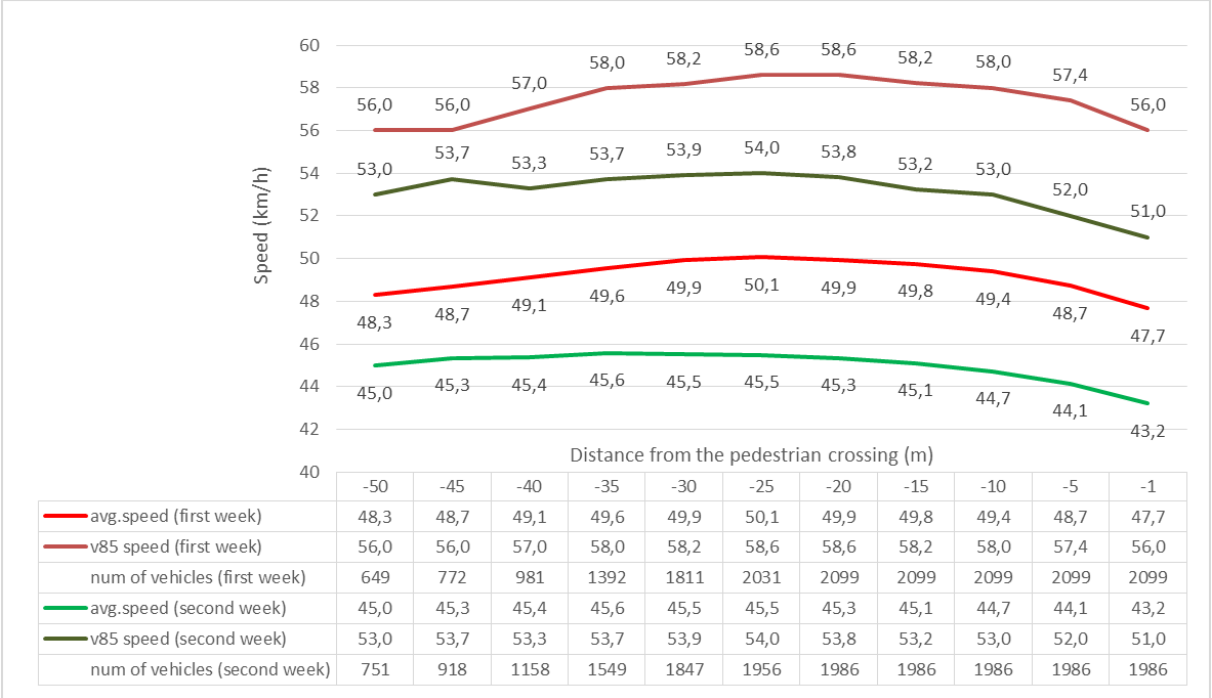
Figure 8: Average and v85 speeds in the different scenarios

To evaluate the effects of the ITS device, weekly aggregated data were used. In addition to the average speeds, the v85 speeds were also shown in the figures below (this means the speed that 85% of drivers do not exceed, and 15% of drivers exceed).

First of all, it should be noted that in spite of the 40 km/h speed limit at the measured location, the average speeds were around 47-50 km/h, and the v85 speeds were around 56-59 km/h. This was presumably the consequence of the previously introduced characteristics of the location. This implies that dealing with speed management is highly justified at the area of the selected pedestrian crossing.

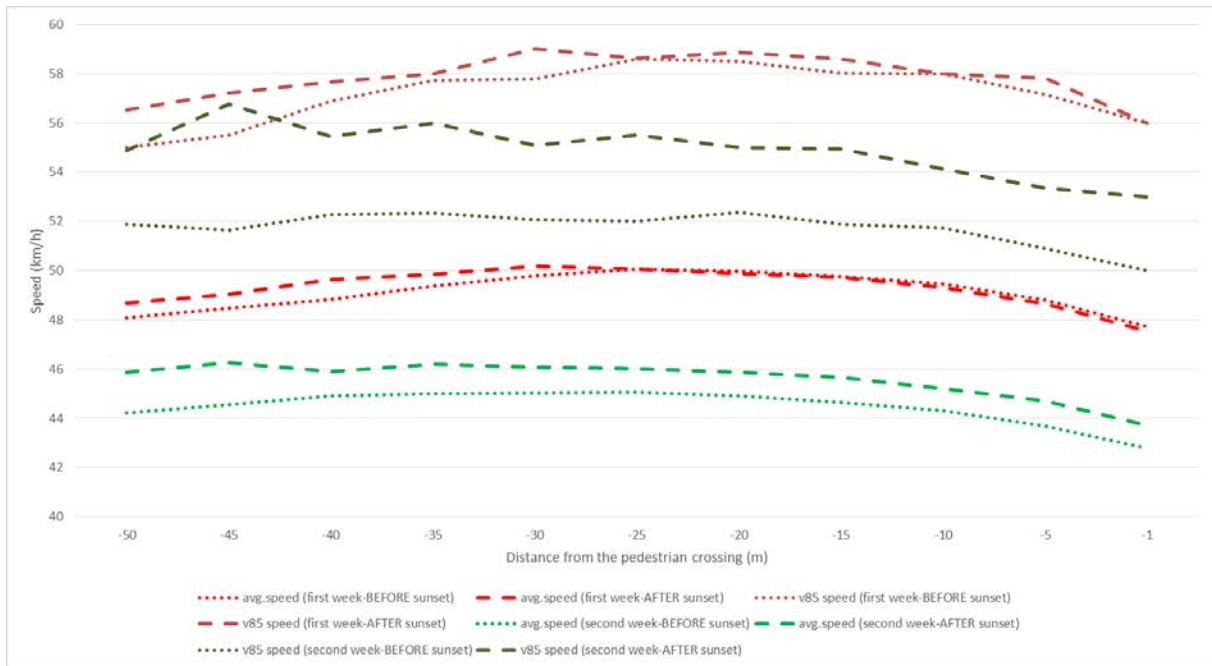
Figure 9: Average and v85 speeds of different periods in the different scenarios

In Figure 9, the v85 and average speeds have been indicated with the same colours as in Figure 8 (red: first week, green: second week; darker: v85, lighter: average speed). The dotted lines show the periods before, and the dashed lines show the periods after sunset.

According to the data from the first week (without the ITS device), there was no significant difference in the average speed, nor in the v85 speed in the periods before and after sunset. Typically, the speed values were only slightly lower, and only at the beginning of the measured section under daylight visual condition.

However, greater differences were observed in the second week. Contrary to the expectations, there was a higher decrease in speed before sunset. Thus, the ITS device achieved greater effects under daylight visual condition than after sunset. A possible explanation for this phenomenon can be that the drivers are less likely to expect pedestrians at the crossing at night. So, the warning by the pedestrian crossing warning sign seems to be given less importance in this period. However, a similar prediction of another hazard (e.g., a dangerous curve) might have the opposite effect. Investigating different type of locations and scenarios in this regard would be an interesting area for future research.

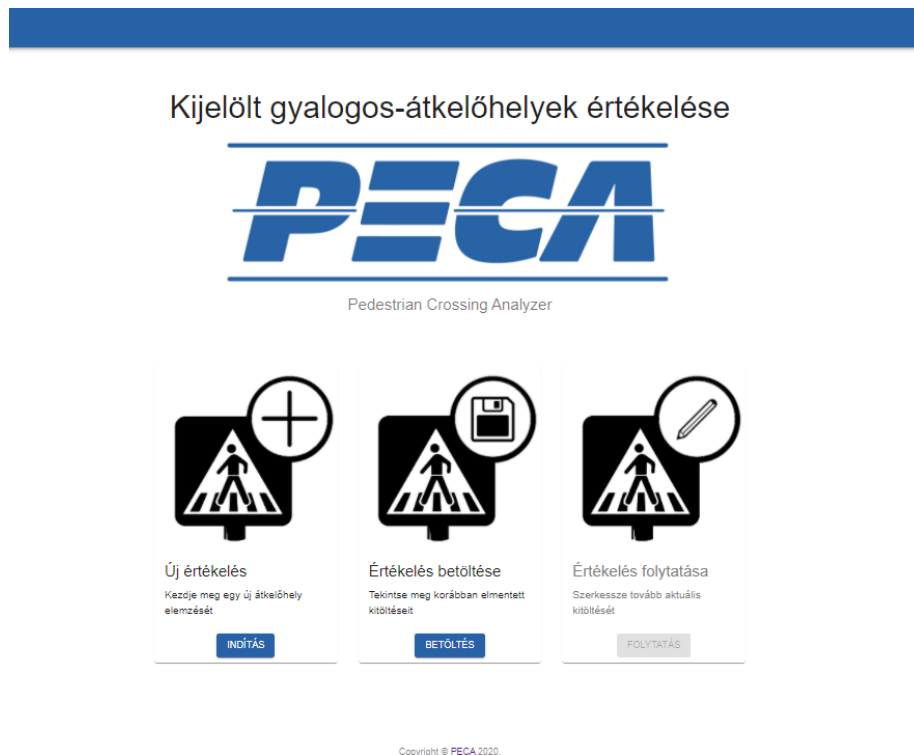
Figure 10: Main menu of the PECA (PEdestrian Crossing Analyzer) web-based application

The PECA software is applicable for the complex evaluation of the road safety and service level of designated pedestrian crossings within urban areas. It is also able to provide automatic recommendations to improve safety based on the coded parameters and results of the analysis.

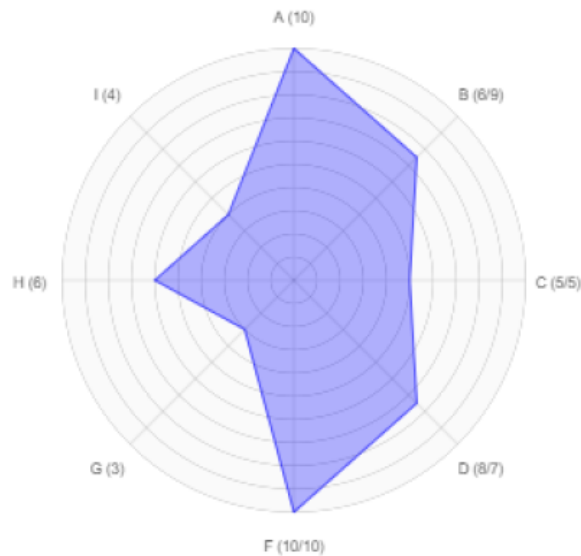
### Szempon-t-csoportonkénti értékelés

A: Környezeti adottságok, elhelyezés, B: Forgalmi rend, C: Horizontális jelzésrendszer, D: Vertikális jelzésrendszer, E: Jelzőlámpás irányítás, F: Gyalogosok és járművezetők egymást történő észlelése, G: Észlelés éjszaka, közvilágítás, H: Gyalogos felállóhelyek, várakozási terület, I: Forgalom jellemzői

- Aggregated rating of safety and service level: 6/10
- The evaluation by criteria groups:
  - A: Location, environmental conditions: 10
  - B: Traffic management: 6 (direction 1); 9 (direction 2)
  - C: Horizontal traffic sign system: 5 (direction 1); 5 (direction 2)
  - D: Vertical traffic sign system: 8 (direction 1); 7 (direction 2)
  - E: Traffic light control (not relevant in this case)
  - F: Mutual detection of pedestrians and drivers: 10 (direction 1); 10 (direction 2)
  - G: Detection at night, public lighting: 3
  - H: Pedestrian stands, waiting area: 6
  - I: Traffic characteristics: 4

In its current state, the pedestrian crossing has received a medium rating (6 stars out of 10). It is favourable that the design of the site is simple, the road is in a good condition (criteria group A), the mutual detection of pedestrians and drivers is not hindered by the alignment of the road or any covering effects (criteria group F).

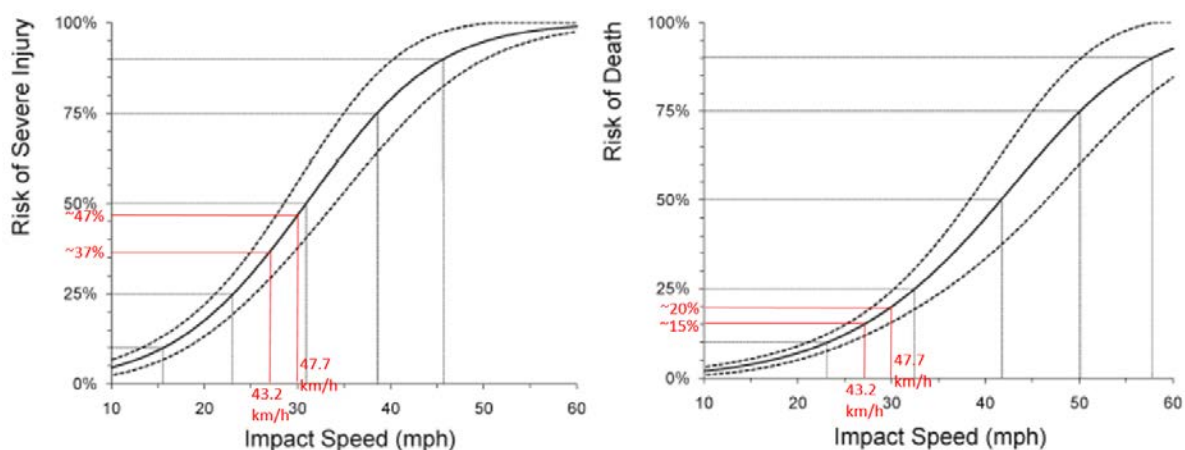
Figure 12: Change of the risks of severe injury and death<sup>22</sup>

To quantify the effects of the proposed Pilot Action on possible injury severity, the diagram published by Tefft (2011)<sup>22</sup> was used. In the diagram, the risk of severe injury (left) and death (right) was determined in relation to impact speed (by averaging data from 422 pedestrian hits).
