Sediment balance and transport in the Five-Country Biosphere Reserve Mura-Drava-Danube

DTP3-308-2.3 lifelineMDD

D.T1.2.3 Sediment balance and transport study

University of Natural Resources and Life Sciences, Vienna

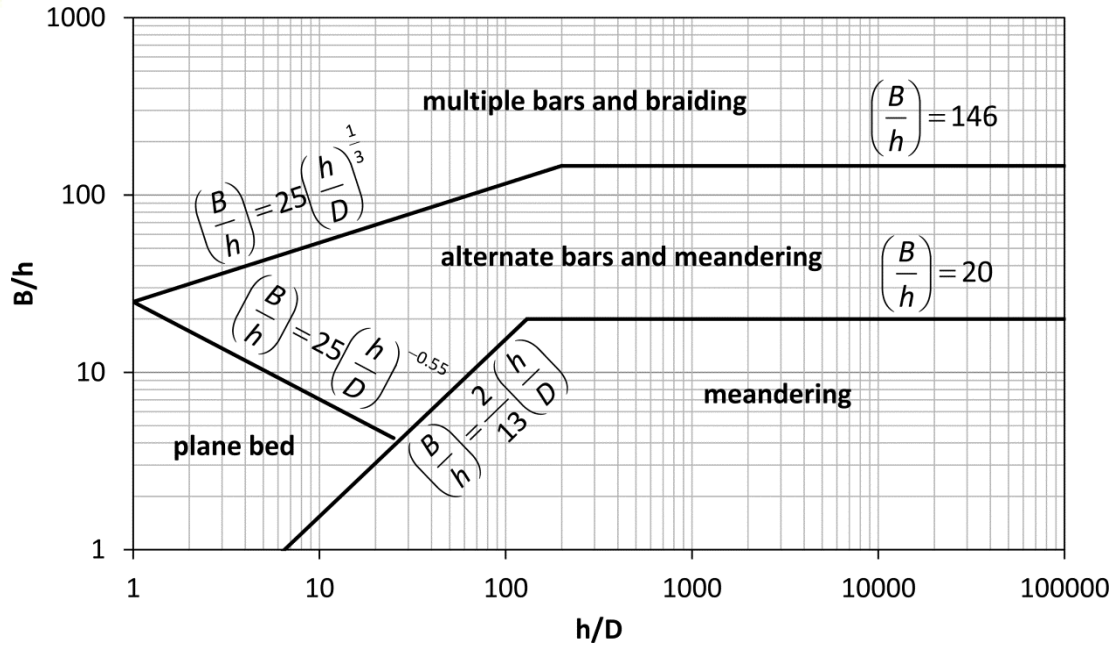
The $(B/h;h/D)$ diagram of Da Silva (1991) relates the width/depth ratio to the ratio between water depth and grain size, allowing different morphological types to be delineated (Figure 9). This diagram can be used to estimate the channel width required to restore a particular morphology. The formulas delineating different morphologies were derived from natural rivers and from laboratory rivers in dynamic equilibrium, hence they are applicable to disturbed rivers only with limitations.

Figure 9. The Da Silva (1991) plan (displayed here in its revised form based on Ahmari and Da Silva (2011)) provides an understanding of thresholds in river morphology useful in planning bed widenings. B : flow width, h : flow depth, and D : grain size.

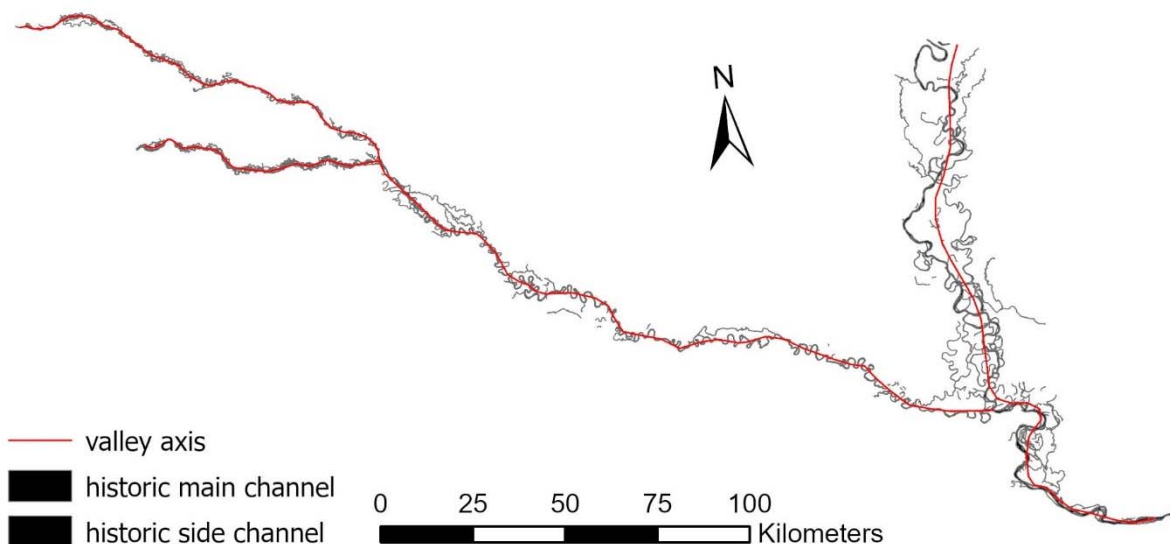
Figure 20. Historic main and side channels of the Mura, Drava and Danube (black) with the overlaying valley axis (red).

The historic and present planform was analysed along the river network of the TBR MDD. The course of the rivers in their historical and the present condition exhibited to deviate strongly. Accordingly, to compare present and historic planform properties, both states needed to be projected onto a common line. For this purpose, Schwarz (2022) used elevation maps to establish valley axes (Figure 20) of the three TBR rivers that meet this criterion of consistency over time. These valley axes were provided to the partnership as a basis for visualisation of the results of the scientific studies.

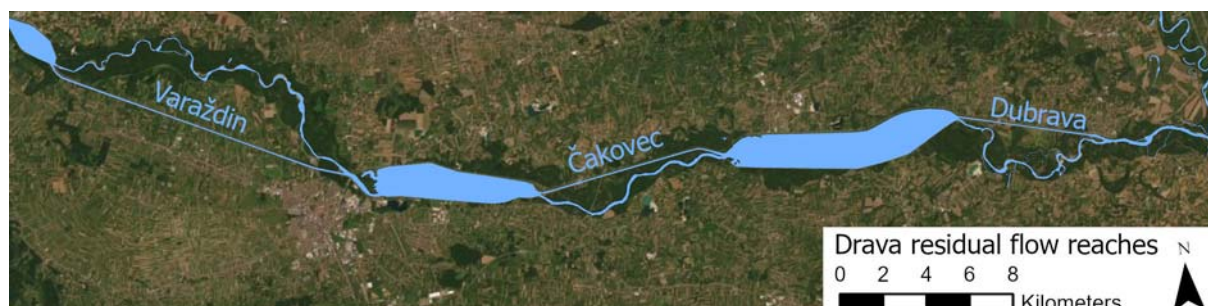
Figure 24. Most upstream section of the Drava River in the TBR MDD.

Along the Drava river, in the most upstream section Dr1 (Figure 24), repeated cross-sectional surveys of the residual flow stretches at the hydropower plants Varaždin, Čakovec and Dubrava were provided for this study.

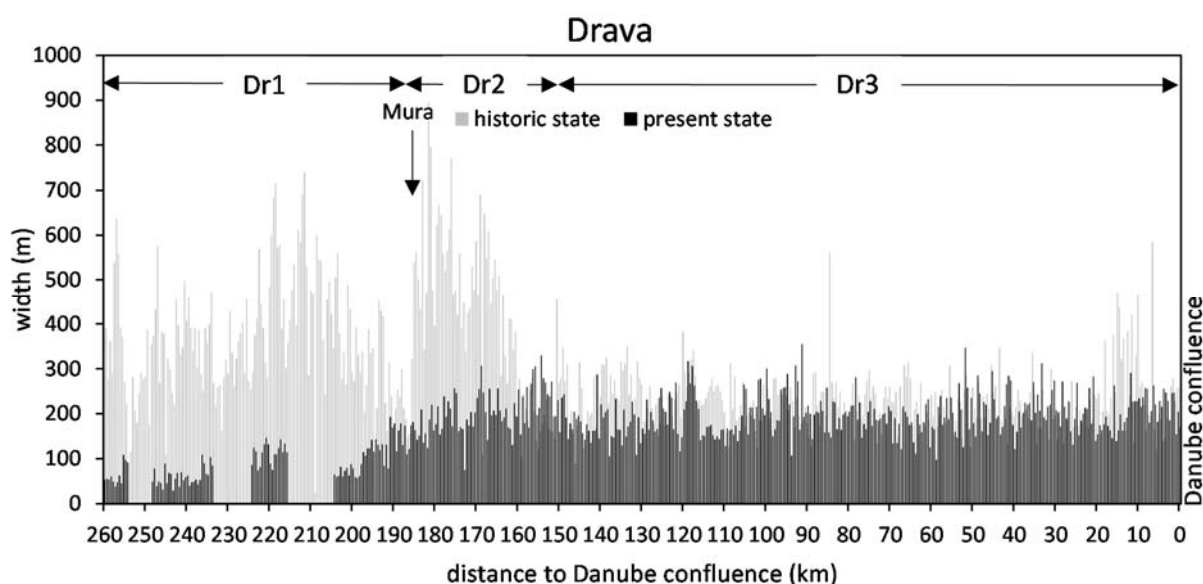
Figure 28. Wetted width of the Drava River from Ormož to the Danube confluence in the historic state (grey) and in the present state (black).

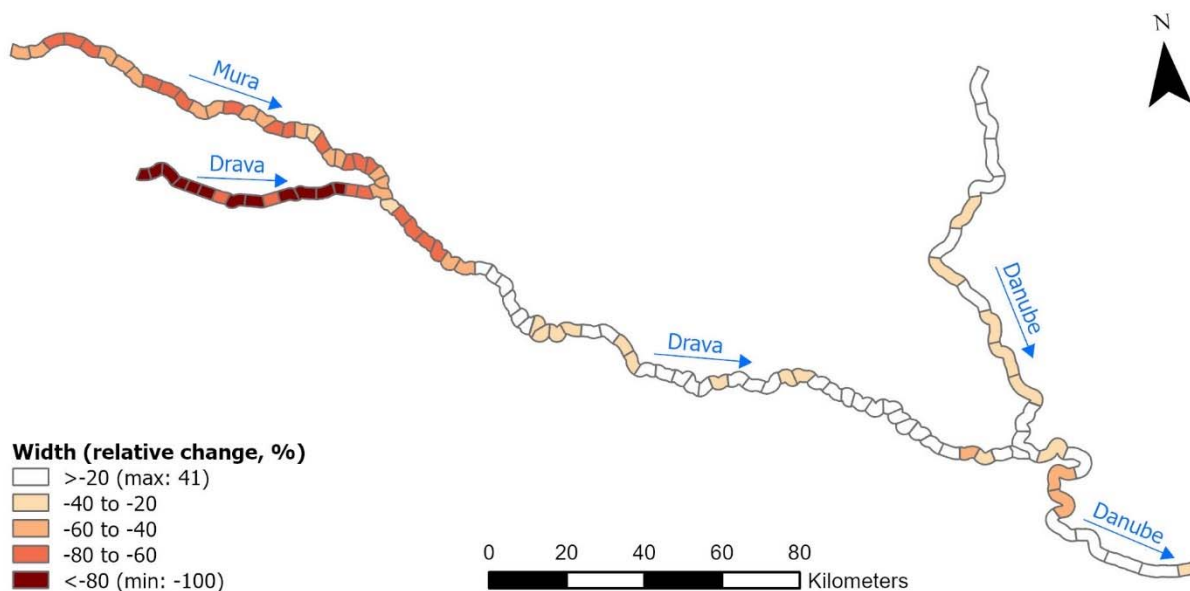
Figure 32. Relative changes in width along the MDD rivers.

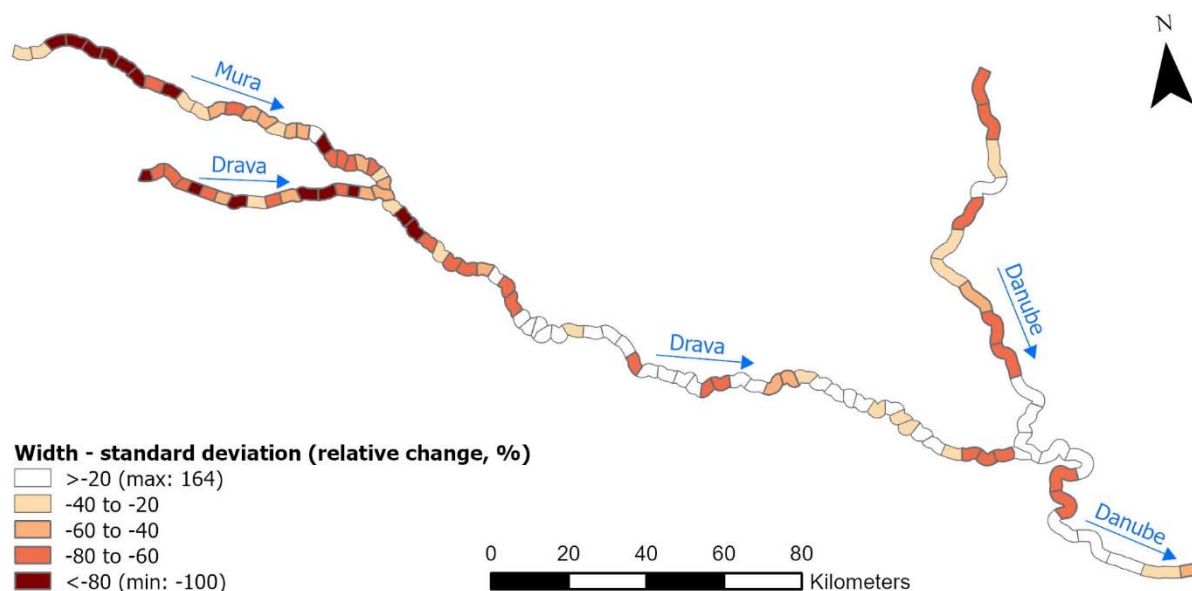
Figure 33. Relative change in the standard deviation of the width within the individual segments.

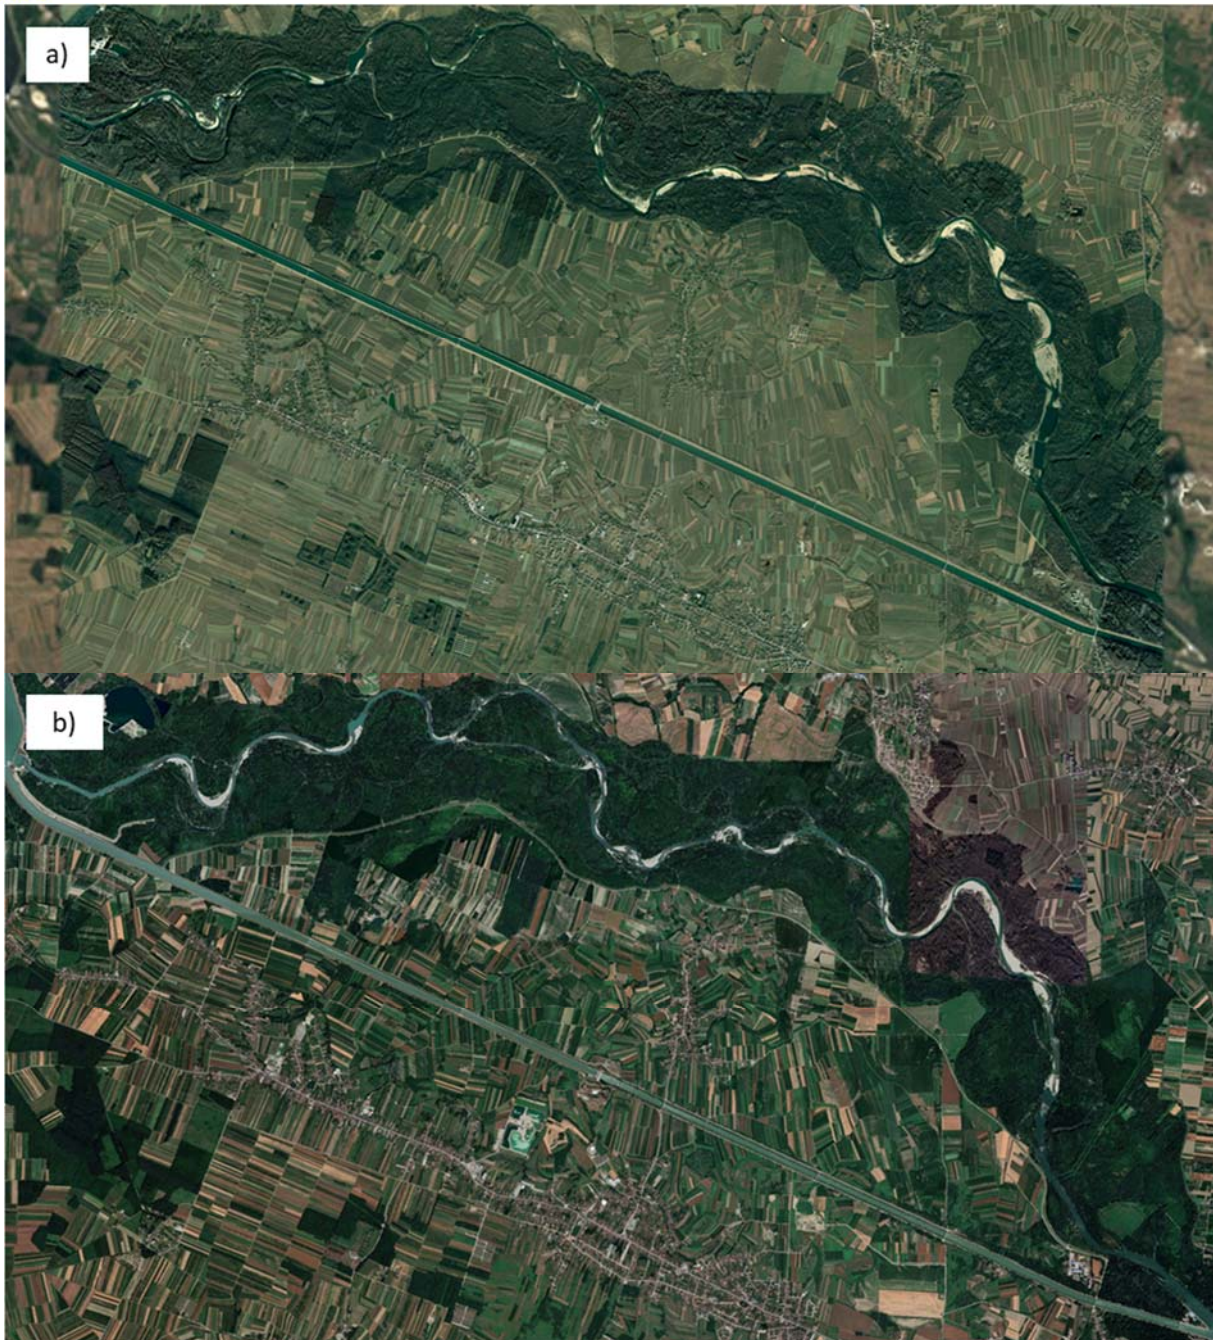
Figure 58 shows the residual flow reach near Varaždin in 2003 (Figure 58a) and in 2021 (Figure 58b), exhibiting significant lateral dynamics.

Figure 58. Residual flow stretch near Varaždin between 2003 and 2021 (source: Google Earth).

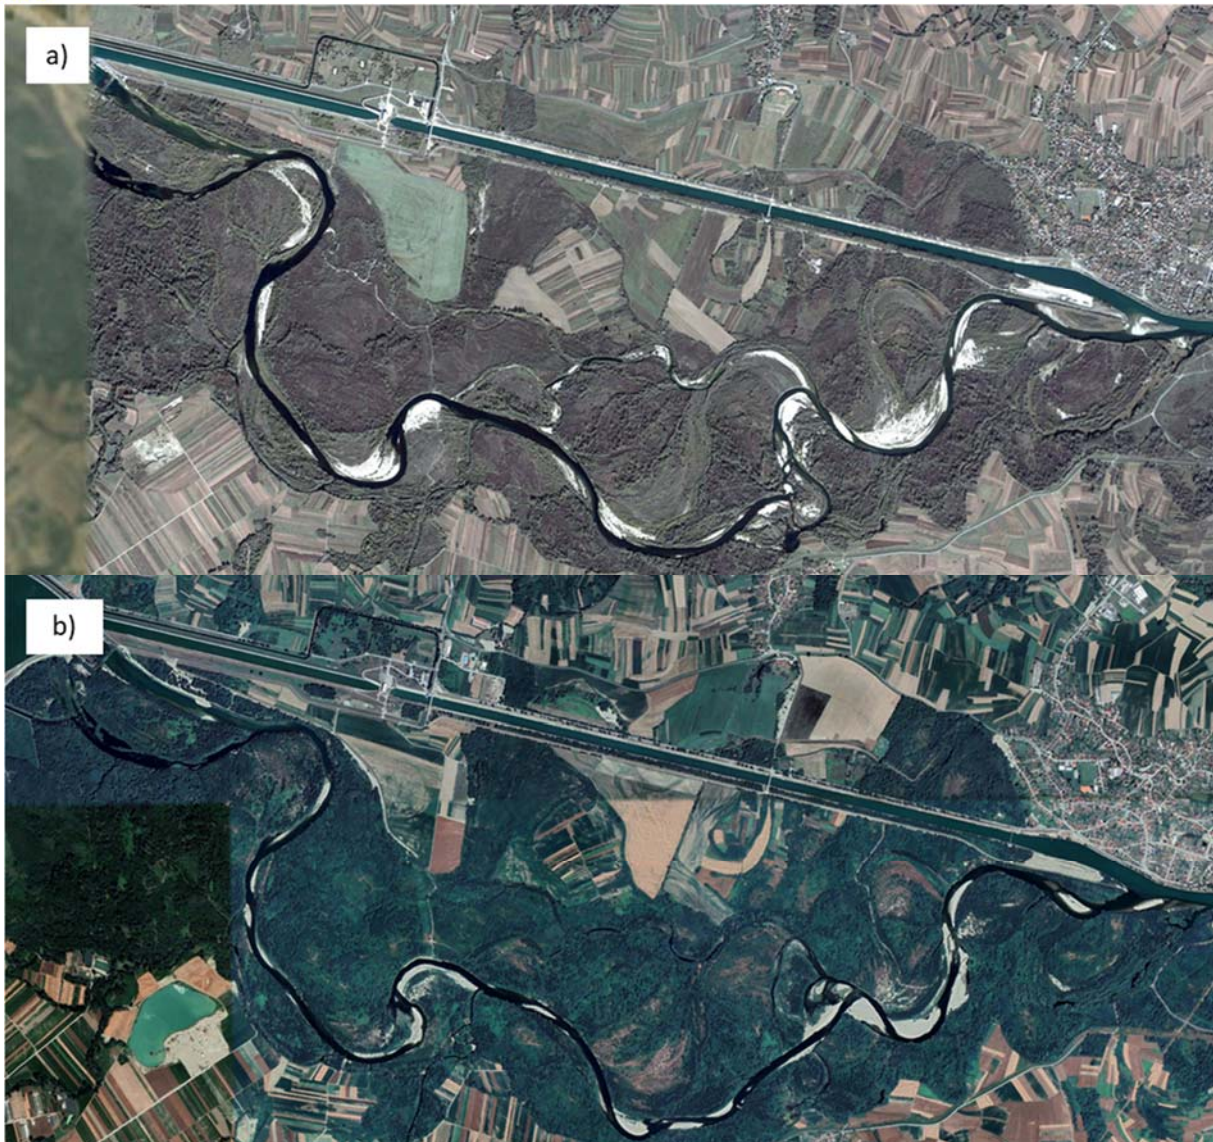
In Figure 61, orthophotos of the residual flow stretch below the Dubrava dam are depicted. Figure 61a shows the old Drava as in the state of 2003, Figure 61b shows the situation in 2021. Again, significant lateral dynamics can be observed.

Figure 61. The Drava river below the Dubrava reservoir in 2003 and 2021
