## **Pilot Actions Evaluation Report**

### **Port of Kotor**

### **Implementation of TWS's in Port of Kotor**

**DANOVA**

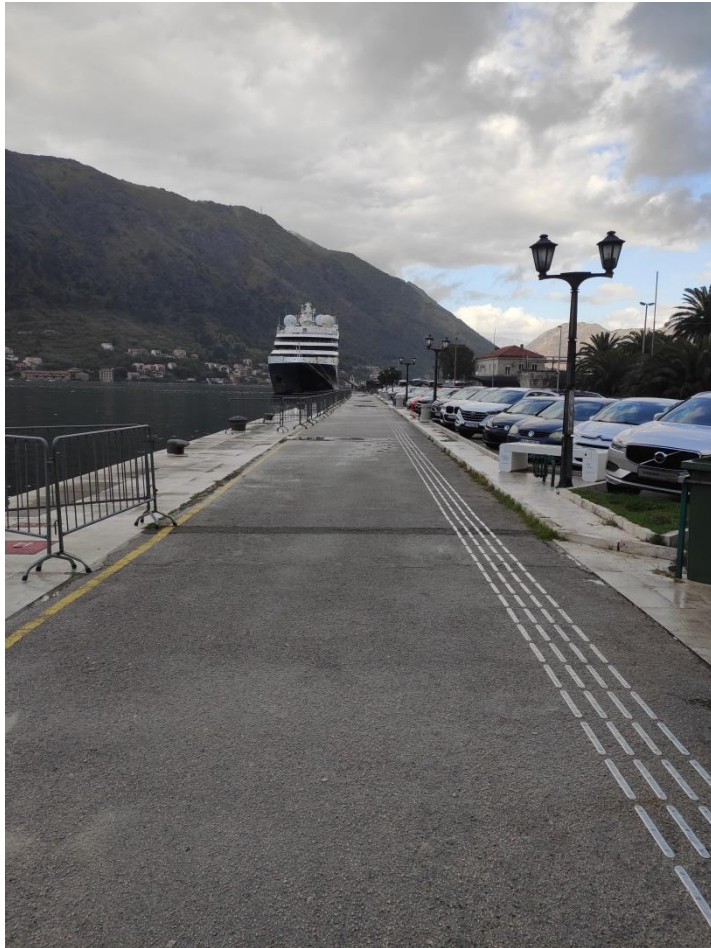
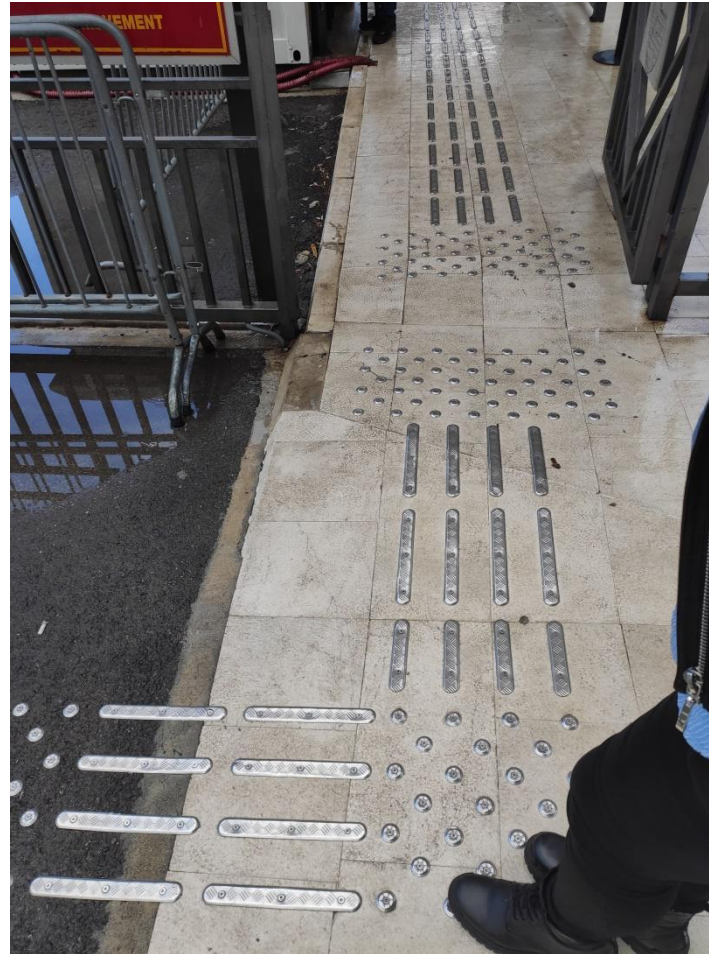
*Picture 1. Approach from public bus stop and entrance to site*

- In front of the port area connecting public bus station with arrival and departure access point
- Inside the port grounds connecting entrance / exit point to the terminal, toilettes and passenger embarkation/disembarkation area.
- Inside the terminal ground floor leading through security and passport check and in separate ground floor entrance guiding to toilettes and second floor of the terminal

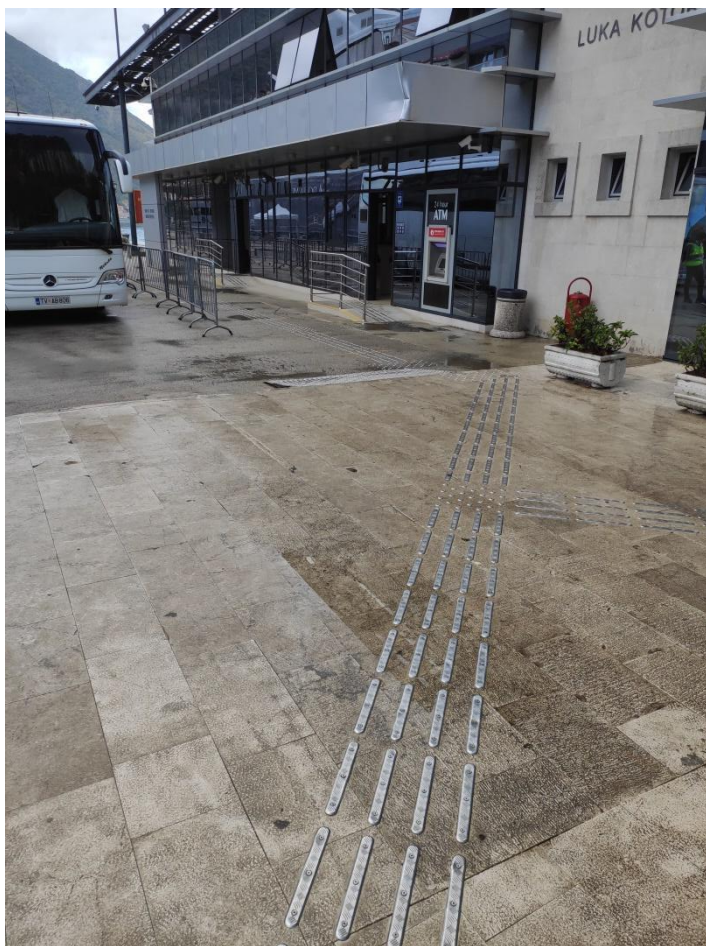
*Picture 2. TWSI's in front of passenger terminal*

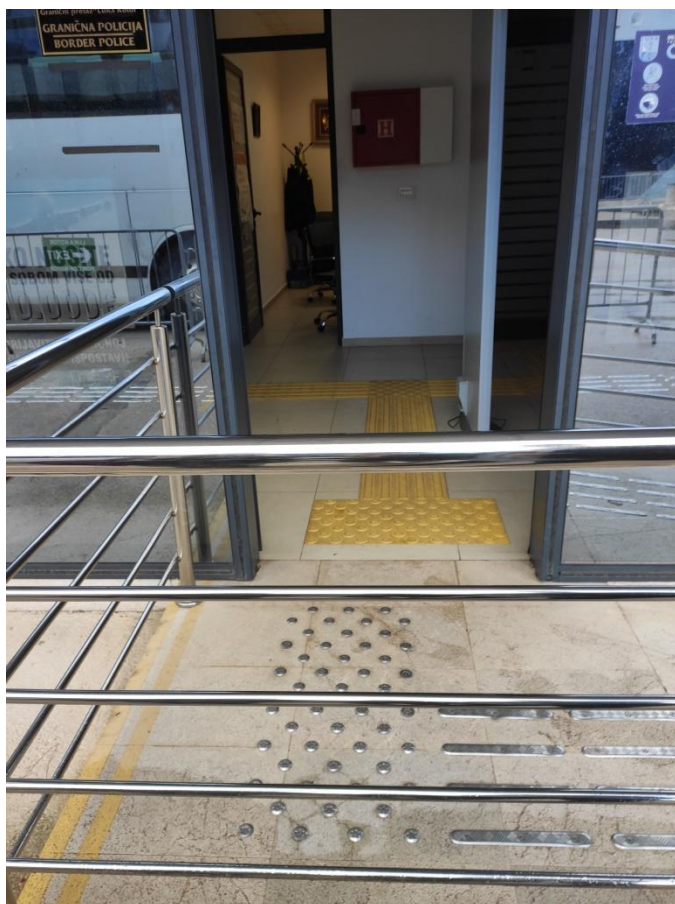
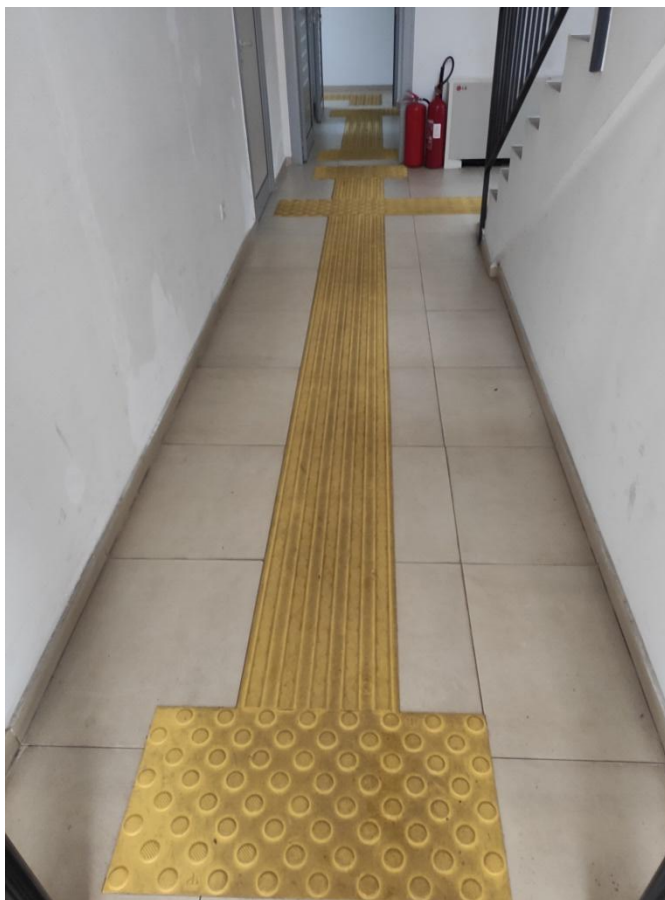
Picture 3. Entrance to terminal and indoor TWSI's to sanitary facilities

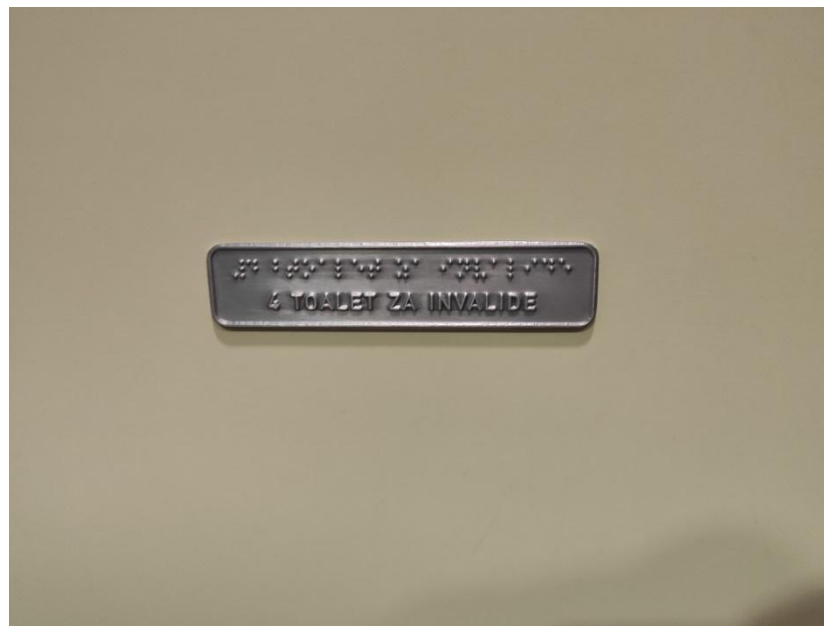
Picture 4. Indoor tactile orientation plan and Braille signage

Also, total of 2 tactile orientation plans were installed: one at the entrance to the ground floor and another at the entrance to the second floor of the terminal both displaying information about the layout of their respective floor areas.
