O.T.3.1.d Pilot Actions on 4 (6) Road Safety Thematic Areas

TA2 VRUS – CZECH REPUBLIC

**RADAR – Risk Assessment on Danube Area Roads**

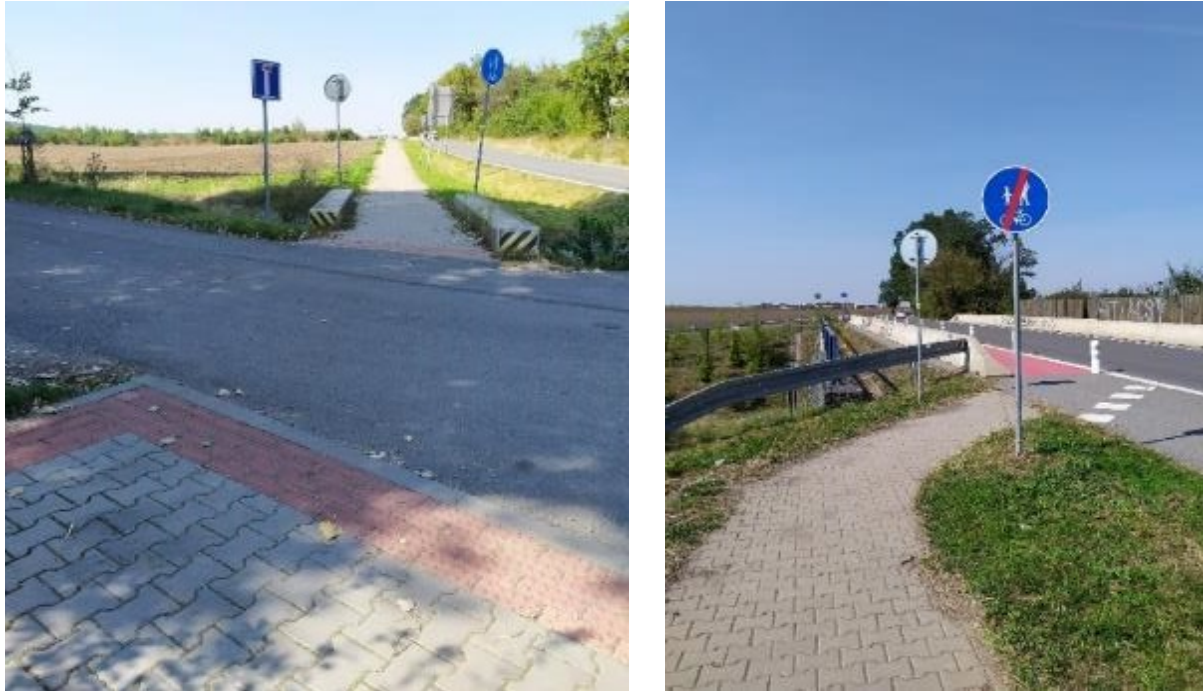
Figure 2 – Pedestrian and cycle path along the road and on the bridge across I/9

The path leaves the municipality in the Družstevní street. It runs segregated from the road on interlocking pavers. At the crossing of road I/9, the path is channelled onto the crossing road and separated with white flexible posts (those were installed recently, no separation from motorised traffic had been in place before).

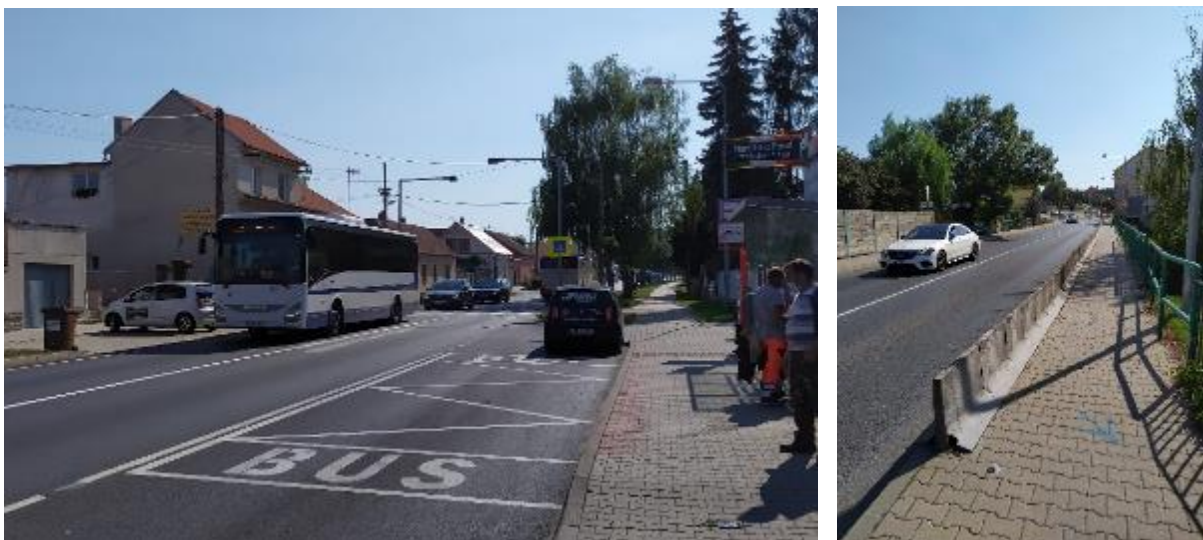
There are numerous traffic calming facilities installed in the centre of Líbeznice (zone 40, elevated crossings, etc.), as well as protective features in high-risk locations.

Figure 3 – Public transport stop area with elevated crossing / barrier separating a narrowed sidewalk from busy road

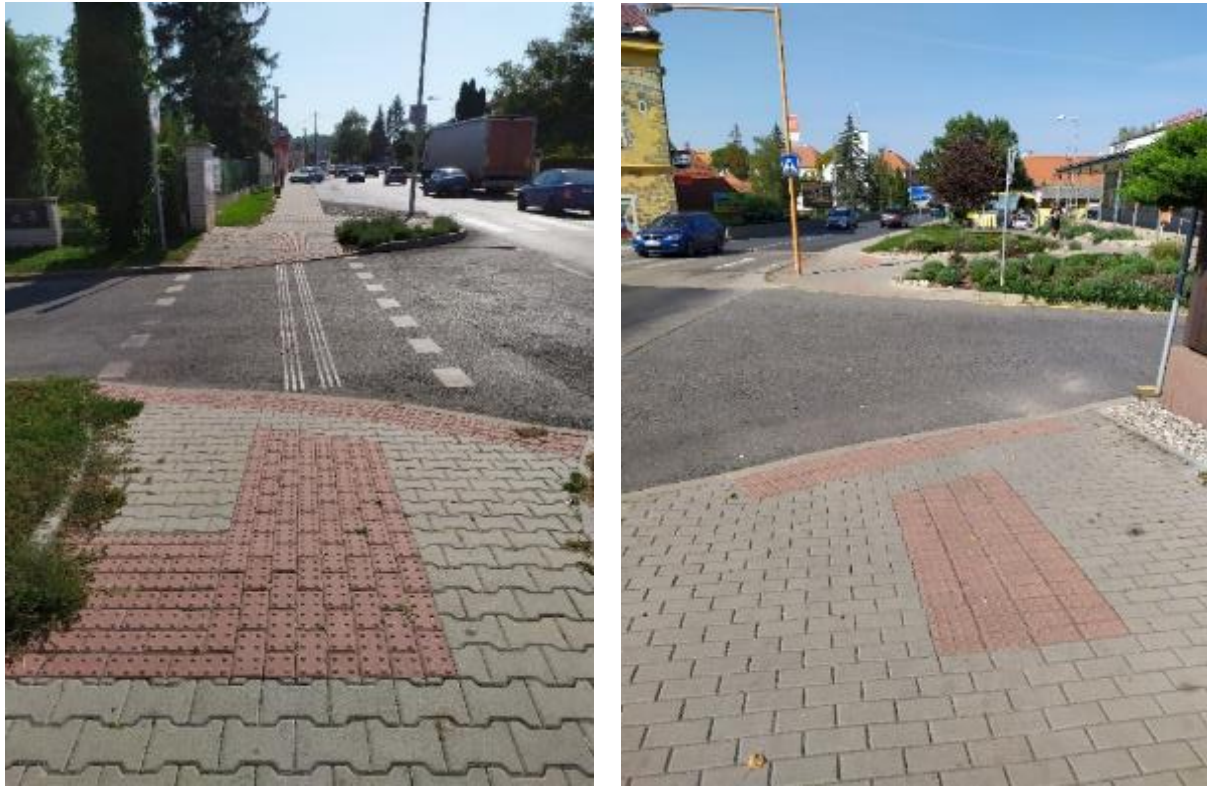
There is a newly reconstructed sidewalk in the whole municipality, with high number of tactual features for visually impaired persons.

Figure 4 – Tactual features at pedestrian crossings

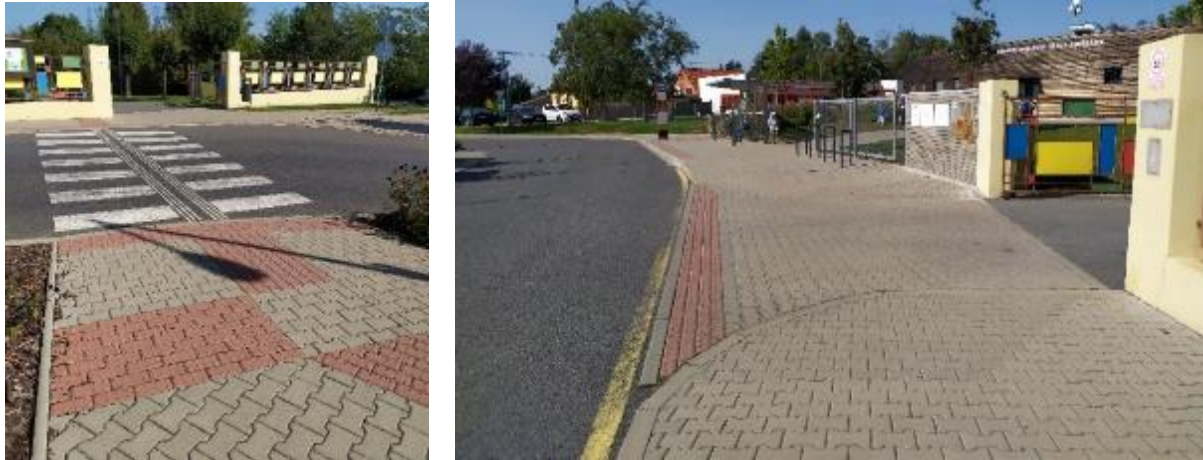
Figure 6 – Treatments of space in front of the school

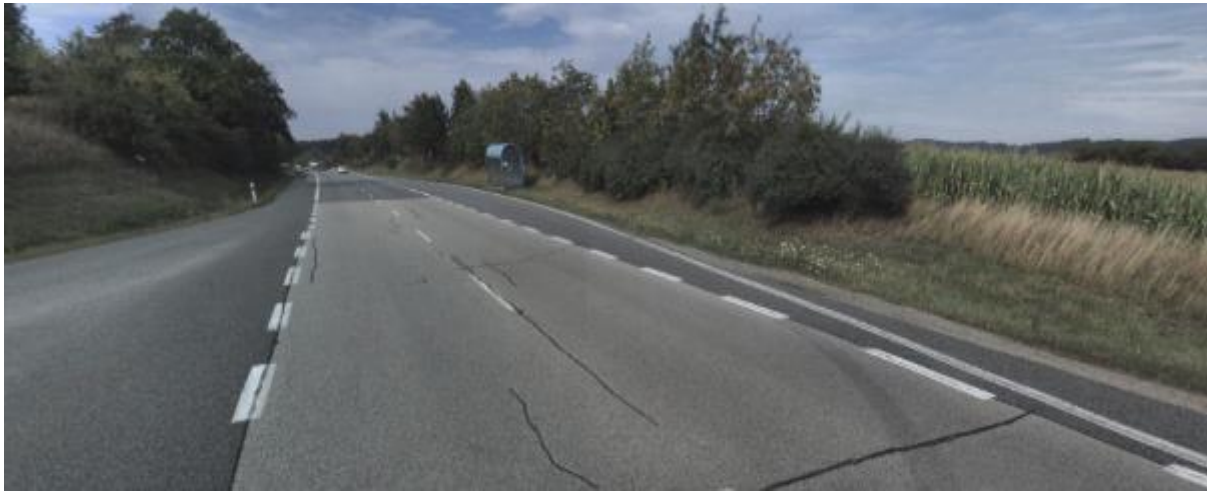
Specific deficit was found at accesses to bus stops, which are on main roads passing the villages. Specifically, for children, the access to/from bus stops close to intersections, without any provision for crossing and access to stops was found serious and regular.

Figure 13 – Recreation area survey, road I/3, accesses to public transport stop Bystřice, Tožice

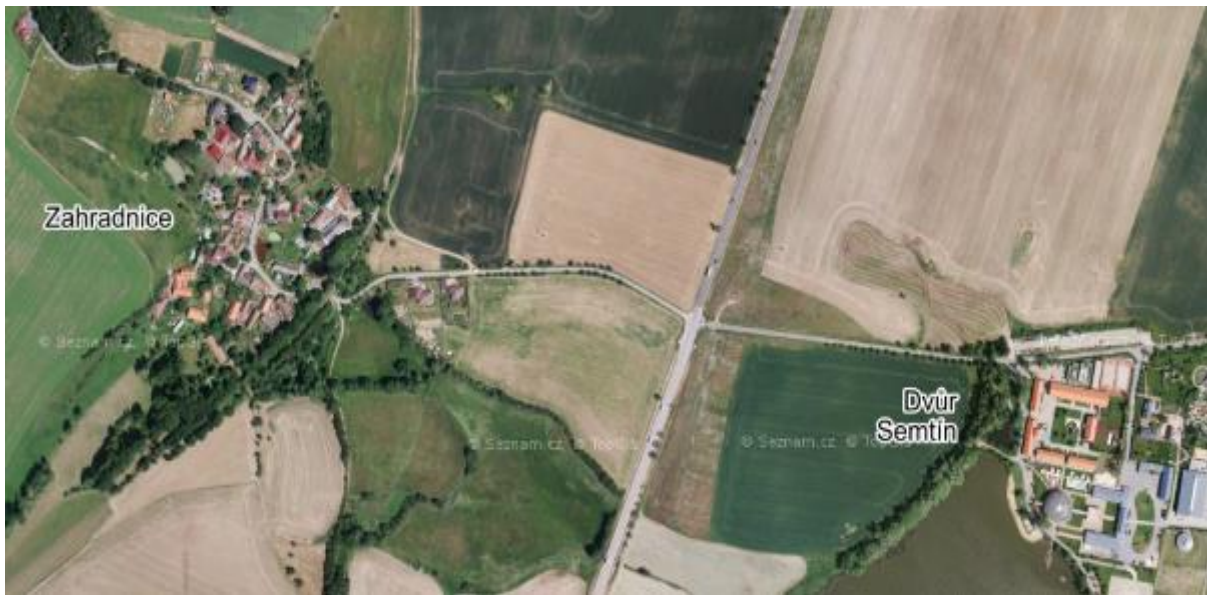
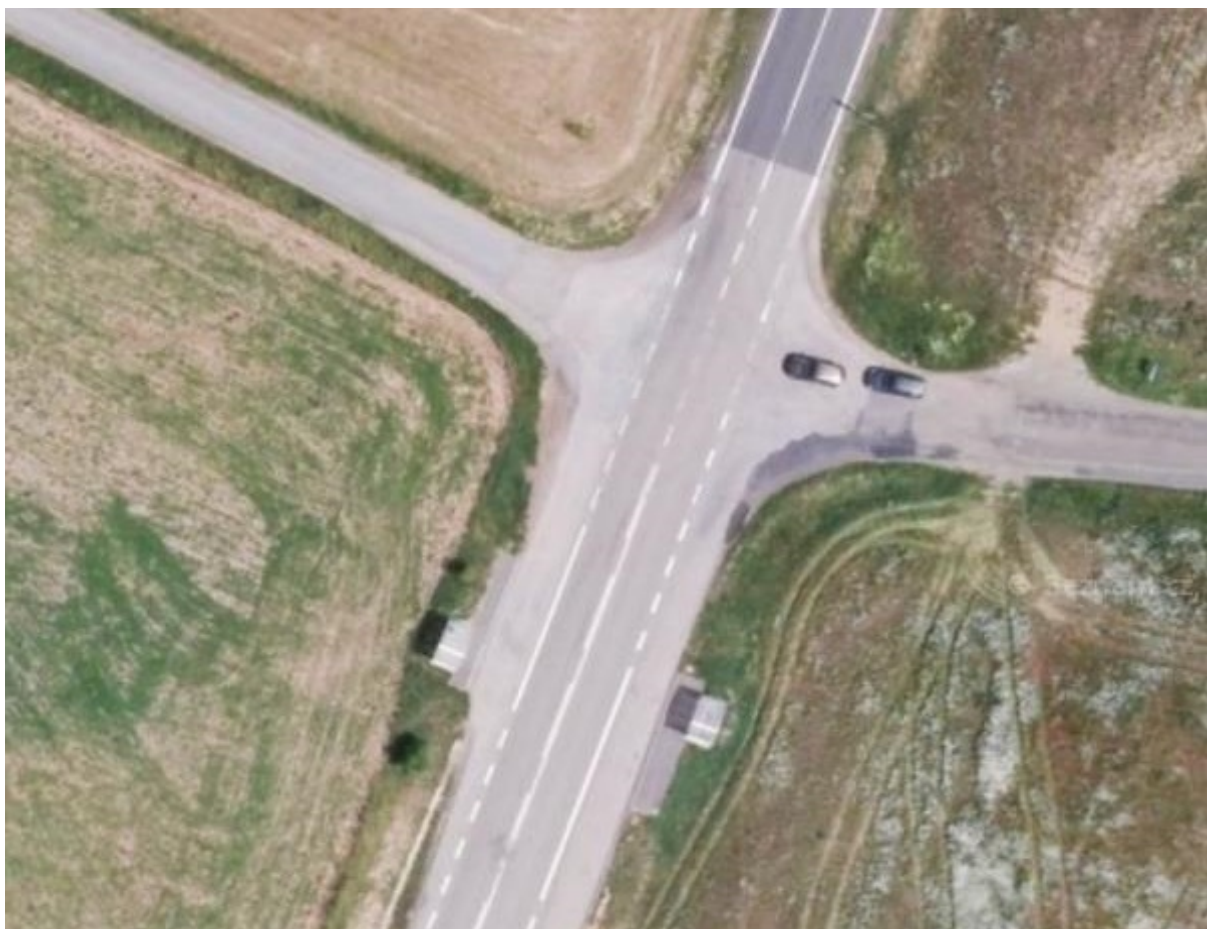
There are no cycling or touristic routes signed in the subject area. The main road I/3 is straight in the length of 1730 m and the bus stops are situated on the horizon of a convexly curved route. There are no pedestrian provisions for crossing the main road at the bus stops, while the crossing distance is 15 m. The following pictures illustrate the setting in more details.

Figure 16 – Detailed aerial view on the subject crossroad and location of opposite bus stops

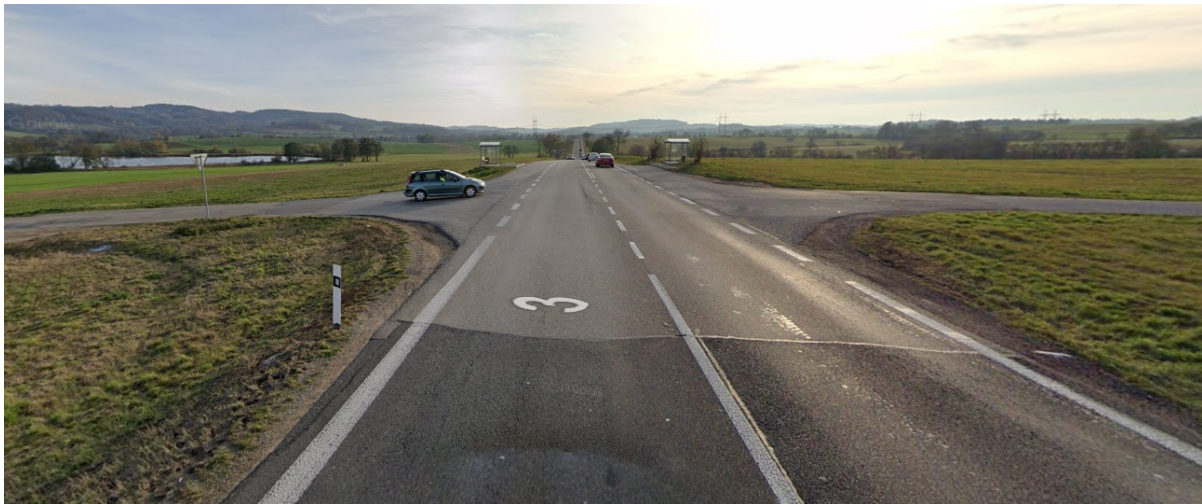
Figure 17 – Crossroad view from north

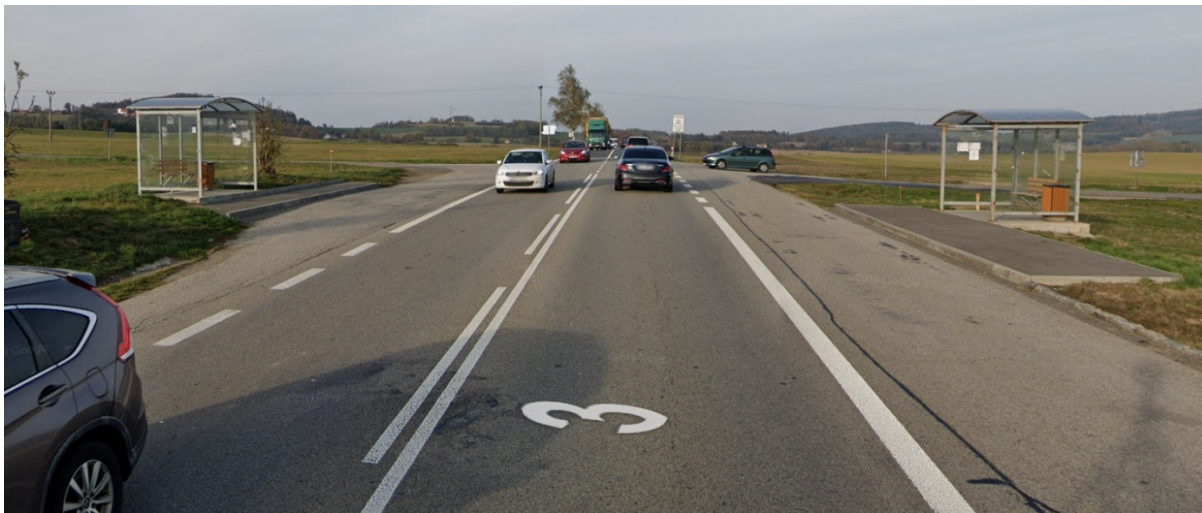
Figure 18 – Crossroad view from south

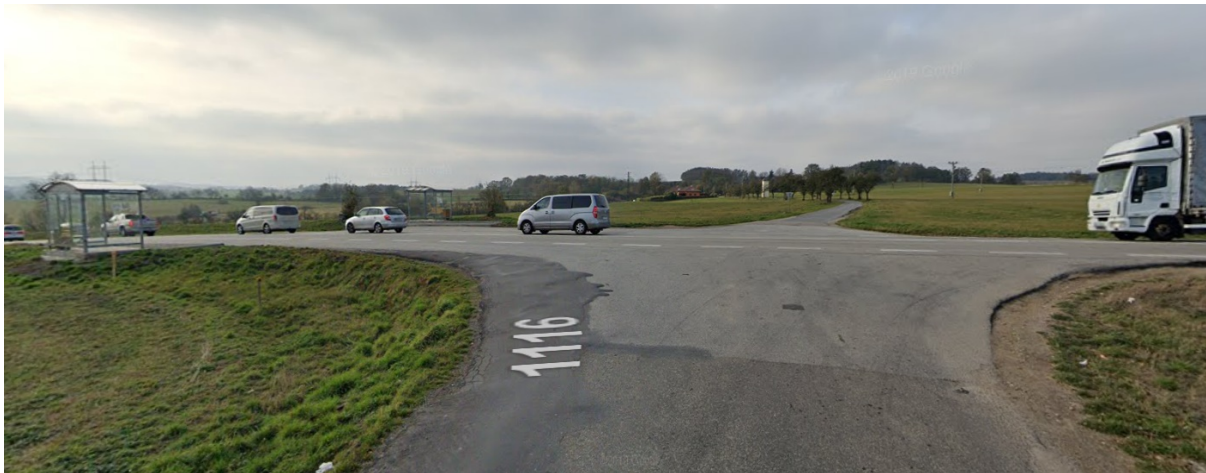
Figure 20 – Crossroad view from east

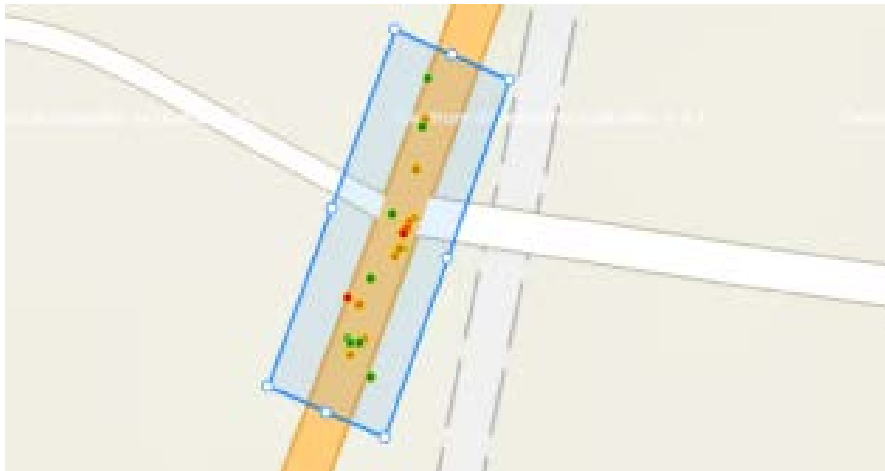
1. Accident from October 8, 2018 – heavy injury of a person hit while crossing the main road, 11-year-old female crossing behind a vehicle standing in the bus stop bay;

2. Accident from September 9, 2019 – light injury of a pedestrian hit at the bus stop, 38-year-old male, bad visibility conditions, rain, influence of alcohol

Figure 21 – Localization of accidents Case 1 (green/orange/red – no/light/serious injury)

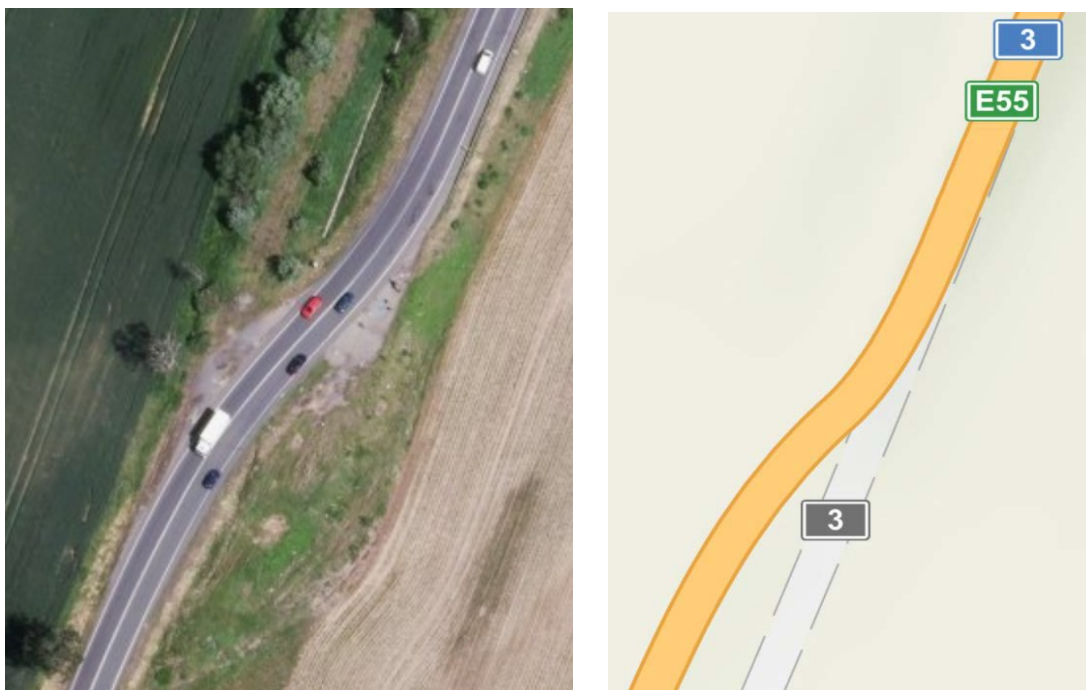
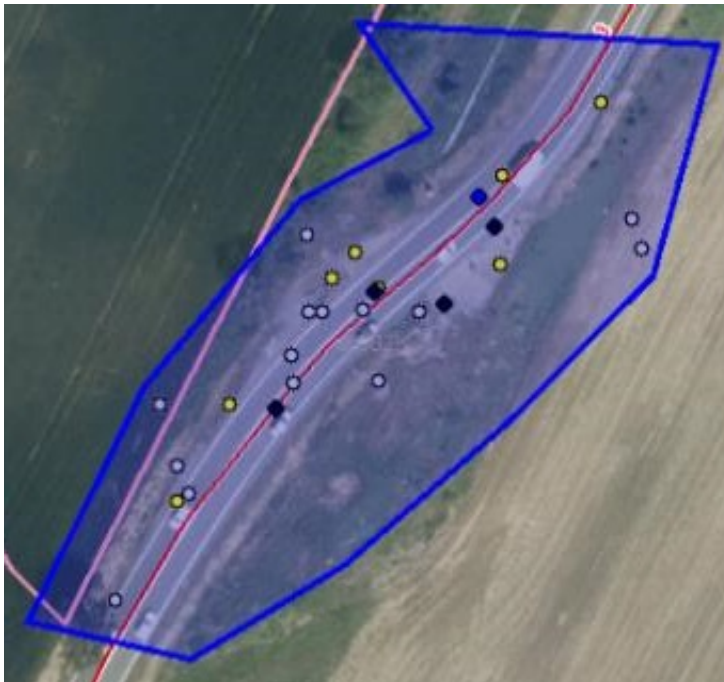
This most critical blackspot in terms of casualties is located just ahead of Olbramovice when coming from Prague – at the location, where the planned bypass shall begin. The present road lay-out creates a very problematic chicane at the place of temporary provisional end of the by-pass, which frequently becomes an accident site, especially for those, who do not know the place and do not expect such an alignment. Even though road marking and signs can be assessed as sufficient now, the spot has been a nightmare for years. The map below clearly illustrates the problematic lay-out and related accident records. The following figures give evidence to the above statements, indicating both the present and future (dotted) road alignment, together with the number of accidents in different severity categories. There were already 5 people killed and further 21 injured (3 seriously) between 2007 and 2020, compared to the town centre, where larger number of accidents were recorded, but with much lower severity.

Figure 24 – Blackspot at the beginning of the future bypass

Since this critical black spot is going to be eliminated completely by the new design and does not relate to any specific VRUs issue, it has not been further analysed in the Pilot study.

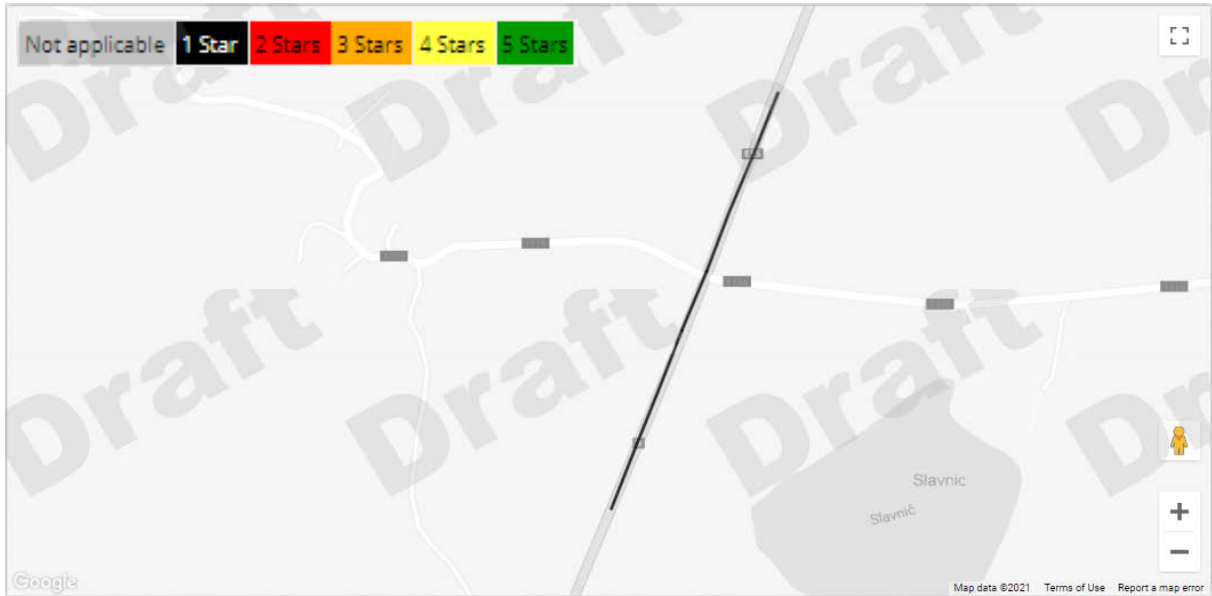
As the following figures indicate, the star rating exercise of the existing provisions identified numerous safety deficits at the location, which resulted in the poorest, 1-star verdict. Star ratings are shown for vehicles, motorcyclists, as well as pedestrians separately.

Figure 28 – Star rating vehicle occupants + motorcyclists – existing layout, star rating for both groups is the same

Star rating score for vehicle occupants = 31,6 (smoothed)

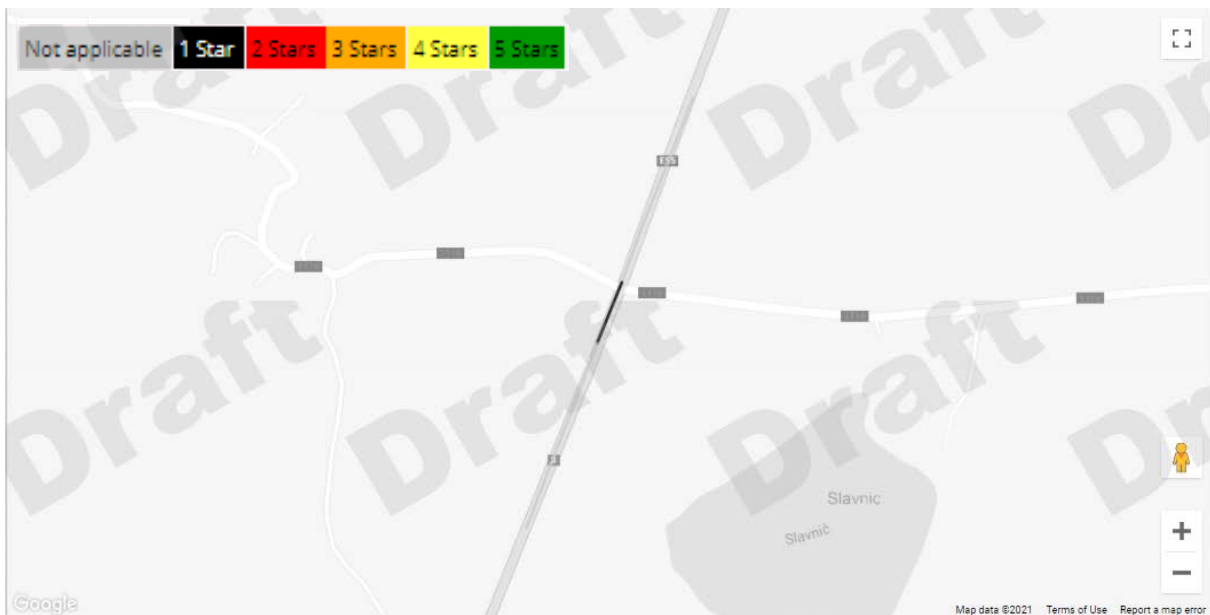
Figure 31 – Star rating pedestrians – existing layout

Star rating score for pedestrian = 620,1 (raw)

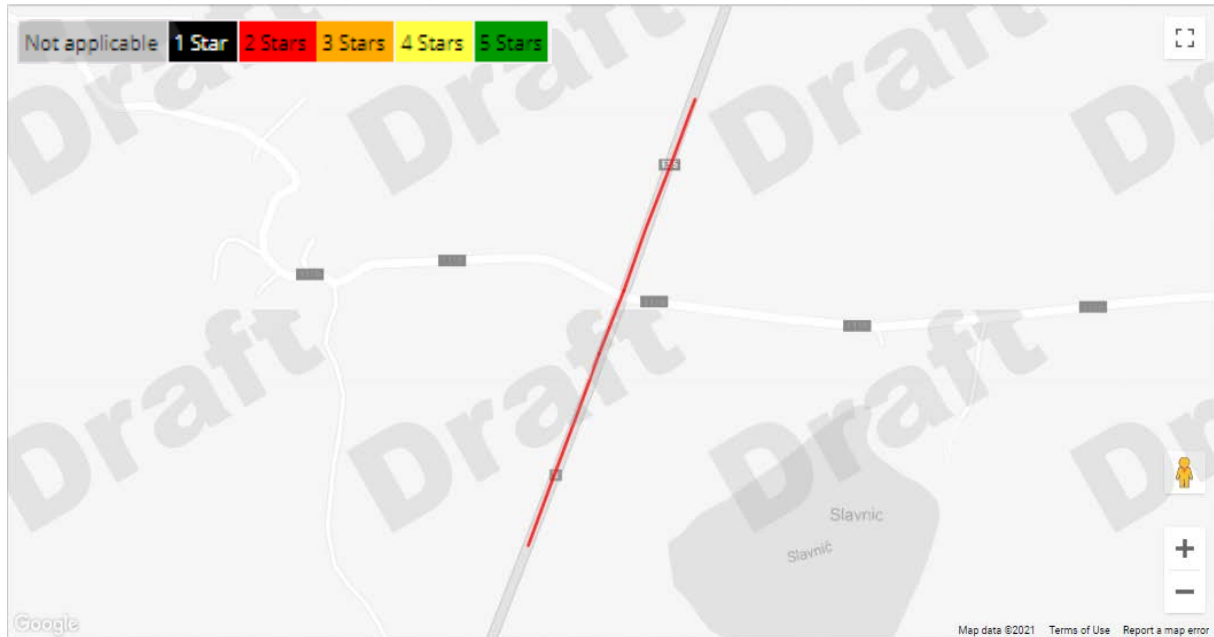
After conducting Star rating assessment of the new layout with proposed countermeasures, the results show significant improvement. On the other hand, it can be observed that – despite much better rating values – the countermeasures were not sufficient enough to increase the number of stars for pedestrians. The drop from 620,1 to 118,2 is a major improvement of pedestrian safety at the location but it still remains in the worst, 1-star black category. For vehicle occupants and motorcyclists, the score was increased to 2 stars.

Figure 37 – Star rating vehicle occupants + motorcyclists – upgraded layout

Star rating score for vehicle occupants = 14,8 (smoothed)

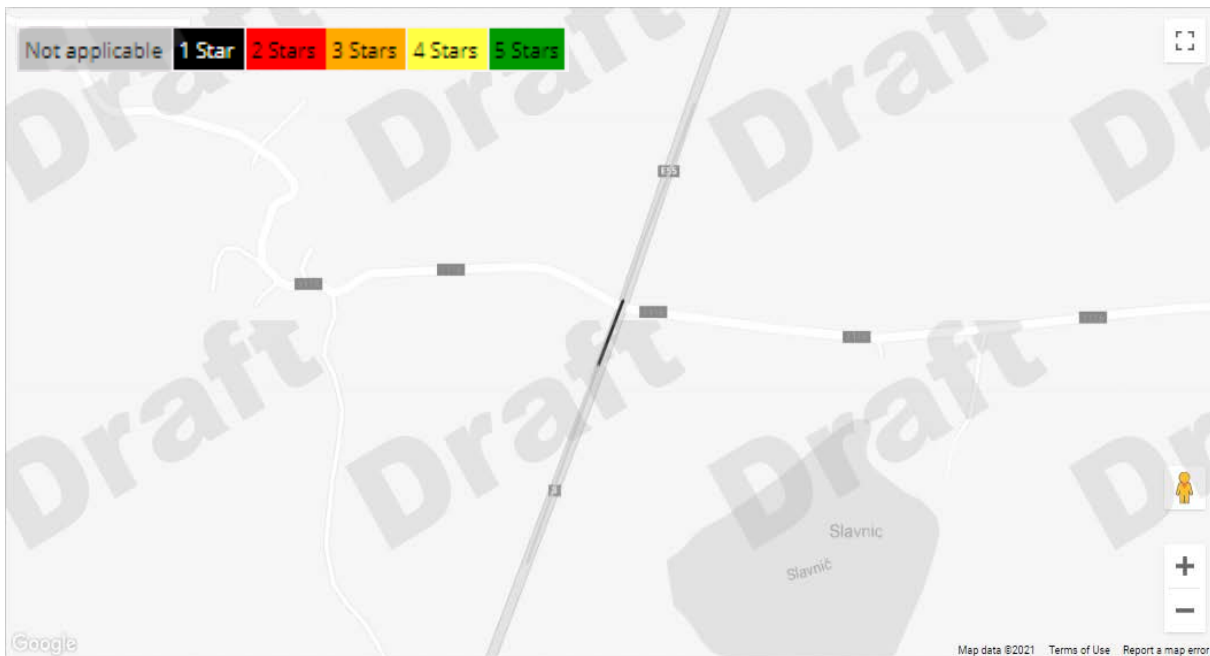
Figure 40 – Star rating pedestrians – upgraded layout

Star rating score for pedestrians = 118,2

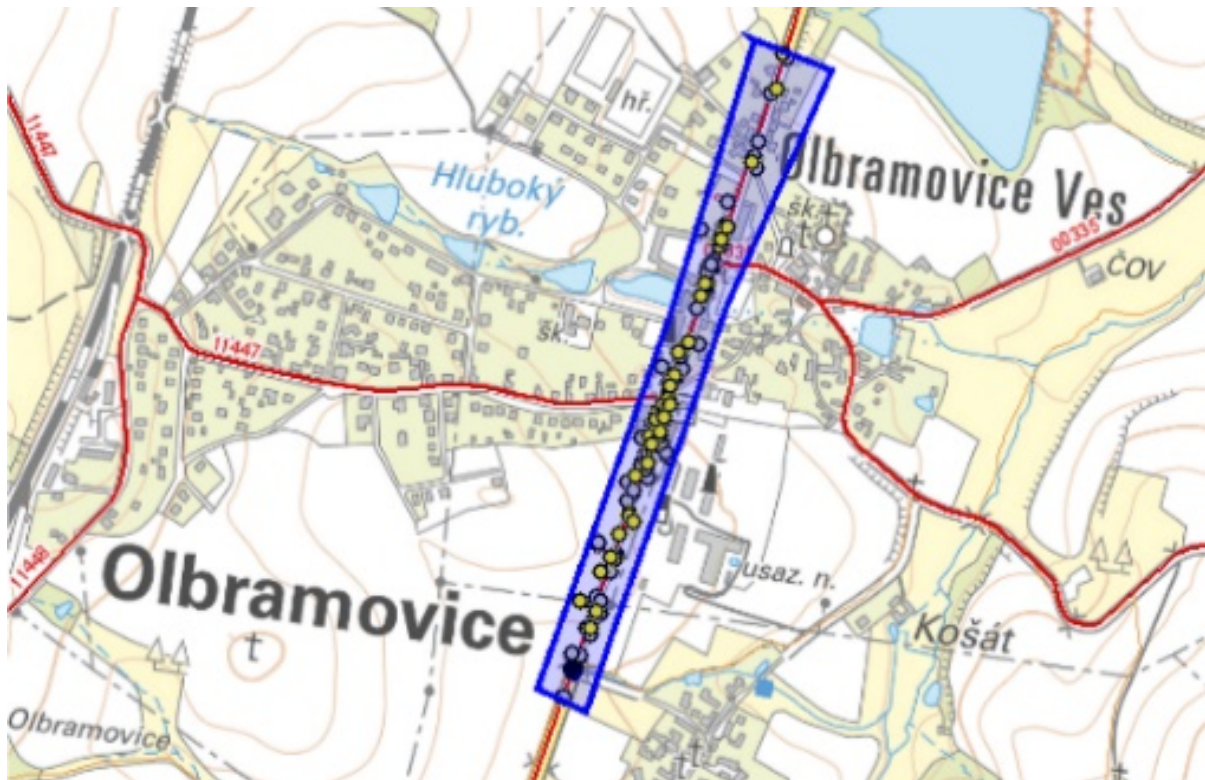
Figure 43 – Localization of accidents Case 2 (light blue/yellow/blue/black – no/light/serious/fatal injury)

Looking at what the most frequent causes of the 164 accidents are, one can find that 99 of them were caused by “not keeping a safe distance behind a vehicle”, while 18 relate to “not paying proper attention to driving”, which quite well comply with the presumption of rather non-fluent, slow and frequently obstructed traffic flow. In terms of VRUs, only 2 accidents involved pedestrians and resulted in their light injuries. However, the aim of the pilot study is to propose infrastructure safety upgrades for VRUs so that the risk of any potential collisions with traffic is reduced.

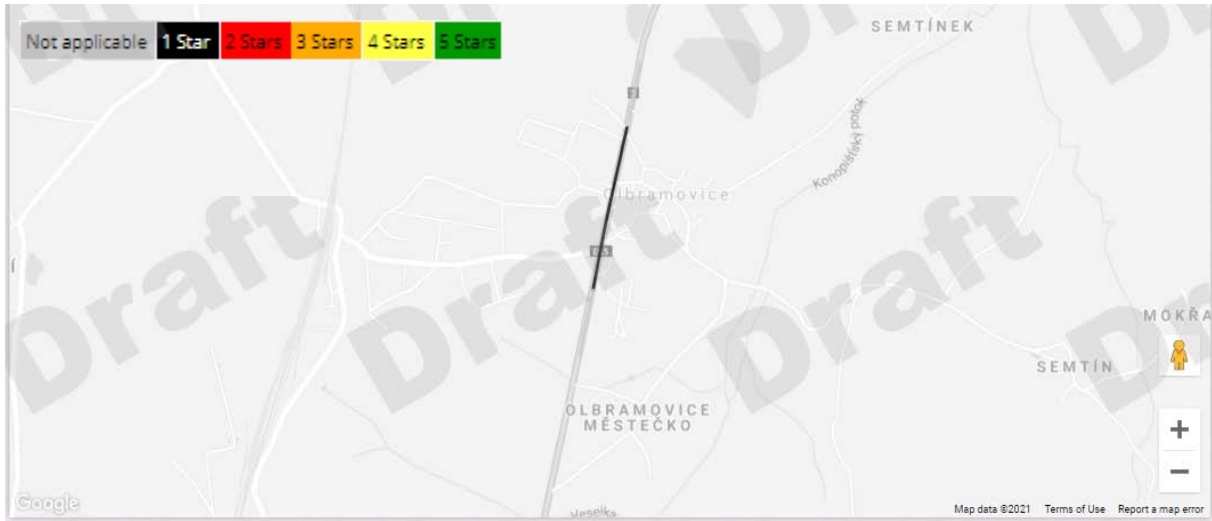
Figure 61 – Star rating pedestrians – existing layout

Star rating score for pedestrians = 52,9 (smoothed)

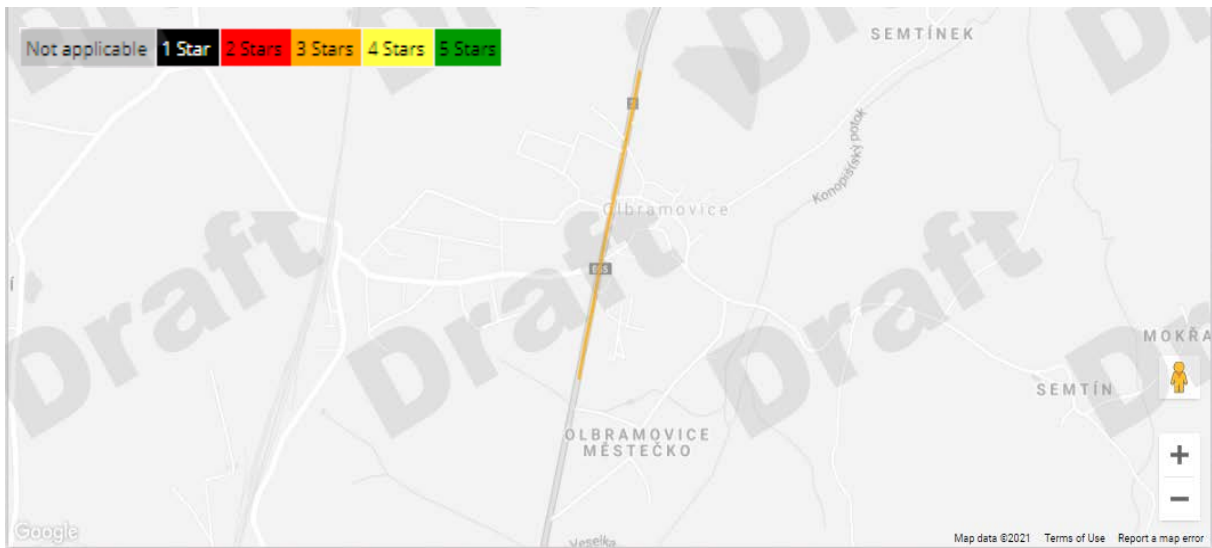
Figure 71 – Star rating vehicle occupants + motorcyclists – upgraded layout

After examining and scoring the new layout with proposed countermeasures, the safety level of the through-road improved significantly. **3-star level for vehicle occupants have been kept (even with lower Star rating score) and a decent improvement occurred with motorcyclists, where the whole section assessed is newly 3-star (first 100m segment of the existing layout was 2 stars. Important and satisfactory improvement can be observed with scoring for pedestrians, where the safety level went from 1 star to 3 stars.**

Star rating score for vehicle occupants = 6,79 – 7,83 (smoothed)

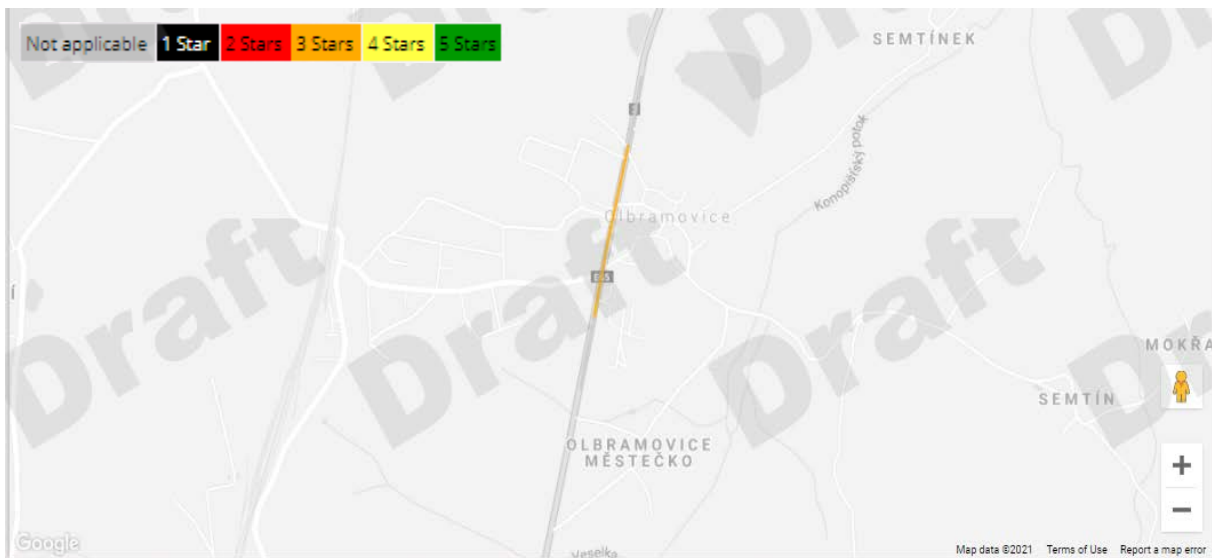
Figure 74 – Star rating vehicle pedestrians – upgraded layout

Star rating score for pedestrians = 12,7 (smoothed)
